Housing Report Blast: Türkiye

Common Housing Typologies and Observations from the 2023 Earthquakes

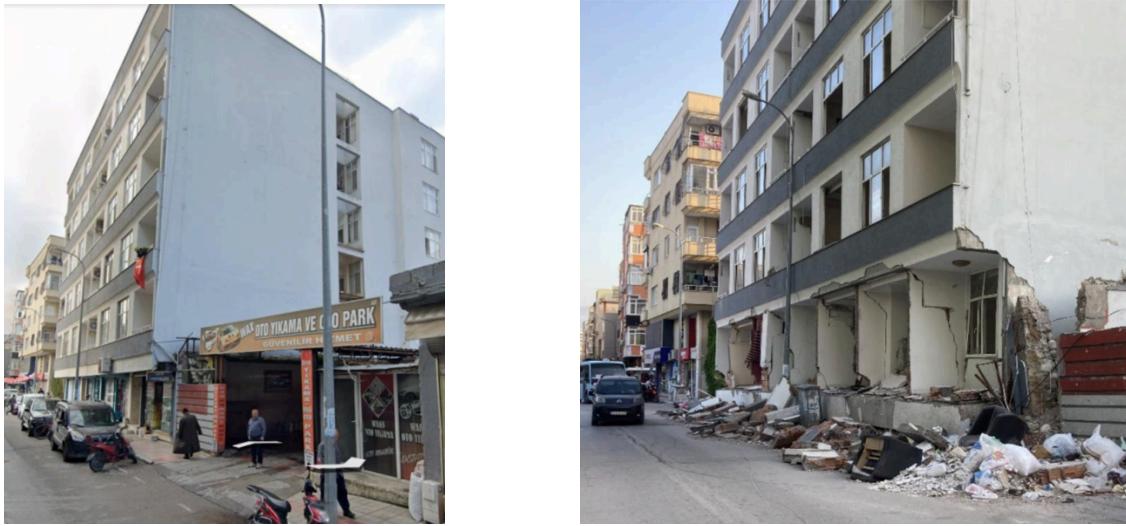
Approximately 80% of Türkiye's urban households live in multi-family mid-rise reinforced concrete (RC) frame buildings with masonry infills (WHE Report, Aktaş et al., 2024), with numerous instances of observed damage to these structures following the 2023 earthquake sequence. Typical damage patterns in these buildings depended on their age, height, type of floor system, and the amount of RC shear walls. Based on reconnaissance findings, many of the RC buildings that collapsed were built before 2000 with poor concrete quality and inadequate reinforcing (Aktaş et al., 2024), though several post-2000 buildings also collapsed, likely due to design and/or construction flaws (Brzev et al., 2025). Mid-rise buildings of this type often have open bottom floor(s) at one or more levels, which are prone to damage or collapse due to a "weak story" vertical irregularity. Similarly, many buildings of this typology have overhangs, where the footprint area increases above the ground floor level. This construction practice also represents a vertical irregularity and leads to earthquake damage or collapse of façade walls within the overhang, a very common damage pattern reported in these buildings after the 2023 earthquakes (Ozkula et al., 2023). Figure 1 shows an example of damage found in an RC residential building with masonry infills; 1(a) shows the building prior to the earthquake, and 1(b) shows the building following the earthquake where the ground floor has completely collapsed. This structure is an example of how vertical irregularities in RC buildings can lead to significant damage and collapse of soft stories.

Figure 1 - Soft story collapse of a mixed residential/commercial RC building in the Hatay province (Brzev et al., 2025)

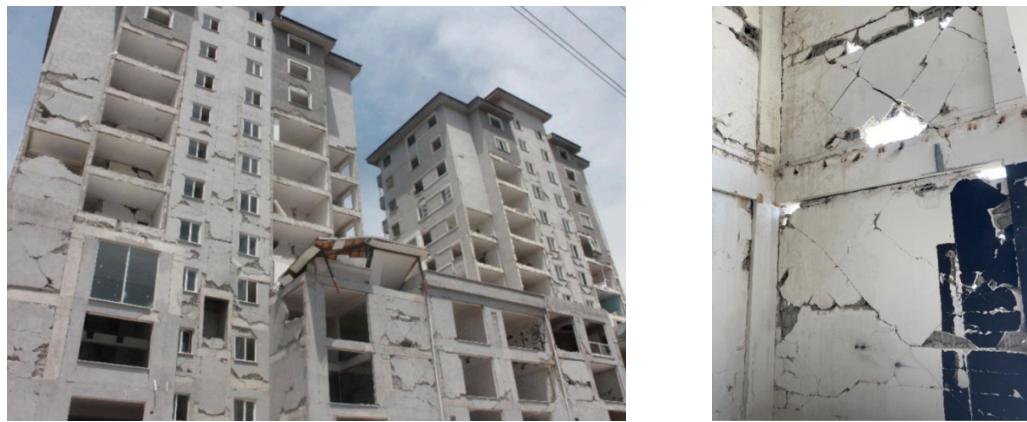
In addition to vertical irregularities, another vulnerability that led to damage and collapse in these structures is related to their RC floor system, characterized by relatively thin RC slabs and shallow frame beams (“asmolen” system). This frame member proportioning results in an excessively flexible lateral load-resisting system, which usually consists of bare frames without RC shear walls. As a result, many of these structures experienced collapse of masonry infills and partitions, as well as extensive non-structural damage. Thus, many buildings that did not sustain significant structural damage still needed to be replaced. Masonry infills saw particularly high levels of damage because they were constructed using either hollow clay tiles with horizontally aligned perforations or light-weight hollow concrete blocks, resulting in substandard levels of strength (Pujol et al., 2024; Brzev et al., 2025; Binici et al., 2023). An example of this type of damage is shown in Figure 2, which makes it evident why extensive damage to masonry infills and partitions can lead to building replacement.

Figure 2 - Failure of exterior masonry infills due to extensive cracking and separation from the frame (Brzev et al., 2025)

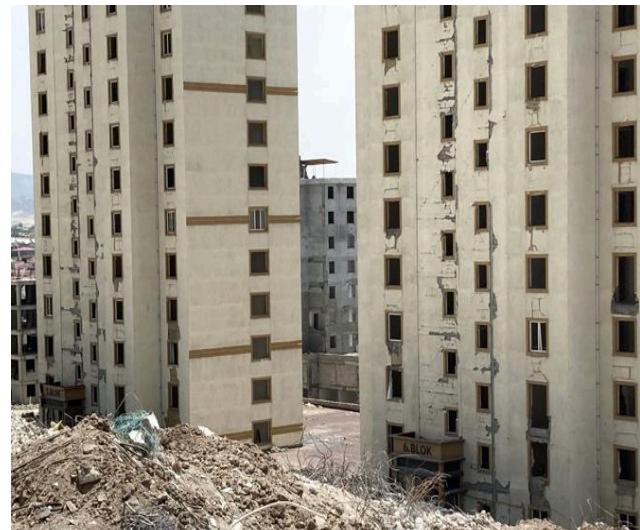
Although RC frames with masonry infill make up the large majority of housing units in Türkiye, there are several other notable housing typologies. One such typology is tunnel-form buildings. Tunnel-form buildings are rapidly constructed, multi-unit residential structures that have been used in Türkiye since the late 1970s. Named “tunnel-form” for their construction methodology, these structures are built by casting the walls and slab in a single operation using “half tunnel” steel forms, thus forming a monolithic joint. The formwork is typically reusable and a standard size, which helps increase construction speed (WHE). These structures are usually mid-rise (4-6 stories), although taller buildings of this type (11+ stories) are also common. The main lateral system is RC shear wall construction, with a cross-sectional wall area ranging from 2 to 6% of the floor plan (Brzev et al., 2025). Following the earthquake sequence, these structures were observed to be configured in one of two ways, (1) including similar amounts of wall in each floor plan direction, or (2) orienting most walls in a single direction (Pujol et al., 2024). The first type of configuration benefited from the relatively high density of well-distributed walls and was observed to perform well during shaking. On the other hand, the latter configuration showed more signs of structural damage (Pujol et al., 2024). Overall, tunnel-form buildings all satisfied collapse prevention across the affected area (Binici et al. 2024), and damage of tunnel-form buildings remained very limited compared to their RC frame counterparts (Aktaş et al., 2024, Binici et al. 2024; Pujol et al. 2024). Most 4-6 story structures had almost no damage in the shear walls. However, some structural and nonstructural damage was observed in taller tunnel-form buildings, including buckling of longitudinal reinforcement, concrete spalling and crushing, and shear cracks at the first story (Figure 3). According to a report from about four months after the earthquake, many housing units were being constructed using the tunnel-form system due to both its proven seismic performance and speed of construction (Brzev et al., 2025).

Figure 3 - Damaged tunnel-form buildings (Brzev et al., 2025)
