# World Housing Encyclopedia

## HOUSING REPORT

### **Reinforced concrete frame building with masonry infills**

<b>Report#</b>	64
<b>Last Updated</b>	
<b>Country</b>	Turkey
<b>Author(s)</b>	Polat Gulkan, Mark Aschheim, Robin Spence,
<b>Reviewers</b>	Craig D. Comartin,

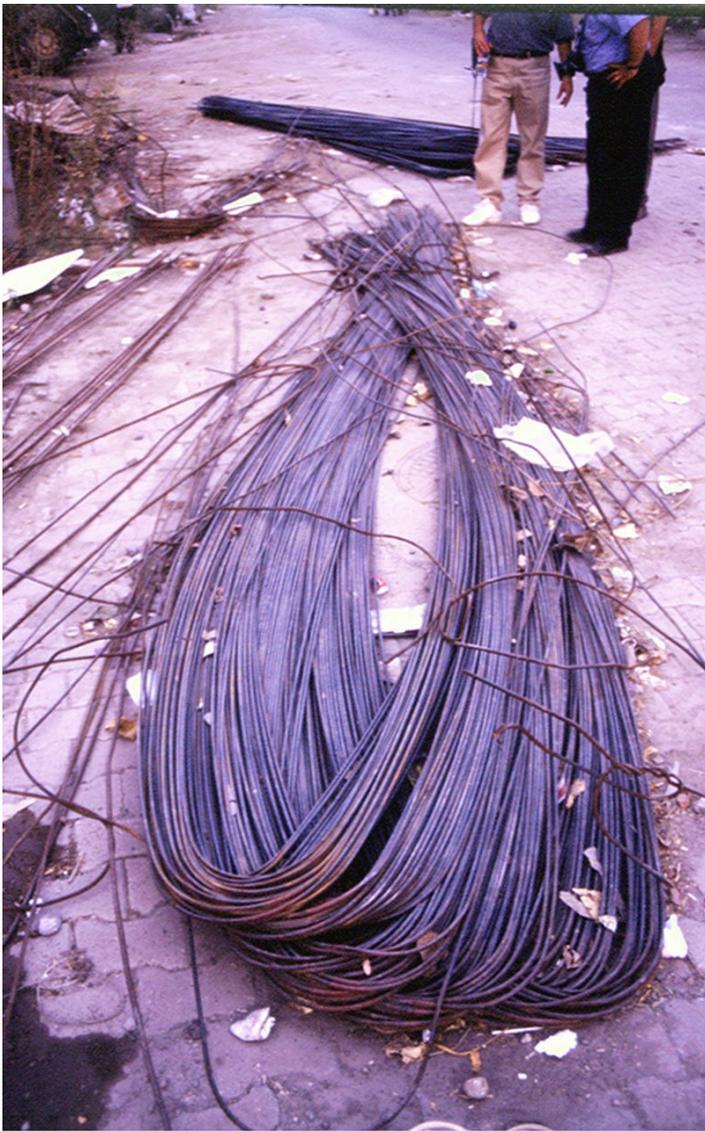
***Critical Structural Details -  
Smooth Reinforcing Steel Delivered  
to a Construction Site Bent into a  
"U" Shape (no material  
certification provided) (EERI 2000)***

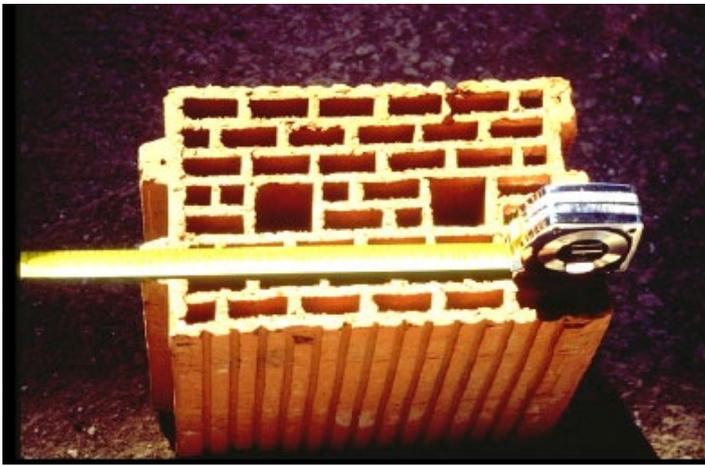
**Critical Structural Details - Typical Hollow Clay Tile Infill Block (EERI 2000)**
