World Housing Encyclopedia

HOUSING REPORT

Street front building with arcade at the first floor (contemporary construction)

Report #	62
Report Date	05-06-2002
Country	TAIWAN
Housing Type	RC Moment Frame Building
Housing Sub-Type	RC Moment Frame Building : Designed for gravity loads only, with URM infills
Author(s)	George C. Yao, M. S. Sheu
Reviewer(s)	Craig D. Comartin

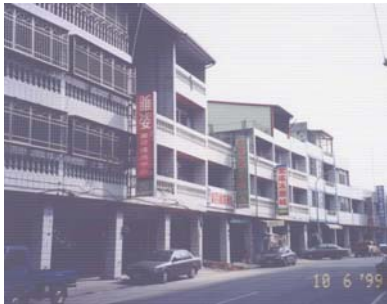
Figure 1A: Typical Building

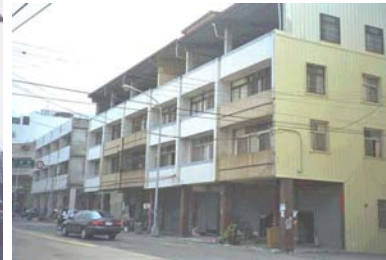
Figure 1B: Typical Building (Source: EERI 2001)

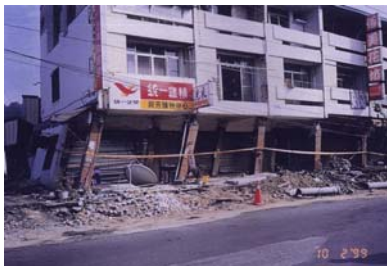
Figure 6A: A Photograph Illustrating Typical Earthquake Damage

Although many buildings of this construction type sustained significant damage in the 1999 Chi Chi earthquake, most of them performed satisfactorily. Earthquake damages are illustrated in Figures 6A, 6B, 6C, 6D, 6E, and 6F. The main causes for damage observed after the earthquake are (EERI, 2001): 1) Poor configuration attributable to the open front combined with inadequate column lateral reinforcement (ties). The large displacement demands from the soft-story and torsional effects often damaged the plastic hinge regions of the columns at the open front. All damaged columns were observed to have non-ductile confinement reinforcement details consisting of widely spaced horizontal hoops, more than 300 mm apart, and 90 degree hooks. Usually, the lack of confinement reinforcement in the plastic hinge regions resulted in brittle failure. In some cases, hinge rotation caused buildings to permanently lean out of plumb. In other cases, buildings with no signs of earthquake damage remained standing next to the seemingly identical buildings that sustained the total collapse of entire bottom stories. 2) There was also widespread damage to the unreinforced brick partitions and perimeter walls. Although partitions are usually considered nonstructural elements, the collapse of or damage to unreinforced brick partitions represents a significant falling hazards, and it forced many people out of their homes. 3) Performance of this construction type in the earthquake was significantly influenced by the infill wall layout. Because brick infills significantly influence the structural characteristics and yet are not considered in the design, the seismic performance of this building type is highly unpredictable.

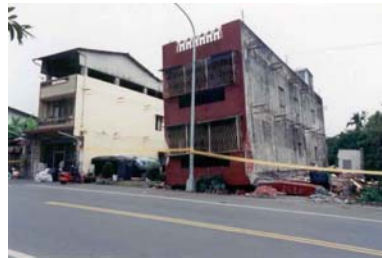
Figure 6B: Earthquake damage-Collapsed Three-story building in the 1999 Chi Chi earthquake (Source: EERI 2001)

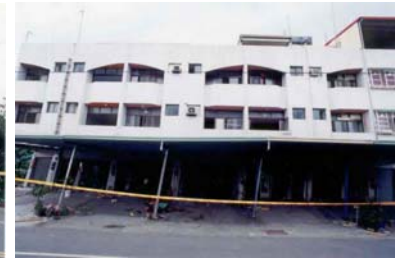
Figure 6C: Earthquake Damage - Partial Collapse of a Three-story building in the 1999 Chi Chi Earthquake (Source: EERI 2001)

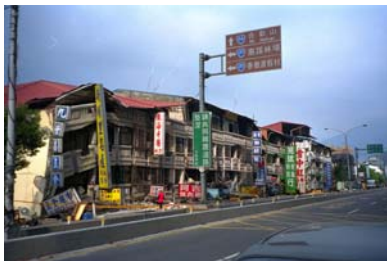
Figure 6D: Earthquake Damage - Pancake Collapse of an Entire City Block in the 1999 Chi Chi earthquake (Source: EERI 2001)

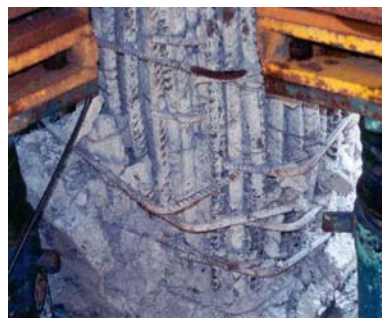
Figure 6E: Earthquake Damage - Opening of 90 degree column hooks in the 1999 Chi Chi earthquake (Source: EERI 2001)

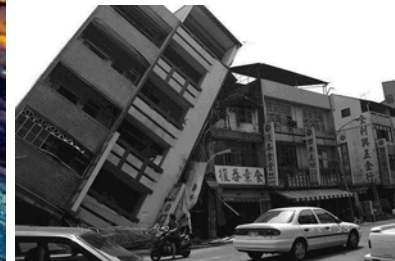
Figure 6F: Collapse of a Concrete Frame Building in the 1999 Chi Chi Earthquake (Source: EERI 2001)
