HOUSING REPORT

Reinforced Concrete Moment Frame Building without Seismic Details

Report#	111
Last Updated	
Country	USA
Author(s)	Heidi Faison , Craig D. Comartin, Kenneth Elwood ,
Reviewers	Mahmoud M. Hachem, Ayhan Irfanoglu ,

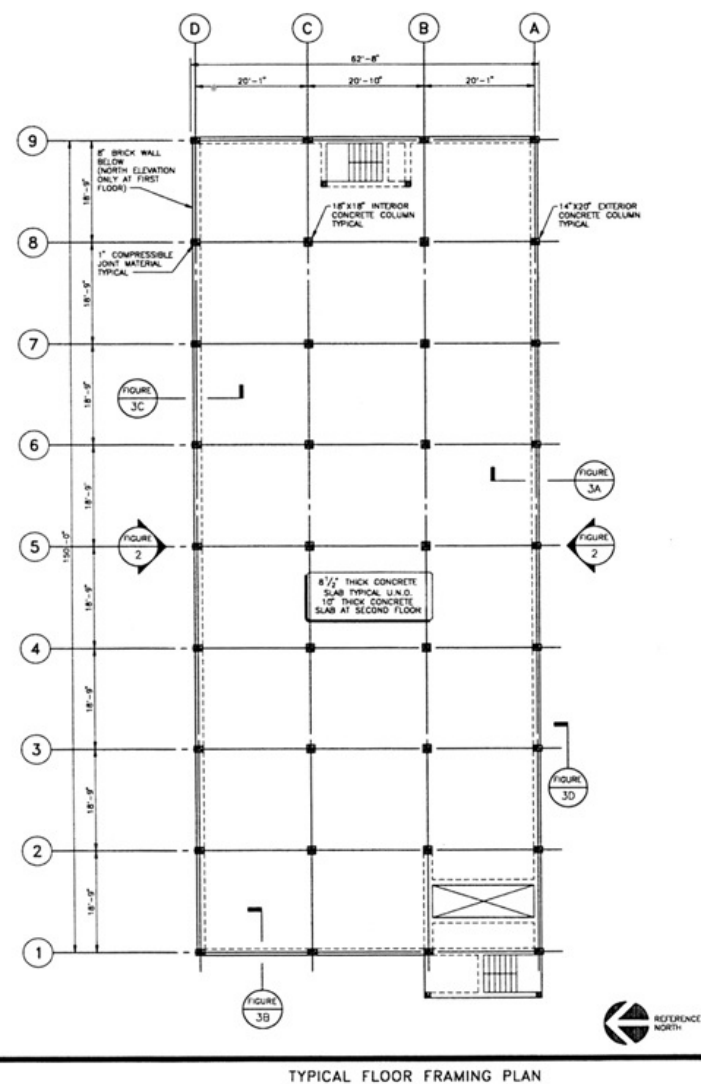
TYPICAL FLOOR FRAMING PLAN

Example Building Study
Holiday Inn, Van Nuys, CA

Typical Building Plan (Holiday Inn, Van Nuys, CA) [1]

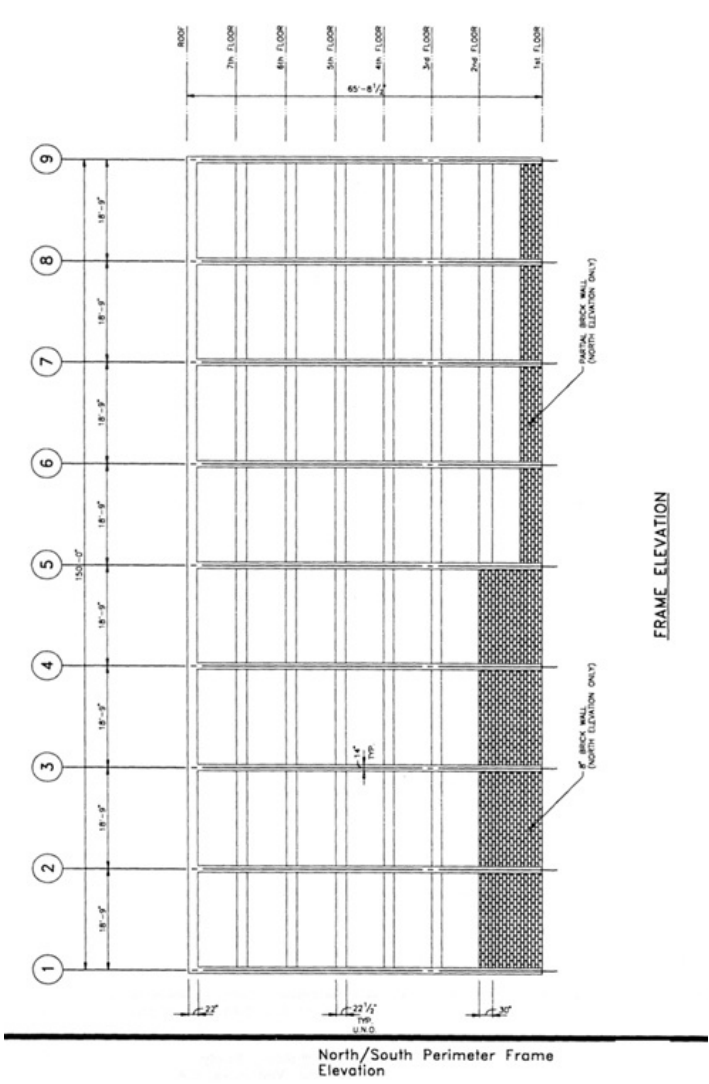
North/South Perimeter Frame
Elevation

Example Building Study
Holiday Inn, Van Nuys, CA

Typical Elevation (Holiday Inn, Van Nuys, CA) [1]

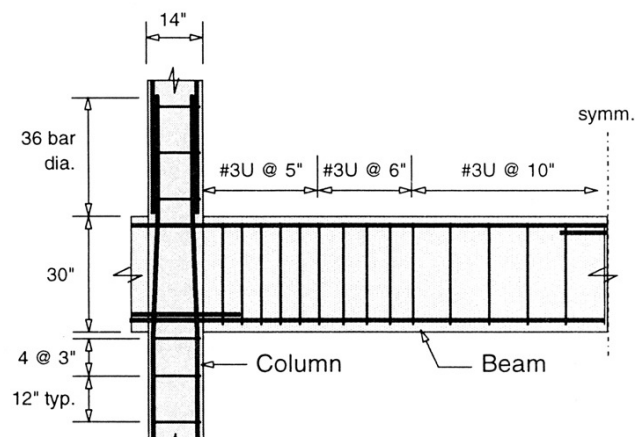
Typical Exterior Frame Detail [12]

Beam Sections and
Elevation at Column
Example Building Study
Holiday Inn, Van Nuys, CA

Typical Details (Holiday Inn, Van Nuys, CA) [1]

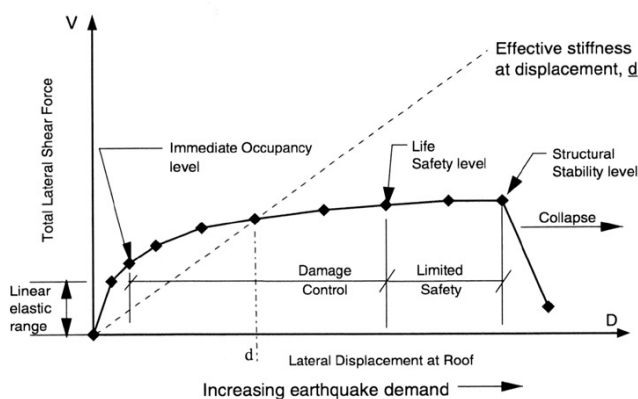
Typical Capacity Curve

Typical capacity curve showing building performance levels. [1]

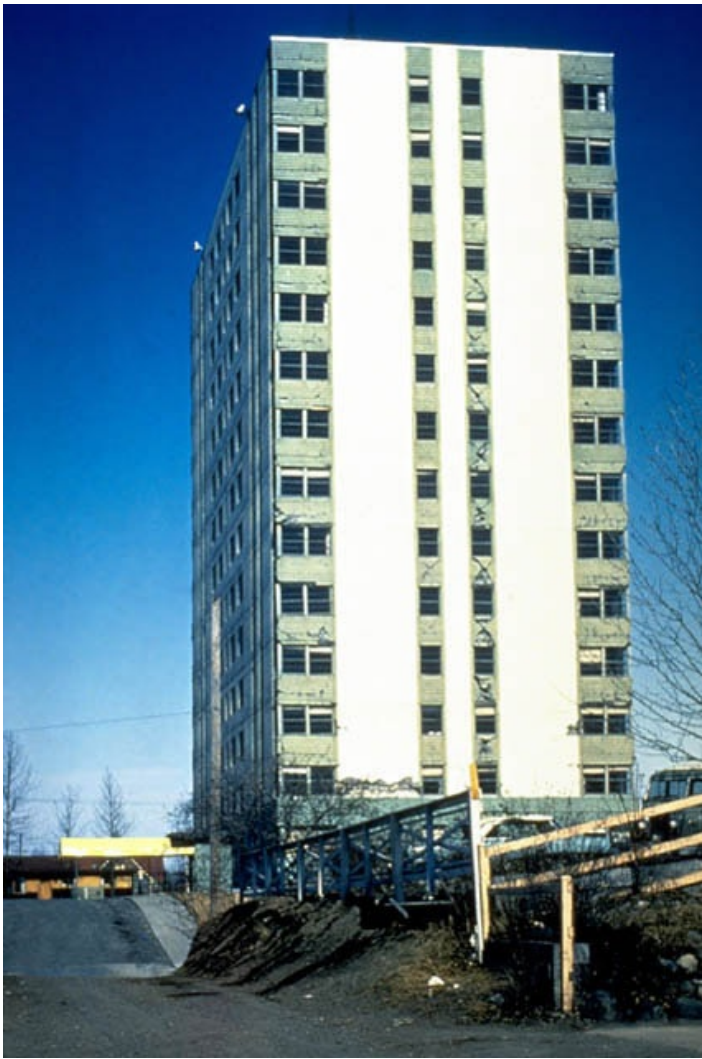
Overall view of the 1200 L Street Apartment building, Anchorage, Alaska after damage from the 1964 earthquake. This 14-story reinforced concrete structure has a basic lateral-resisting structural system and a series of slender walls

reinforced concrete L Street Apartment building in Anchorage, Alaska used a series of slender walls connected with short spandrel girders to resist lateral loads. Characteristic x-shaped shear cracks in the girders showed that the girders were not properly designed to resist shear demands (Figures 6 & 7). West Anchorage High School in Anchorage, Alaska was a 2-story concrete frame building with shear walls that showed extreme damage. Failures were present in its beam-column joints, columns, shear walls and roof diaphragm (Figures 8 & 9). (c) After the 1971 San Fernando earthquake, the engineering community realized that more seismic detailing would be necessary for concrete buildings. The damage and subsequent research from this earthquake inspired key changes to code design requirements for concrete moment frame buildings. (d) Several main buildings highlighted the vulnerability of reinforced concrete design following the current building code in the San Fernando earthquake. Olive View Medical Center experienced damage in many of its buildings. The Olive View Psychiatric Day Care Center was a two-story moment frame building whose bottom story columns failed and caused the collapse of the complete lower story (Figure 10). The Olive View Hospital experienced great damage as well (Figures 11-12). The main issues related to moment frame design from this building are in regard to column detailing. General views of the hospital building show distortions of the first story columns, which were of two designs (Figure 13). The twelve corner columns were L-shaped with six ties (No. 3's at 18 inches) spaced over the story height (Figure 14). These columns completely shattered. The other 152 columns in the building had spiral steel ties (5/8 in. at 2-1/4 in. spacing) and although they lost much of their concrete covering, they retained load-carrying capacity (Figures 15 - 17). The ability of the spirally-reinforced columns to maintain vertical load carrying capability with such large horizontal drift demonstrates the advantage of detailing concrete for ductile behavior. These spiral columns would have been helped even more by the placement of all longitudinal steel within the spirals. Figure 13 shows the detail of the spiral column with its longitudinal steel within the steel spiral yet the damage images shows some rebar on the exterior of the spirals (Figures 15 & 16). While much of the major building damage was restricted to the first floor columns, there were shear failures in some of the upper story columns. Also many of the connections were damaged. Another concrete

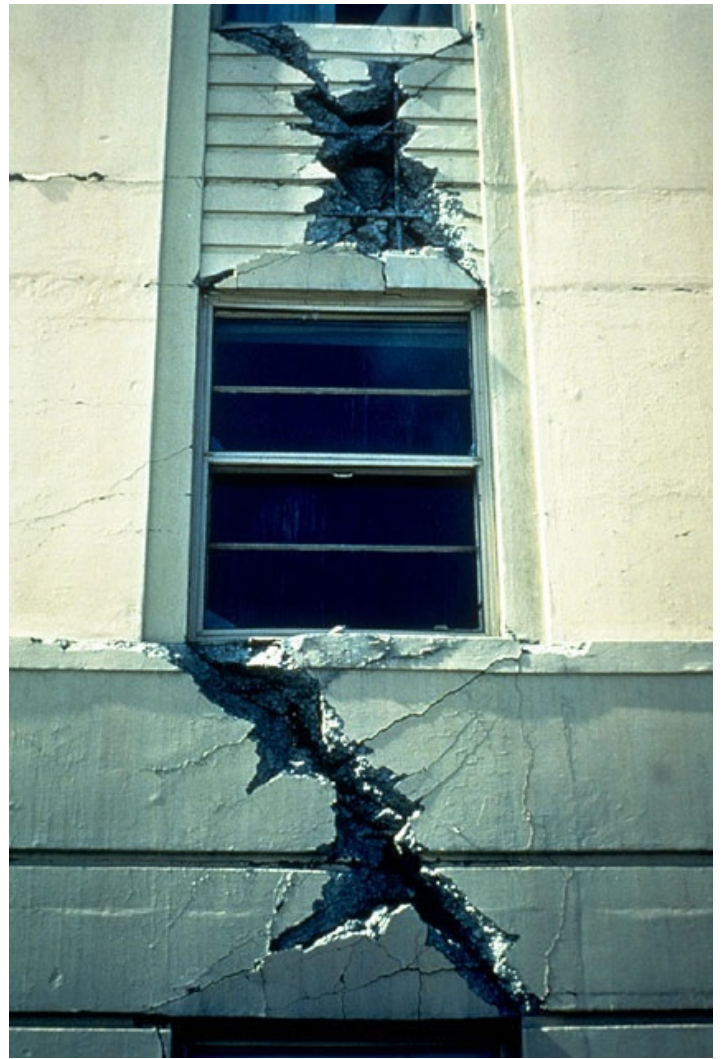
Close-up of characteristic X-shaped cracks and failure of coupling girders or short spandrel girders in the L street apartment building, Anchorage, Alaska. These girders were not properly designed for the shear demands. [10]

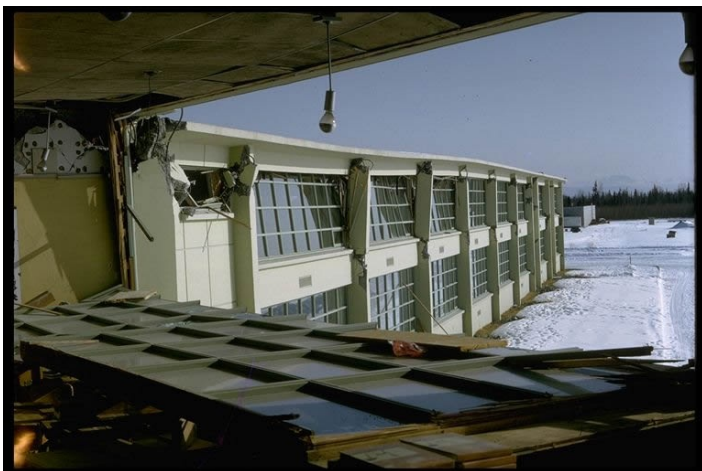
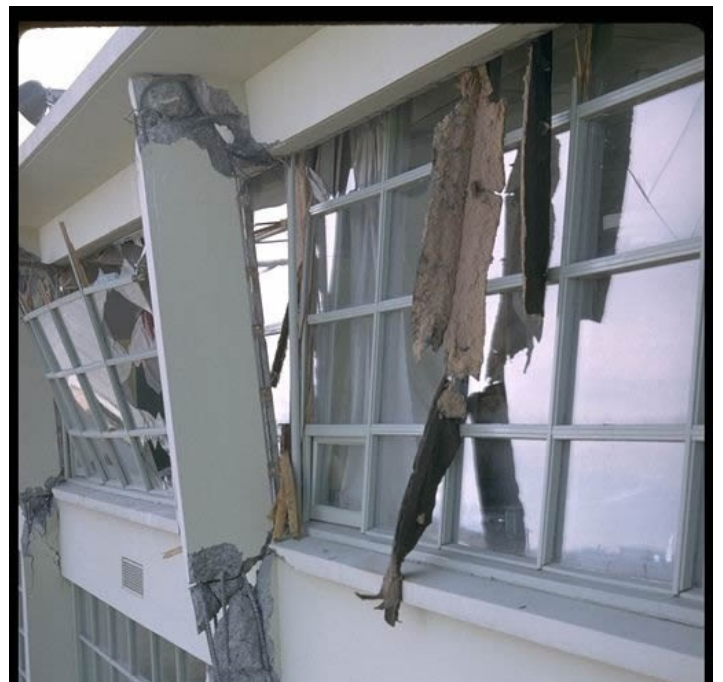
Damage to West Anchorage High School from the 1964 Alaska earthquake. Window wall fell inwards into the classrooms. Note sag in roof due to failure of

reinforced concrete diaphragm. [9]

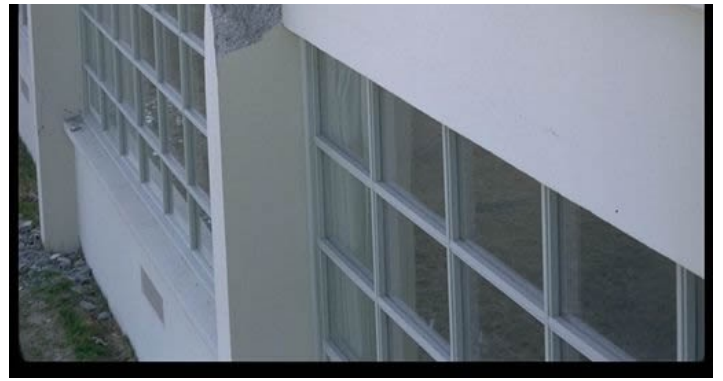
Detail view of damage to the column and beam joints at West Anchorage High School, Anchorage, Alaska. [9]

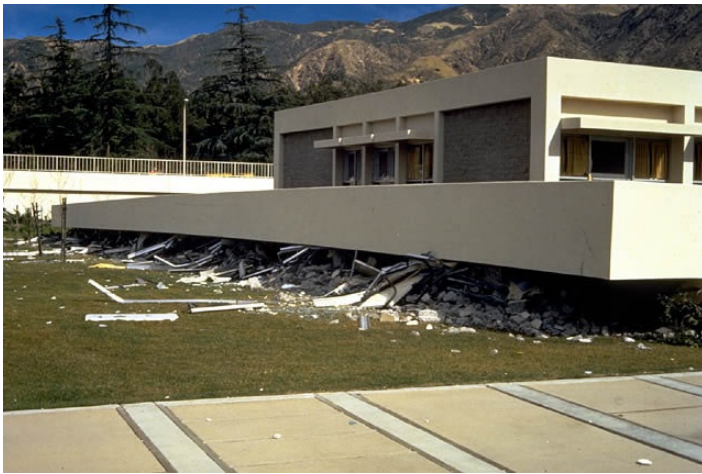
Olive View Hospital, Psychiatric Unit, 1971 San Fernando Earthquake. This unit was a 2-story reinforced concrete building. The structural system was a moment resisting frame.

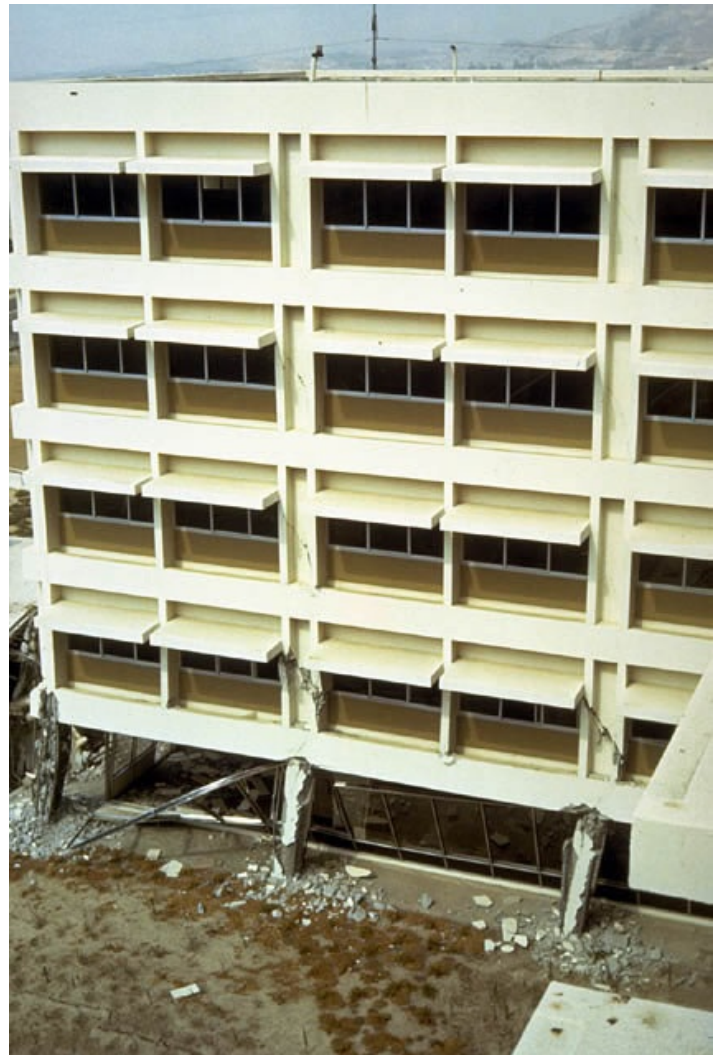
Olive View Hospital, Medical Treatment and Care Unit, 1971 San Fernando earthquake. View of the end of one of the four wings of this 5-story reinforced concrete building after the earthquake.

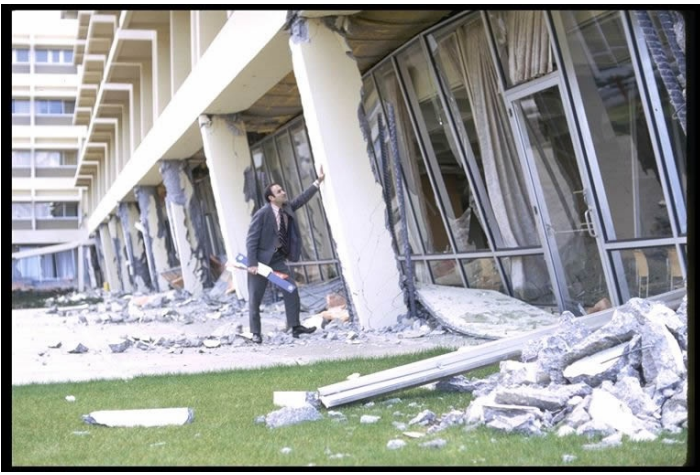
Damage to Olive View Hospital bottom story moment frame columns from the San Fernando earthquake. [9]

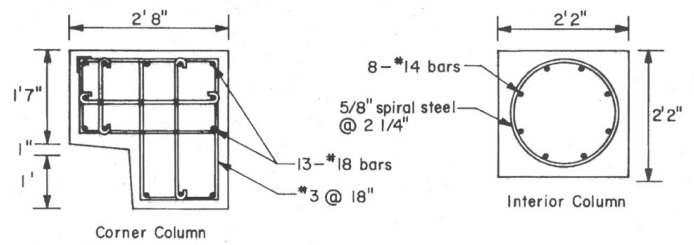
Typical First Floor Column Details

Details of Olive View Hospital Columns. [8]

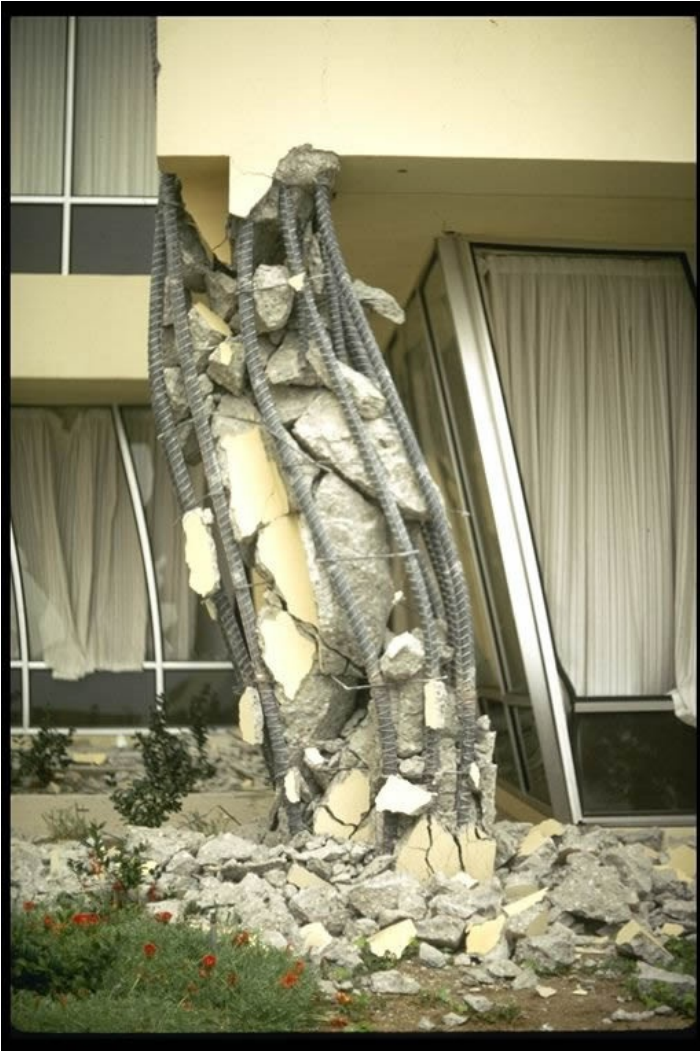
Example of damage to the corner columns at Olive View Hospital which was the result of poor seismic detailing. [9]

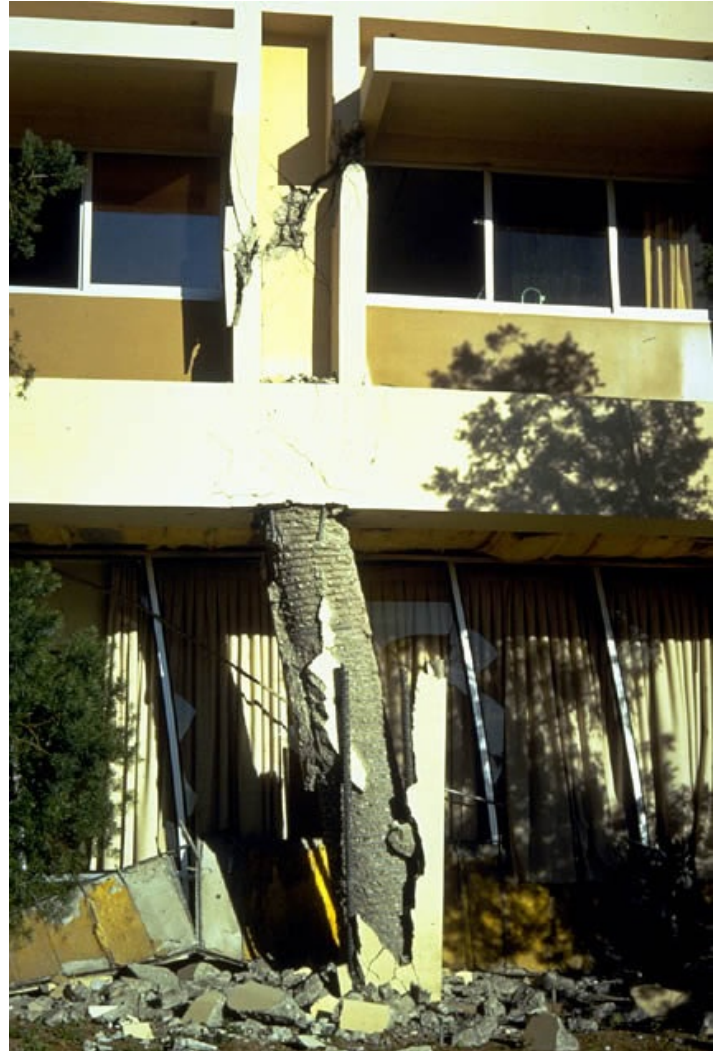
Detail view of the behavior of one of the first and second story columns in the Olive View Medical Treatment and Care Unit during the 1971 San Fernando Earthquake. Note the large permanent distortion of the first story column.

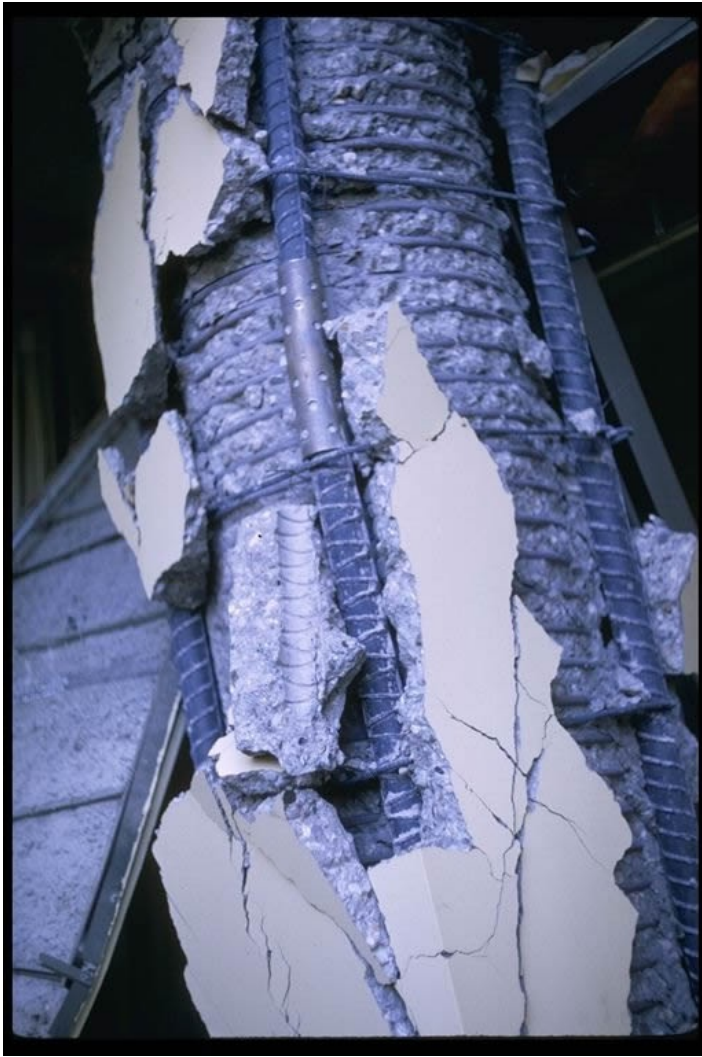
Detailed view of column with spiral confinement steel. The spiral confinement steel helped keep the concrete core intact. The longitudinal reinforcement is tied on the exterior of the spiral; this detail leaves the longitudinal steel vulnerable.

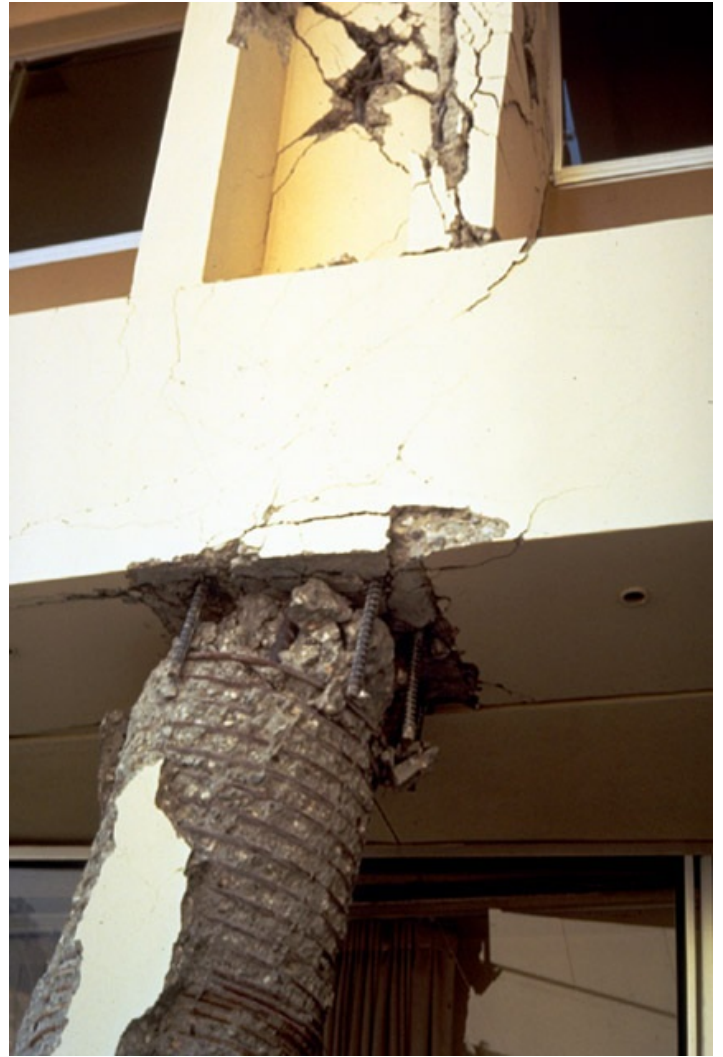
Olive View Hospital, 1971 San Fernando earthquake. Close-up of the top of the column illustrating how the concrete in this critical region has been disrupted (broken off) as a consequence of the premature ending of the spiral reinforcement. [10]

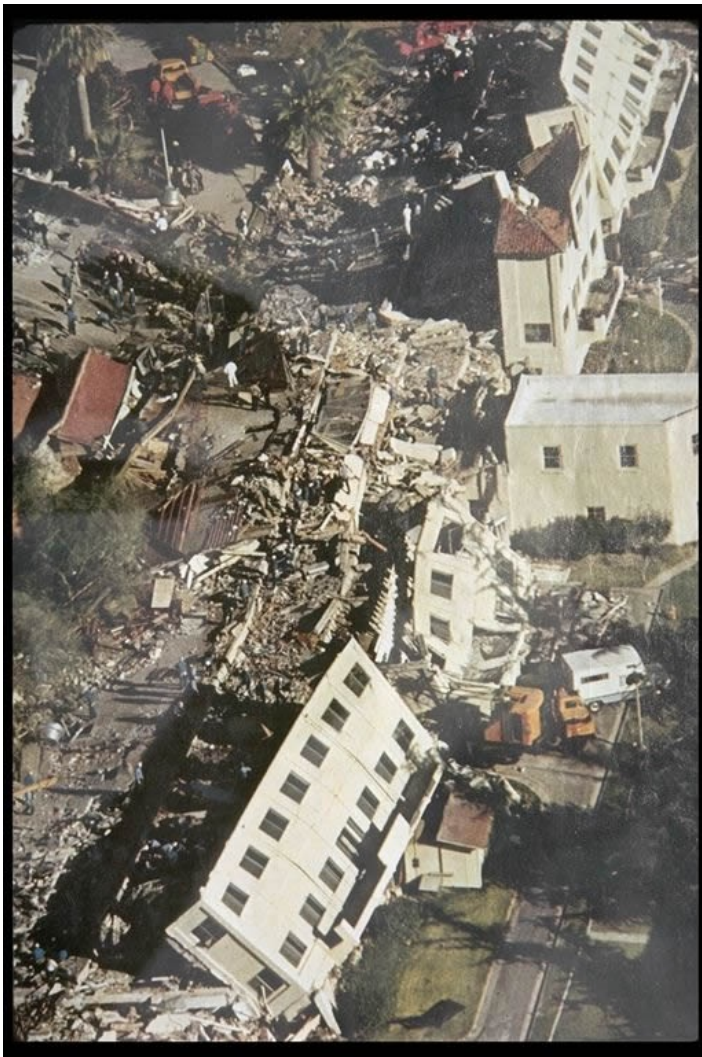
Collapse of the San Fernando Veterans Administration Hospital from the 1971 San Fernando earthquake. The image is from air photos take shortly after the event. [9]

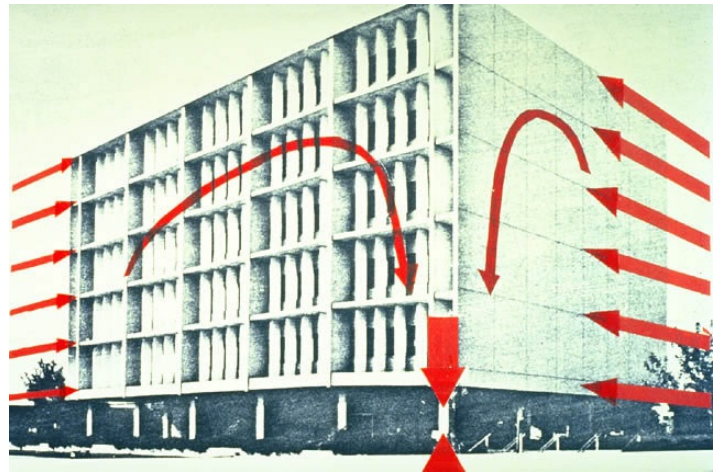
During the 1979 Imperial Valley earthquake, the 6 story reinforced concrete Imperial County Services Building developed significant inertia forces simultaneously in the two main directions (illustrated in red).

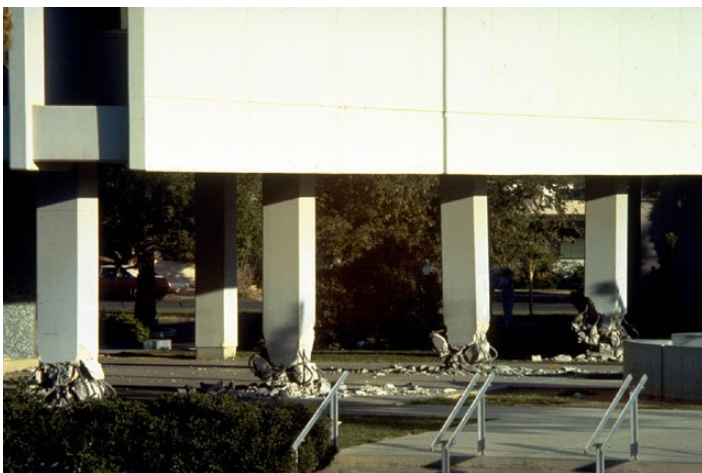
View of the 1979 Imperial Valley earthquake damage in the first story columns located in the east end of the Imperial County Services building. Note the explosive type of failure just above the ground.

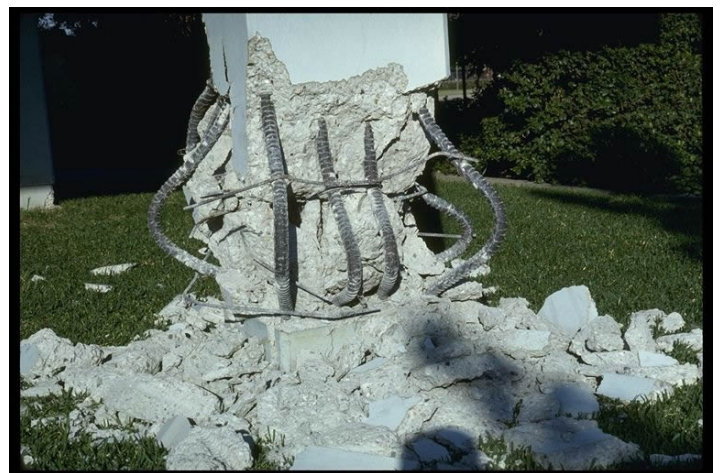
Close-up of the failure at the bottom of a column of the Imperial County Services building. The failure occurred in the zone of the column where there was not adequate confinement of the concrete and no

shear reinforcing steel. [9]

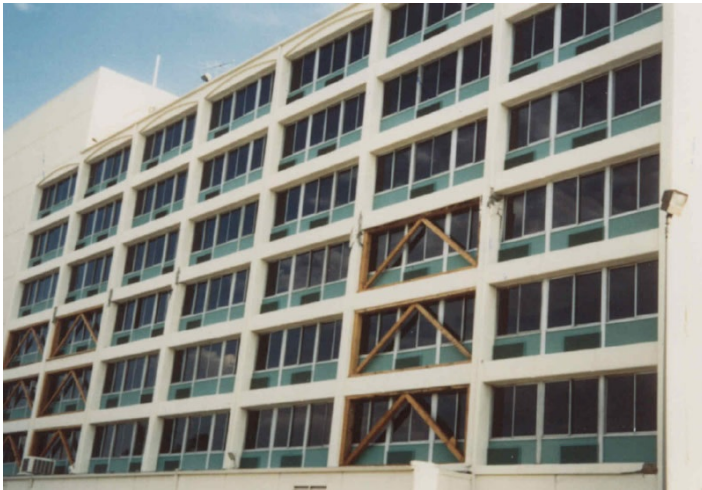
View of Holiday Inn, Van Nuys, CA with damage from the 1994 Northridge earthquake. The lateral system consists of reinforced concrete perimeter moment frames.

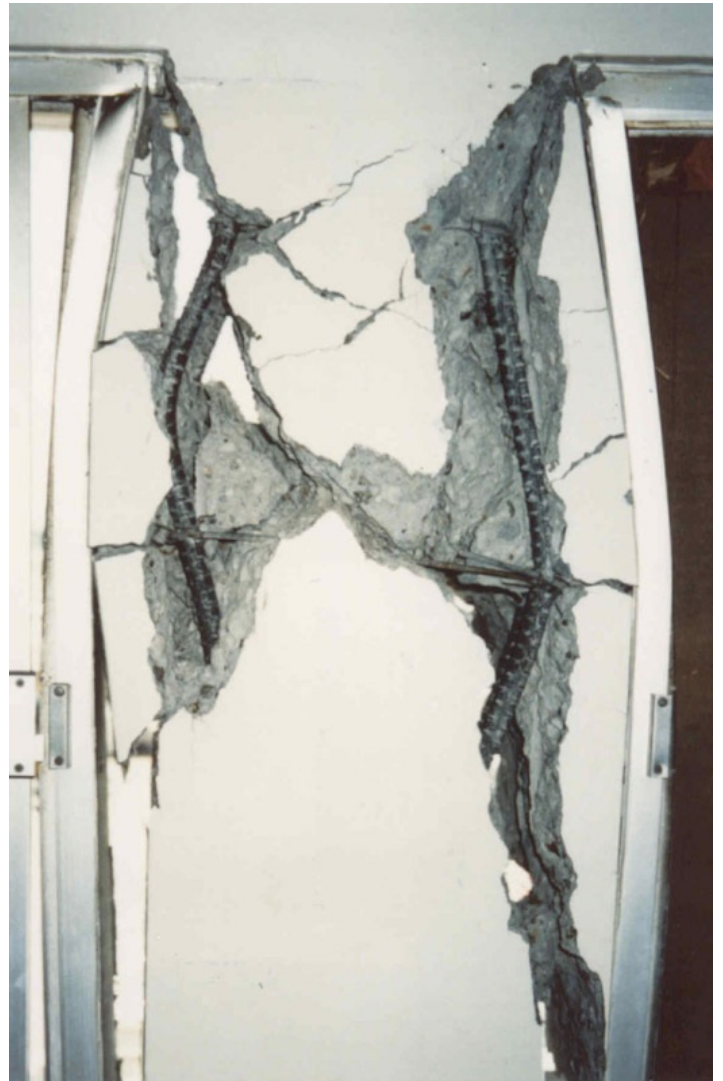
Damage to the Holiday Inn, Van Nuys primarily consisted of shear failure of the columns and subsequent buckling of column vertical reinforcing between the ties where added confinement provided by the concrete cover was no longer available,

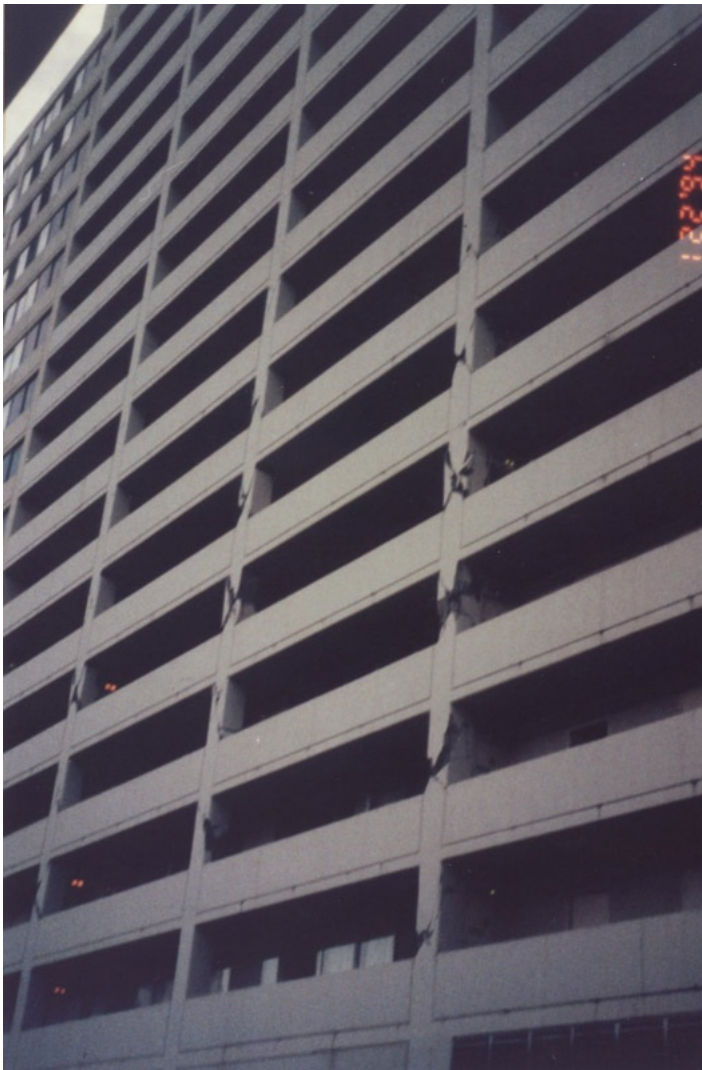
Damage from the 1994 Northridge earthquake to the perimeter moment frames of the Champaign Tower in Santa Monica, CA. [5]

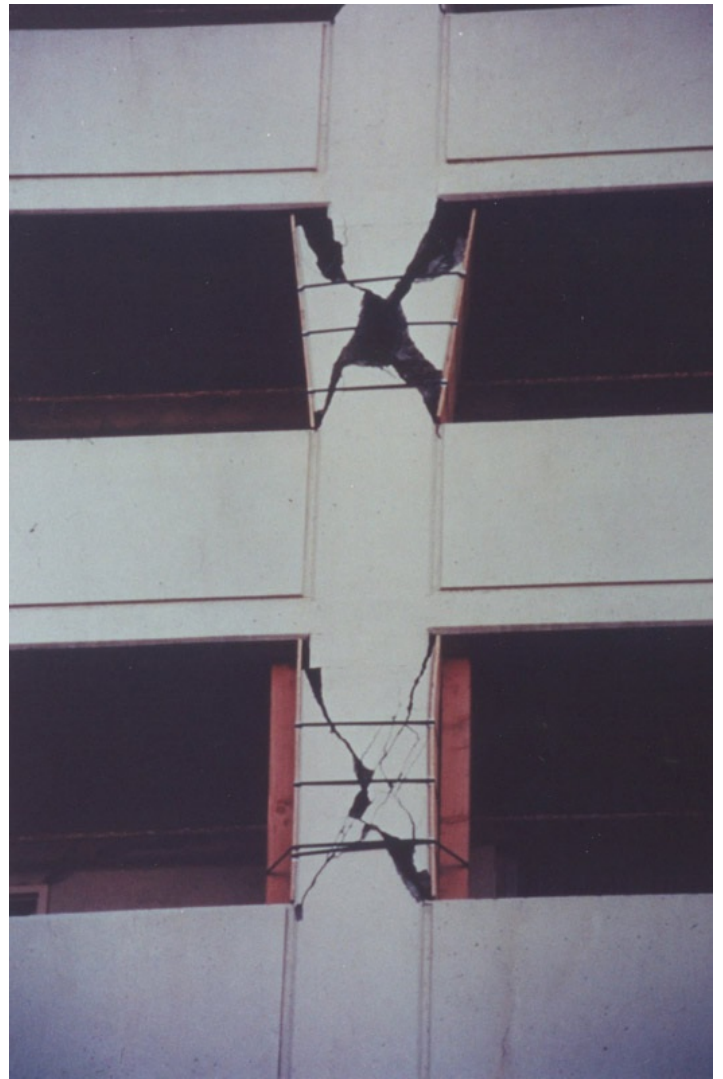
Balcony parapets induced short-column effects in the Champaign Tower moment frames. Typical X-shaped shear cracking from the short-column behavior is shown. [5]

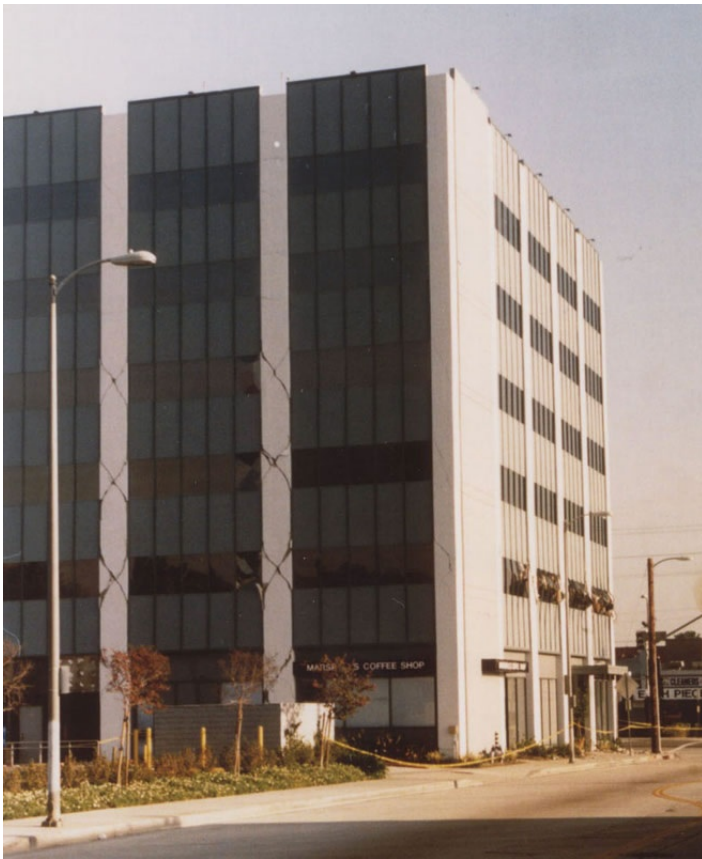
Damage to the L-shaped Barrington Medical Building, West Los Angeles, CA. Shear cracking in the perimeter frames undermined the column strength enough at some levels that the windows buckled due to a decreased column/story height. [5]

Concrete moment frames without seismic detailing were among the most susceptible building types and experienced vast amounts of damage and many collapses. Many of these buildings suffered due to inadequate strength but the main problem was their inadequate ductility. Brittle shear failures and other undesirable failure modes often dominated the building behavior and performance. --An example of reinforced concrete moment frame damage from the Northridge earthquake is the Holiday Inn in Van Nuys, CA. The Holiday Inn is a 7-story concrete flat slab building with perimeter frames built in 1966 whose lateral loads were resisted by a combination of the interior column-slab frames and the exterior column-spandrel beam frames (Figures 1 - 3). Damage primarily consisted of shear failure of the columns and subsequent buckling of column vertical reinforcing between the ties where added confinement provided by the concrete cover was no longer available due to spalling (Figures 22 & 23). Minor to moderate shear cracks were observed in many beam-column joints at the lower stories. Several spandrel beams showed minor spalling as well as flexural cracks at the bottom of the beams, suggesting possible yielding of the bottom reinforcement. The building was red-tagged after the event and temporary shoring was placed in some bays where the vertical load carrying capacity was compromised. The Champaign Tower in Santa Monica, CA was a 15-story concrete building with nonductile moment frames in one-direction and shear walls in the other. Balcony parapets shortened the column spans, which induced short column effects on many columns in the lower stories as shown by the X-shaped shear cracking (Figures 24 & 25). Extensive coupling beam shear failures were evident in the building direction that had shear walls to resist the seismic loads. The Barrington Medical building was a 6-story, L-shaped reinforced concrete building built in the late 1960's. The lateral system included perimeter frames, shear walls along the interior core and shear walls at the perimeter. Shear cracking in the perimeter frame columns comprised most of the structural earthquake damage and undermined the column strength enough at some levels that the windows buckled due to a decreased column/story height (Figure 26).

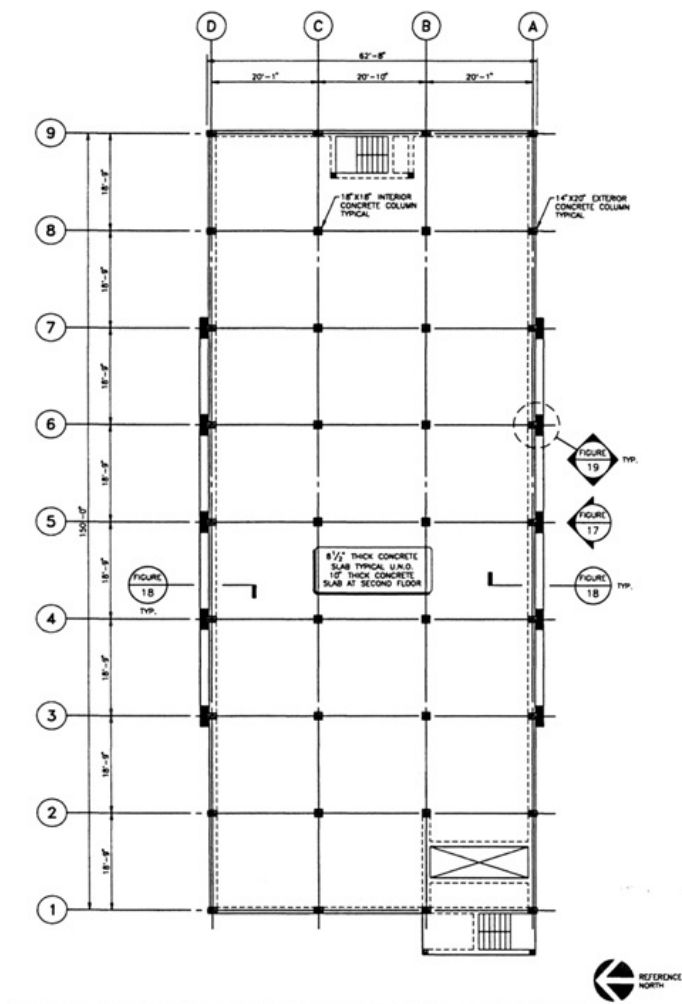
Typical Floor Framing Plan :
Life Safety Retrofit

Plan of retrofit design for Holiday Inn, Van Nuys, CA. [1]

Many of these strengthening techniques have been applied to institutional buildings (i.e. universities) throughout California. The Holiday Inn in Van Nuys, CA which was damaged in the 1994 Northridge earthquake was retrofitted after the earthquake to repair the structure and improve its future earthquake performance. The method used for this structure was to insert new lateral load resisting elements to take the full seismic loads. New

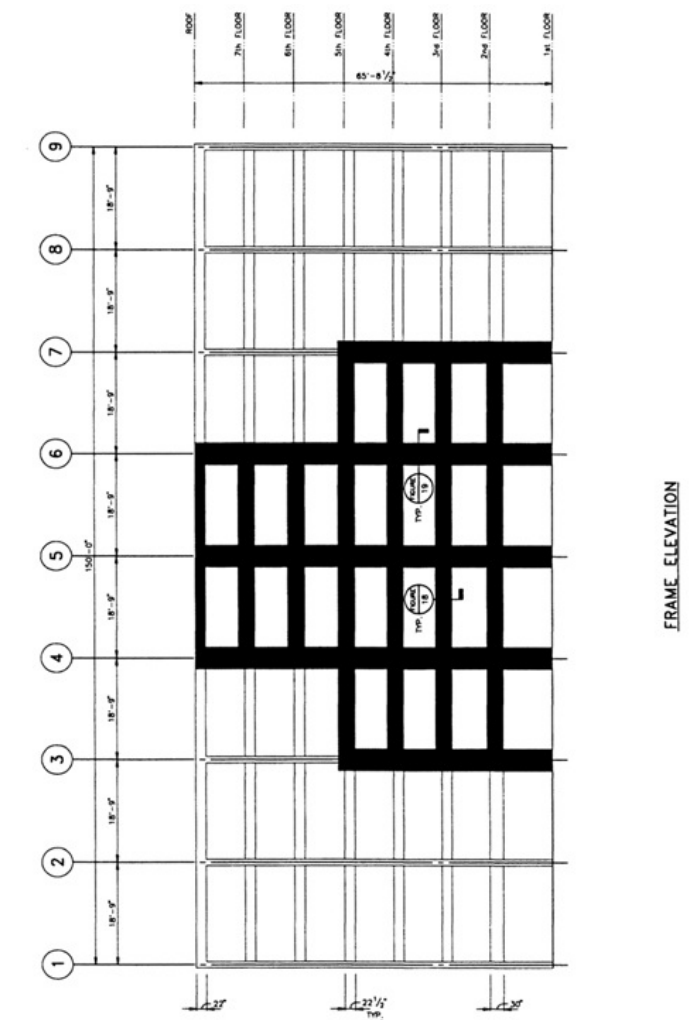
South Perimeter Frame
Elevation : Life Safety Retrofit

Elevation of retrofit design for Holiday Inn, Van Nuys, CA showing new moment frames to be added. [1]

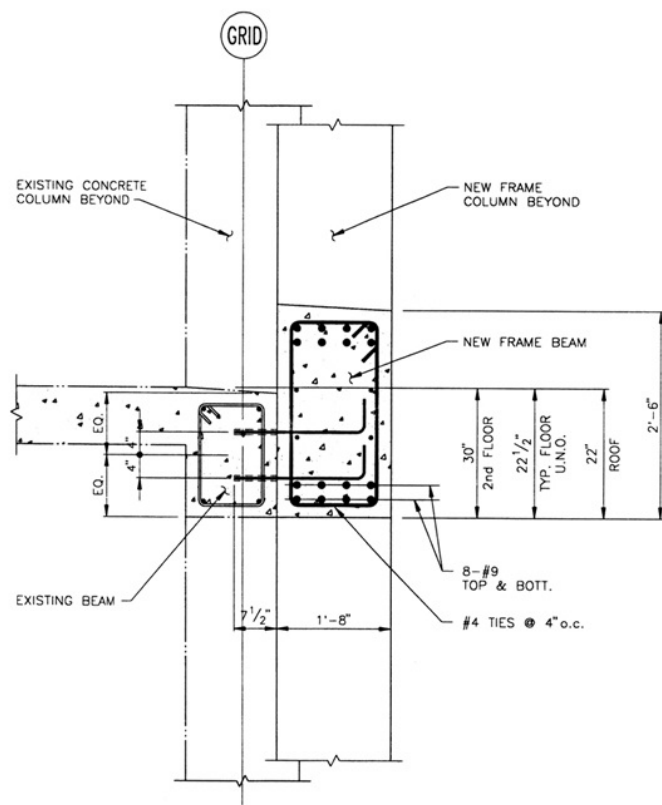
FRAME BEAM SECTION

Detail of retrofit design for Holiday Inn, Van Nuys, CA showing connection of new moment frame beam to old moment frame beam. [1]

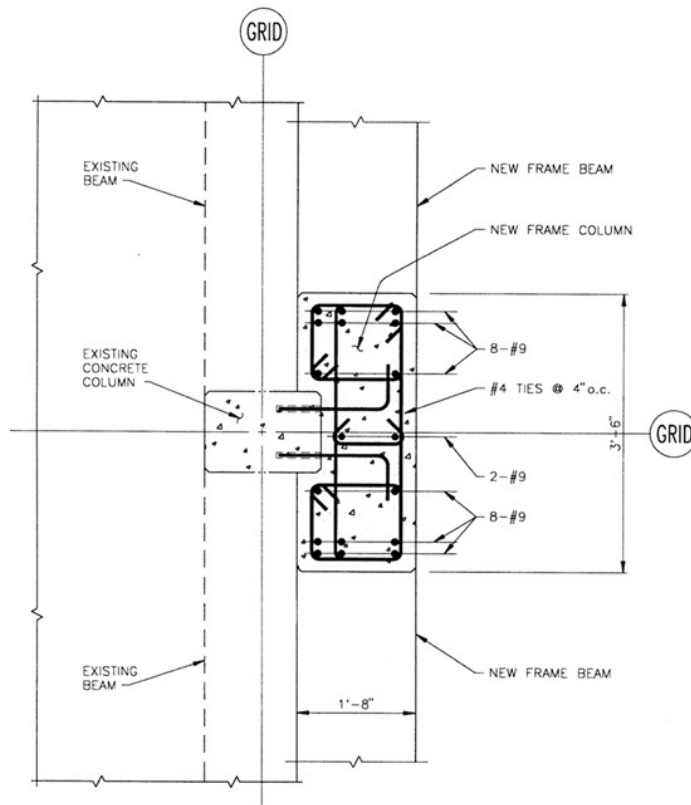
FRAME COLUMN DETAIL

PLAN VIEW
