HOUSING REPORT

**multistory tower masonry with stone pillars and wood or arched beams
(Casa Torre)**

Report#	113
Last Updated	
Country	Italy
Author(s)	Mauro Sassu, Chiara Cei,
Reviewers	Svetlana N. Brzev,

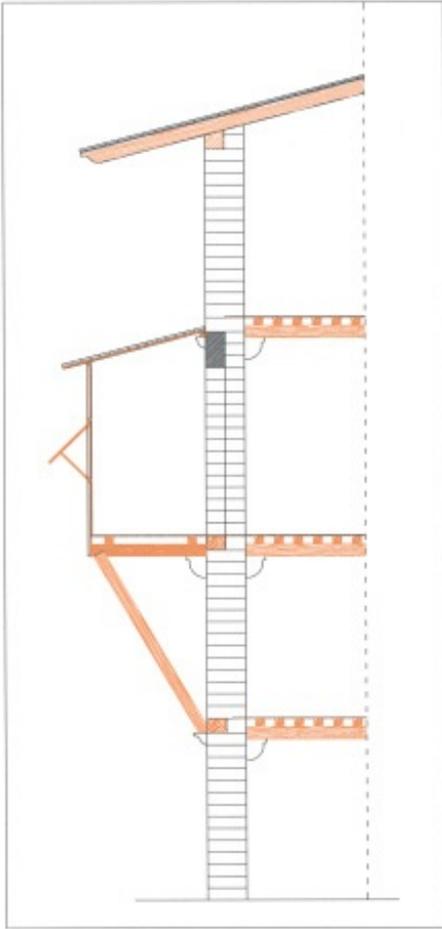
Typical section of the building

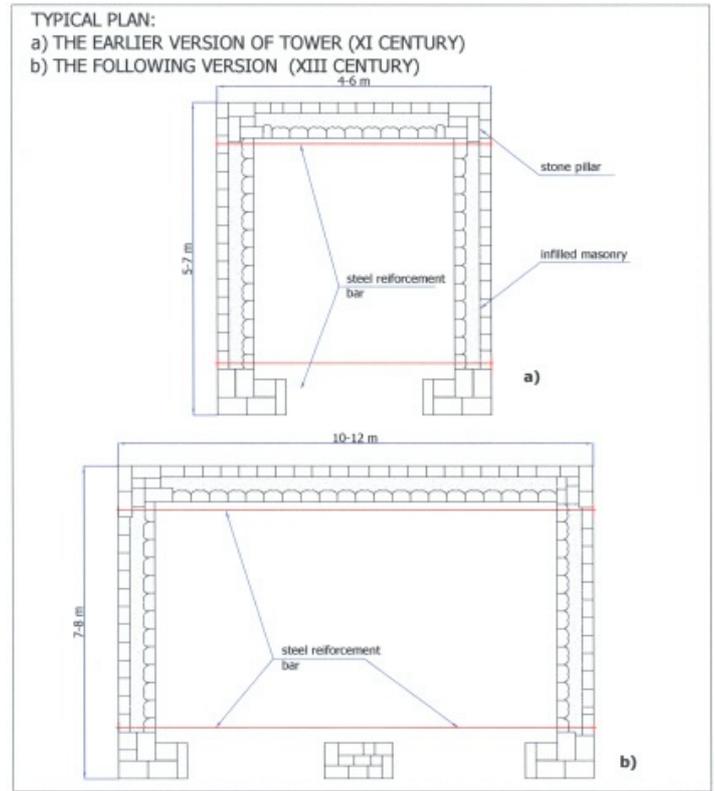
Design plan with the arrangement of steel reinforcement bars.

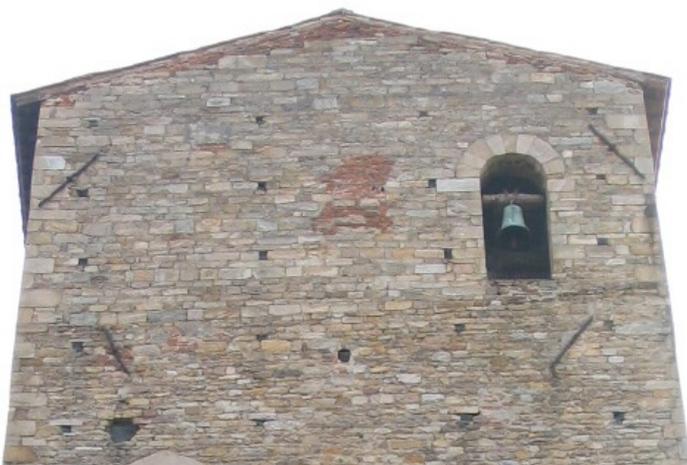
Opposite walls are connected by the use of tie-rods, with evident improvement in seismic behavior.

Structural Deficiency	Seismic Strengthening
Transverse connection between opposite walls	Steel tendons: grid wood floor frame
Vertical settlement	Reinforcement of the foundations with RC tub-fix micropiles

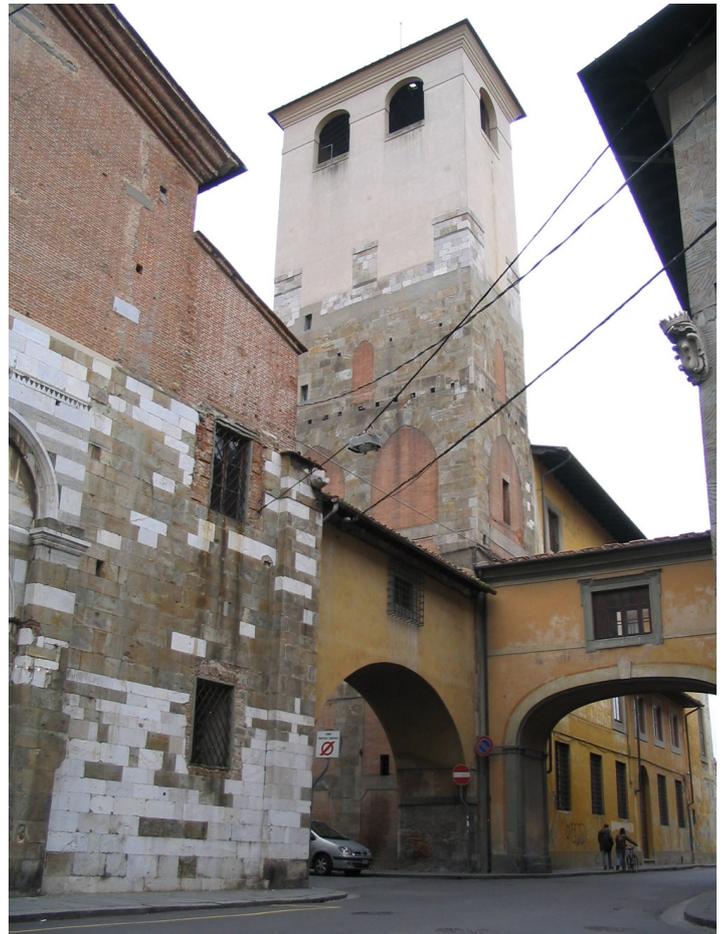
"Torre della Verga d'oro." Structural reinforcements: two large arched openings supporting horizontal forces at the base of the tower have been infilled by clay units.
