World Housing Encyclopedia

HOUSING REPORT Dhajji Dewari

Report#	146
Last Updated	
Country	Pakistan and India
Author(s)	Kubilay Hicyilmaz, Jitendra K Bothara, Maggie Stephenson,
Reviewers	Randolph Langenbach, Dominik Lang,

Building Type:	Dhajji Dewari
Country:	Pakistan and India
Author(s):	Kubilay Hicyilmaz Jitendra K Bothara Maggie Stephenson

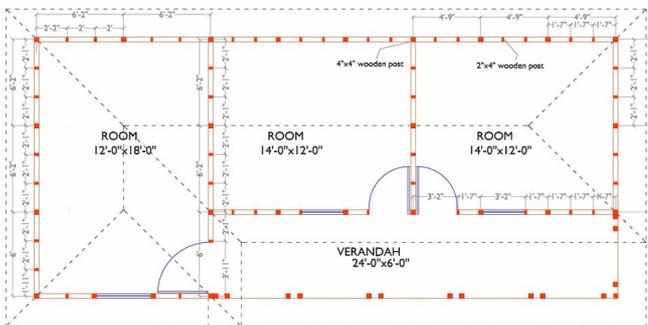
Typical Dhajji House

Typical plan view of an engineered Dhajji building after the 2005 Pakistan earthquake.

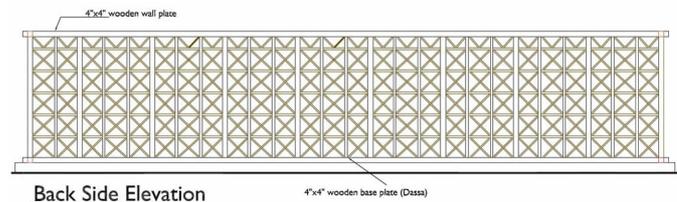
Typical rear elevation of an engineered Dhajji building after the 2005 Pakistan earthquake.

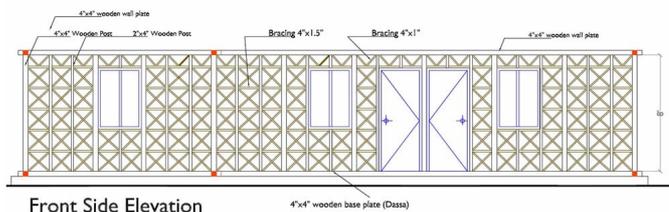
Typical front elevation of an engineered Dhajji building after the 2005 Pakistan earthquake.

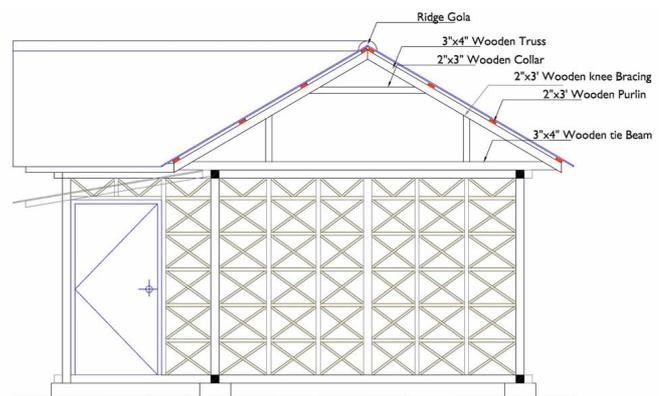
Section

Typical side elevation of an engineered Dhajji building after the 2005 Pakistan earthquake.

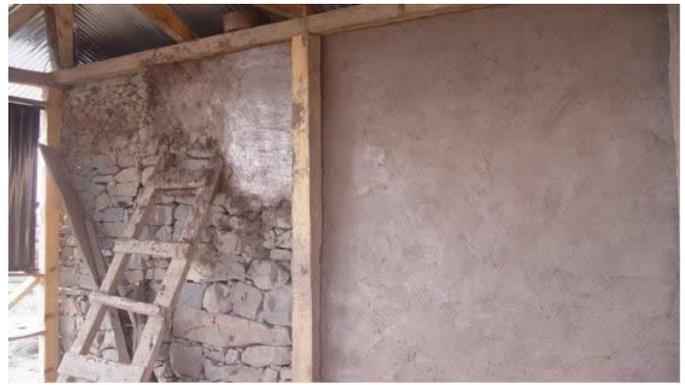
Plastering with cement sand plaster or mud mixed with natural fibres (note that the wall is not a Dhajji wall).

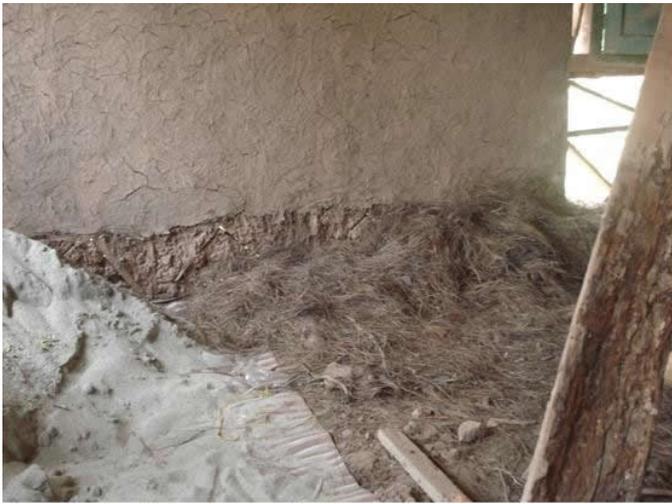
Plastering with cement sand plaster or mud mixed with natural fibres.

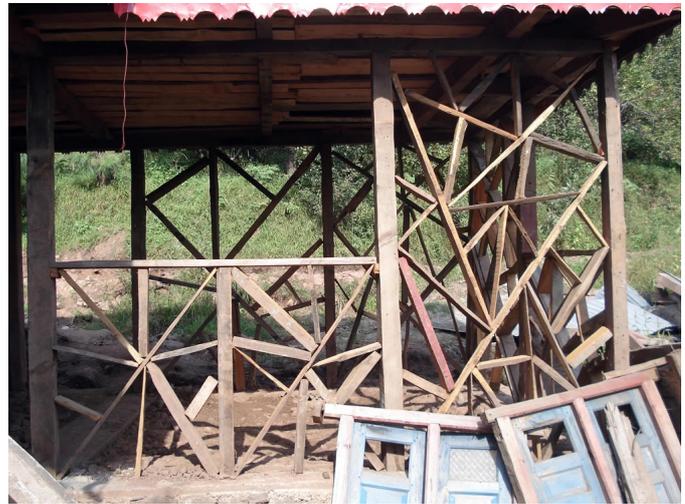
Mixed bracing pattern making uses of salvaged timber and window frames.

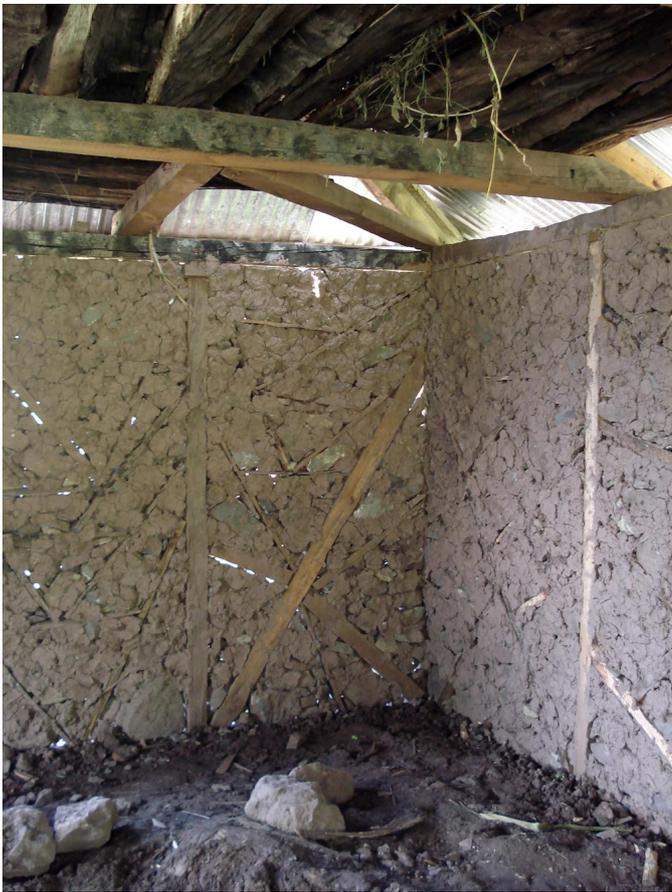
Internal view of completed wall. Note that the timber frame is not protected from getting wet as it is built straight in to the ground.

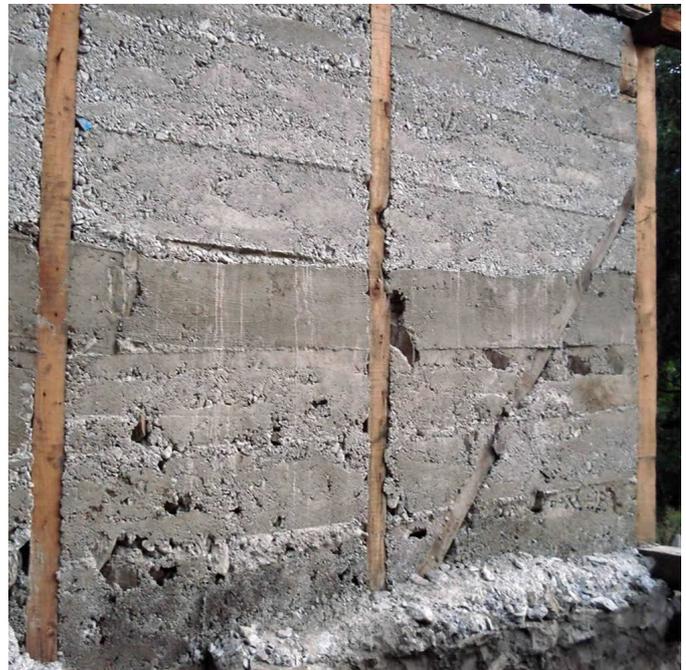
Timber, stone laid in concrete. This is not traditional dhajji construction. There is a risk that the entire panel may fall out as a rigid object during an earthquake.

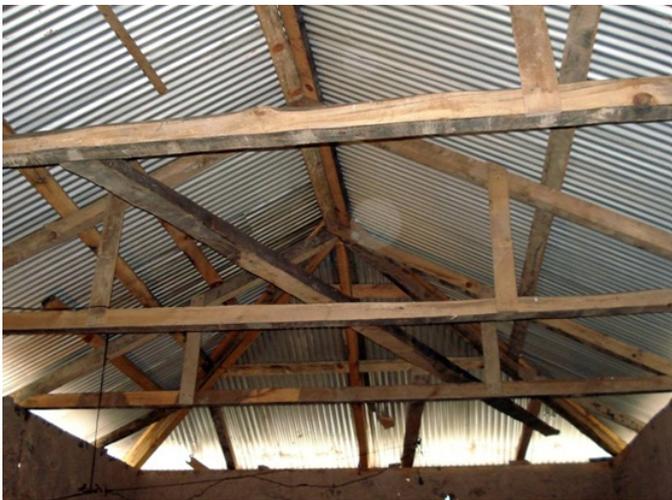
An internal view of a hipped roof. Apart from the CGI sheets there is no bracing to stiffen the roof structure. (Note: This roof is likely for storage/use. There will be a floor and ceiling of some kind added at a later date depending on the budget availa

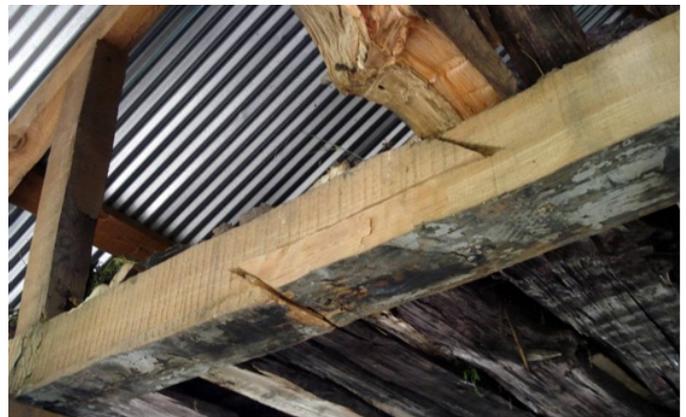
Timber connection details. Unless nails have been used this connection will not have very limited tension capacity to poor joint interlock.

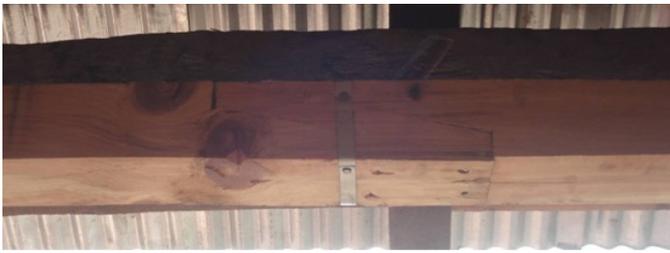
Simple strapping of nailed scarf joint will provide confinement to the joint and help increase its capacity. The nailing increases the scarf joints tensile capacity

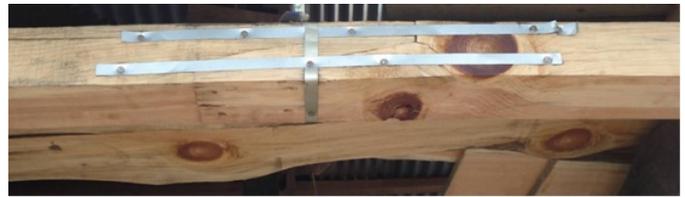
Strapping around the timber will help confine the scarf joint; long straps will help with tension as will the nails.

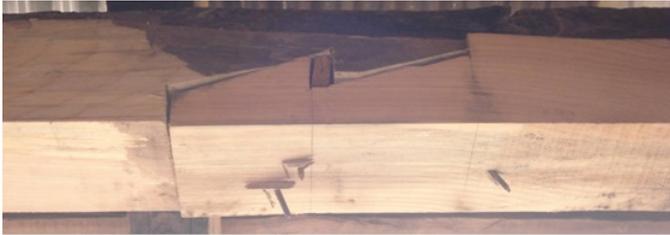
Poorly built scarf connection. The joint is a poor fit and the wooden peg that should pre-stress the joint appears loose. Note that the joint has been crudely reinforced with nails.

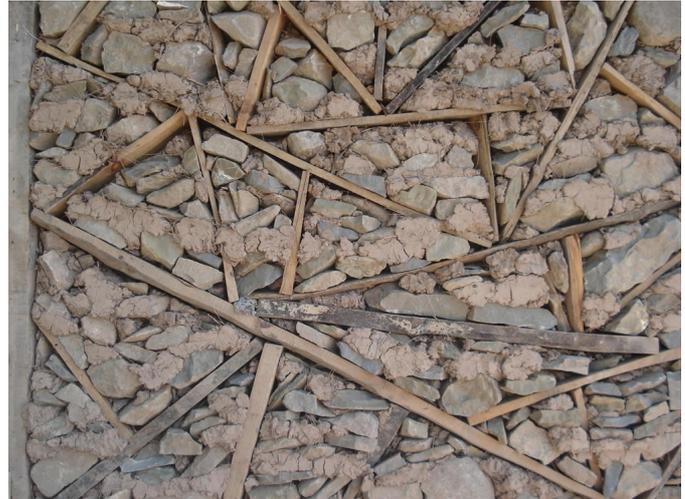
Common random bracing in small panels.

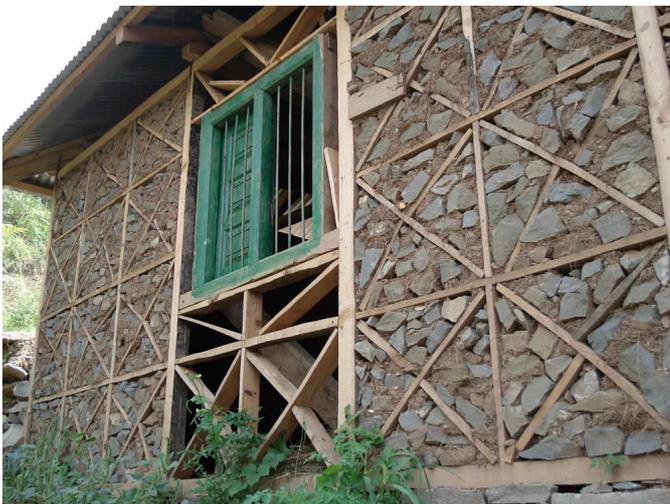
X-bracing pattern using partially cut stone.

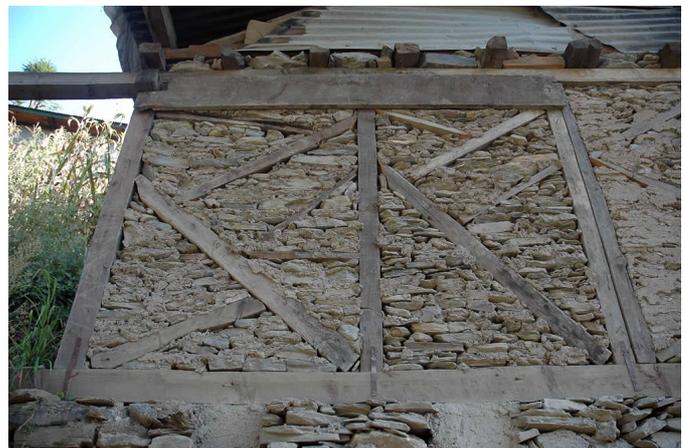
Bracing using large timber braces as timber resources are less constrained in the higher altitude. Note the more layered infill effect due to the type of locally available rock.

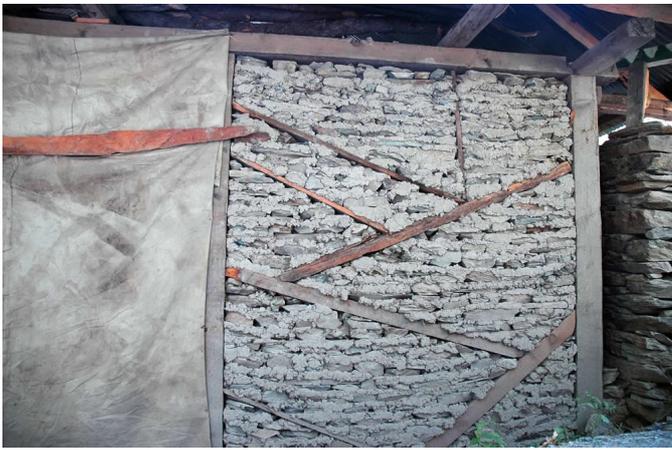
Large panel that appears to be in poor contact with the timber frame. Lack of tight fit may result in the entire panel falling out-of-plane. Again note the layering of the infill due to local rock characteristics.

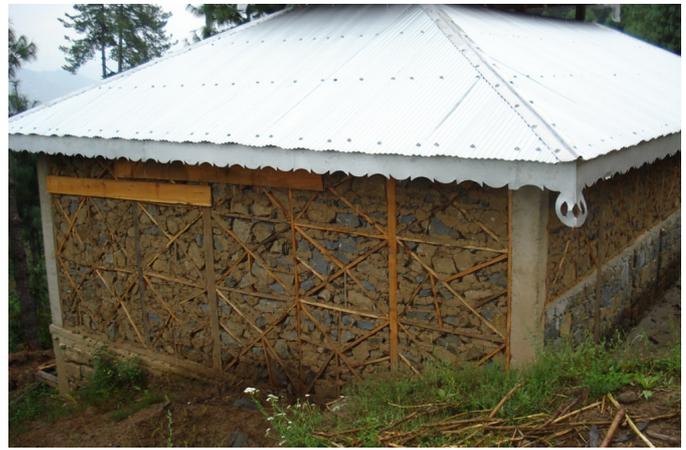
Mixed reinforced concrete and timber framing in dhajji style using X-bracing pattern.

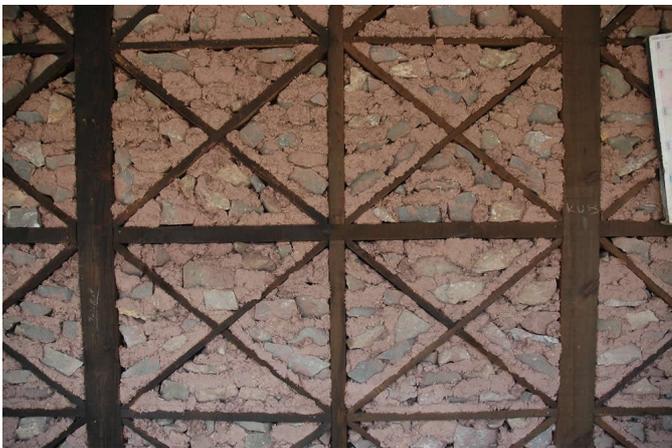
Reasonably cut stone laid with a lot of mud mortar. Note that the timber has been soaked in old engine oil as a way to give it some better protection against rotting.

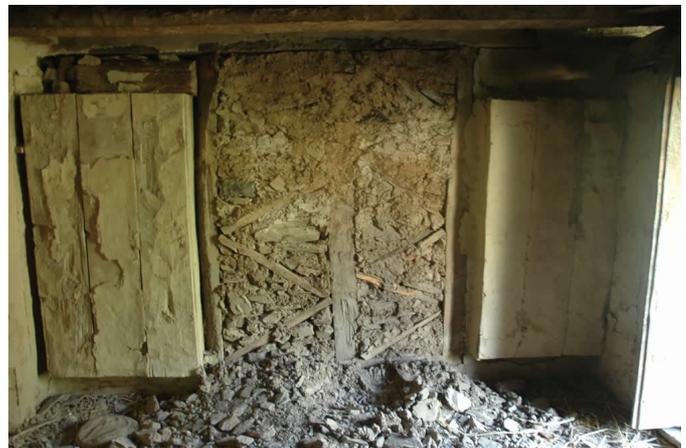
Wall built before the 2005 earthquake.

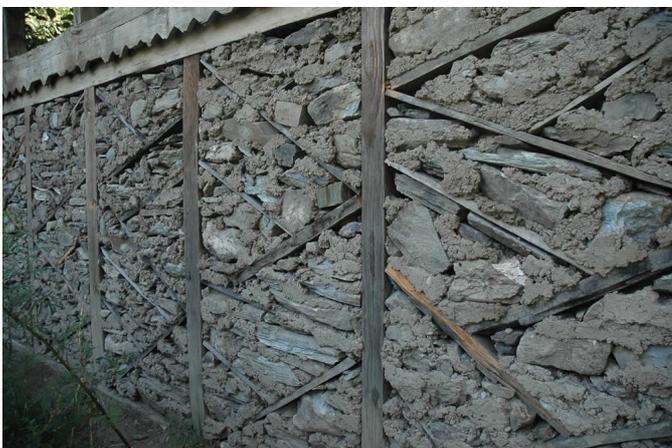
Wall built after the 2005 earthquake.

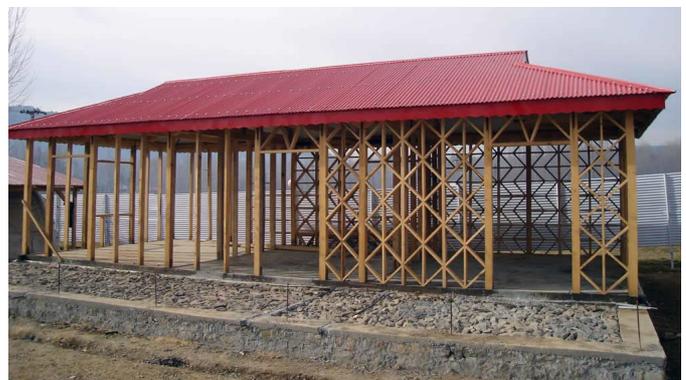
Zigzag bracing that nodes out. Note that the roof is erected early as it helps to stabilise the walls before their completion and helps keep the work dry. Also note the hipped roof giving stiffness in both principle

building directions. Note 1: anchor rod

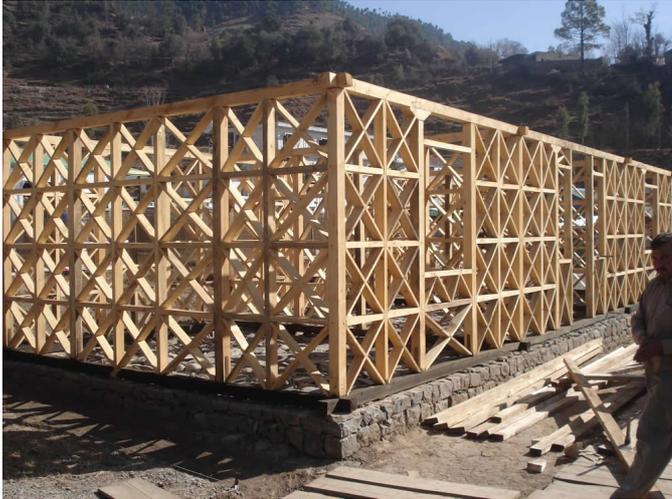
Engineered dhajji building frame under construction.

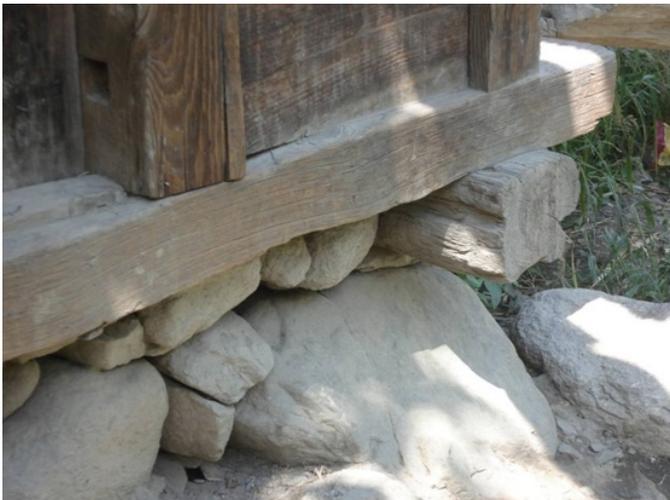
Foundation below plinth beam, note no connection between plinth wall and timber beam (existing building).

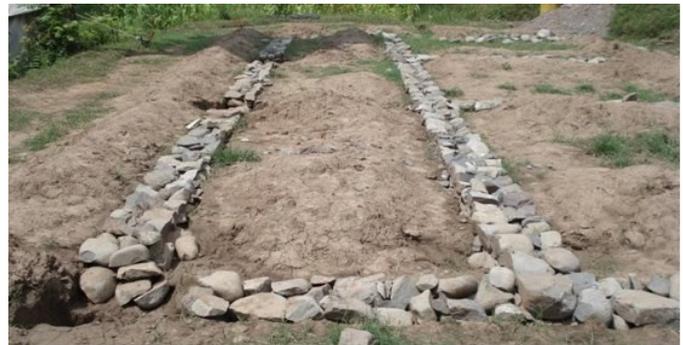
Stone strip footing under construction to raise the timber frame off the ground (new building).

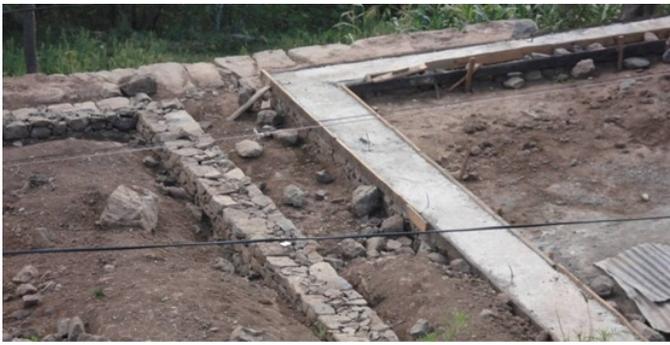
Strip footing made from stone with concrete capping and embedded steel reinforcement.

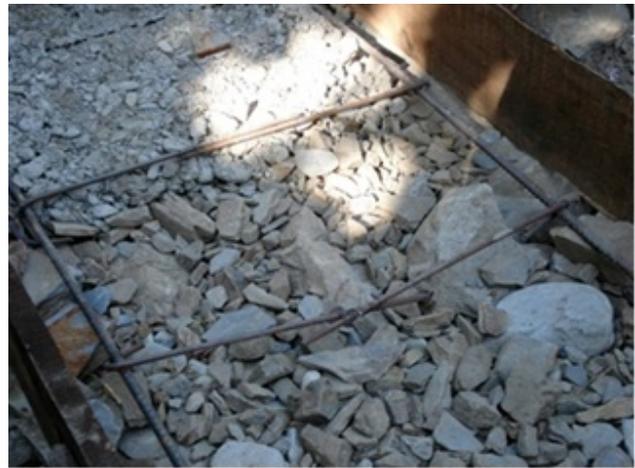
RC plinth band under construction (note poor splicing of stirrups) (Note: This was constructed for ERRA reinforced masonry. Picture was taken in Leepa in September 2006 before dhajji decision from ERRA. Picture from an area with no prior knowledge of rein

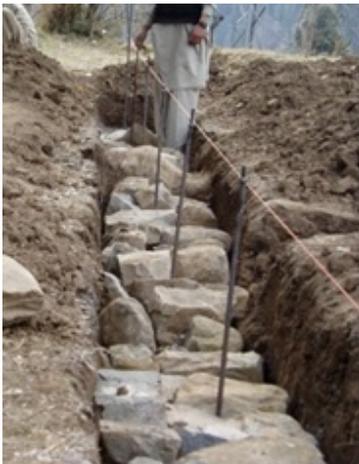
Bolts in the foundation to tie-up plinth timber

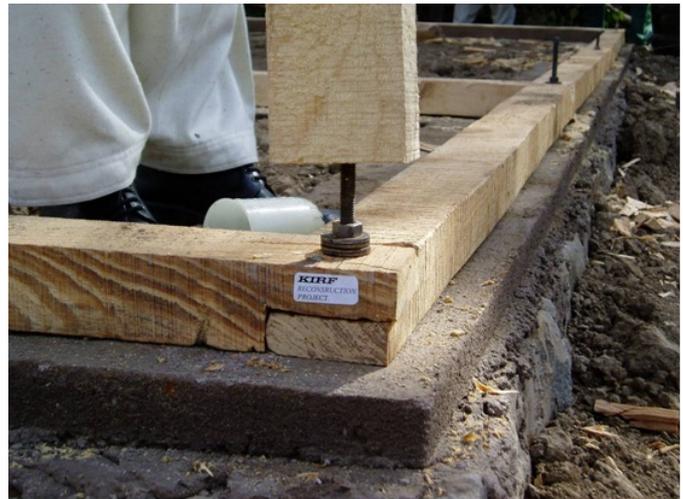
Bolting of plinth band with foundation. Note that a damp proof course has not been used.

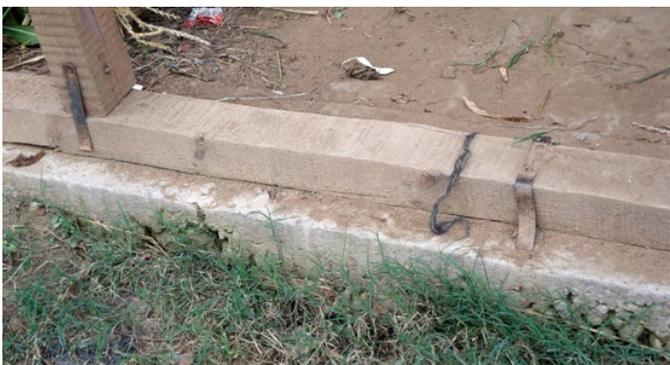
Timber ground beam (or sill beam) raised above the ground to protect the timber frame from rotting. Note attempted connection of the timber beam with the foundation. Damp

proof course not provided.

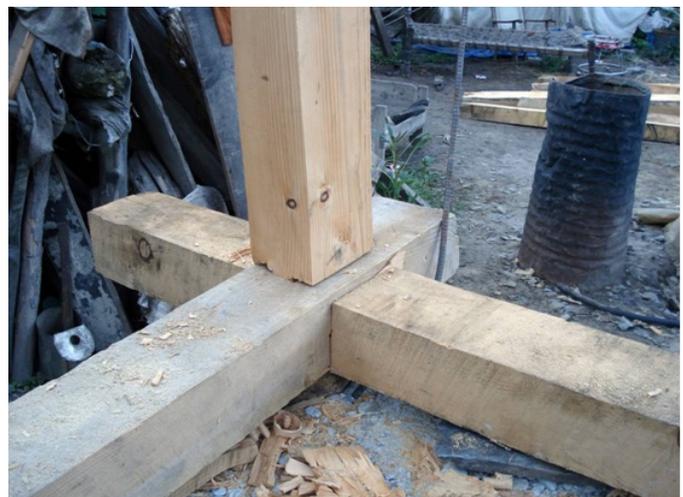
Corner connection detail with

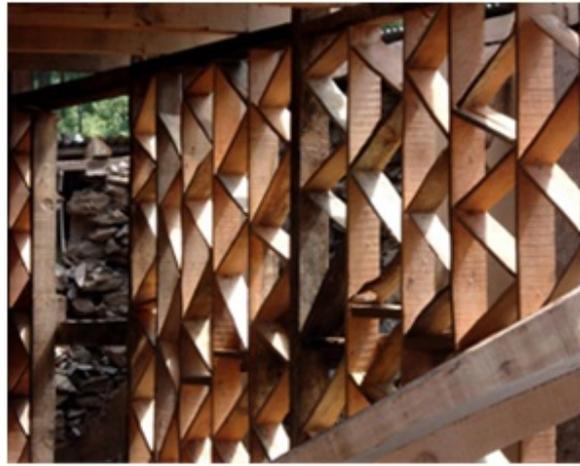
Timber frame ready to receive stone infill. Bracing has a zigzag pattern and bracing does not coincide/node-out.

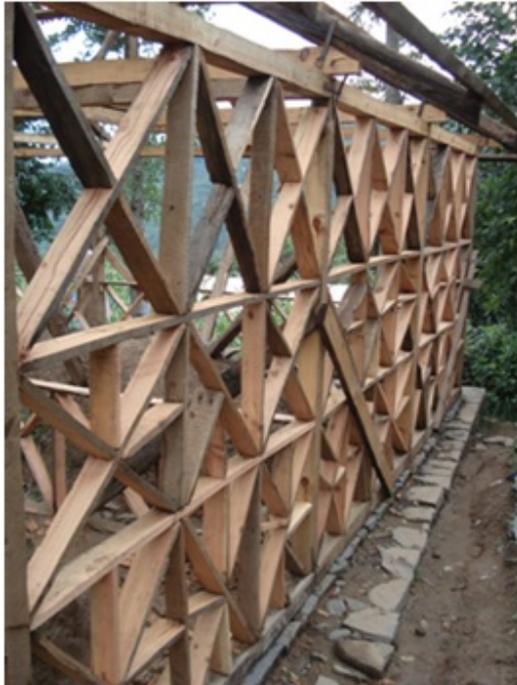
Timber frame ready to receive brick or stone infill, bracing is very much in the form of x-bracing

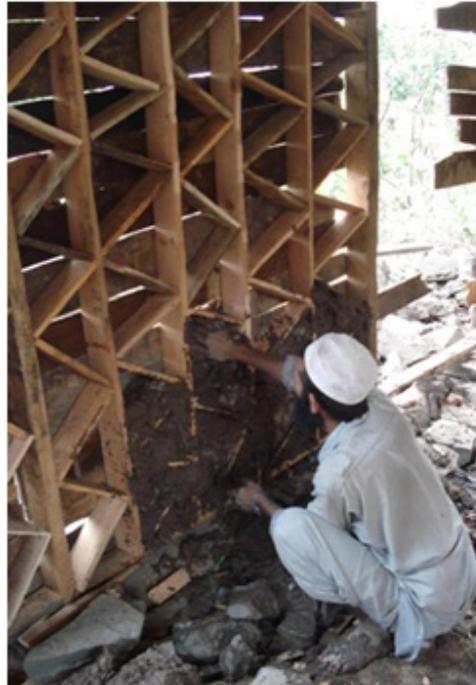
Construction of wall with stones and mud mortar. The planks on the other side of the wall act as formwork and will be removed after the infill placement is completed.

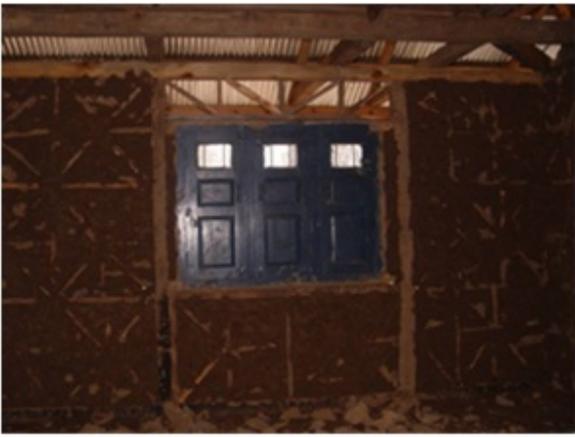
A wall ready to receive final coats of mud plaster (view taken from inside a building).

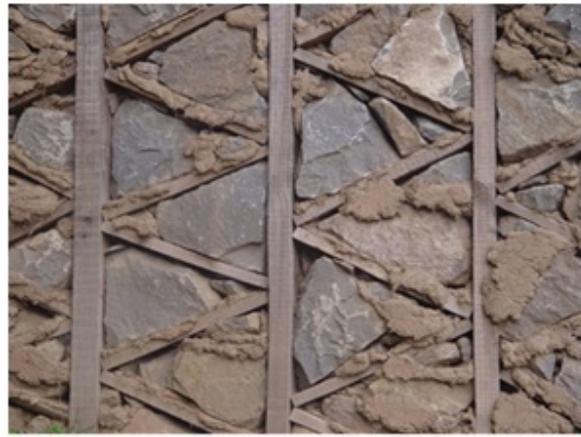
A completed wall, note large stones. (Note: This was built before the earthquake; it is a cheap commercial building. Mostly for houses people use smaller stones and are afraid of large stones falling on them. They may use chicken wire or timber boards to

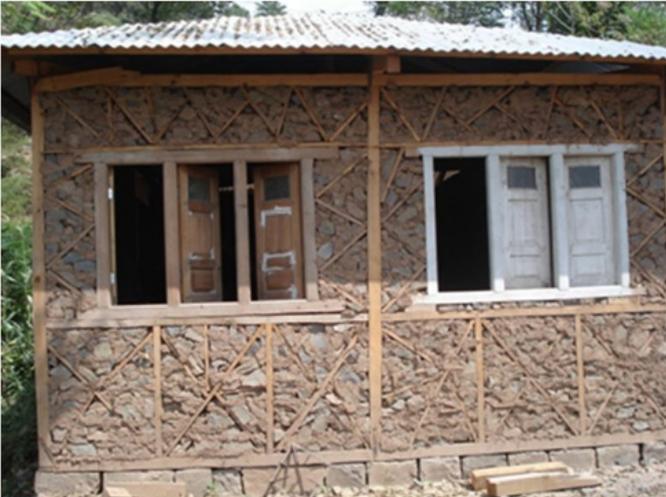
A completed wall. Note that the entire building has been raised above the ground level by a stone masonry foundation.

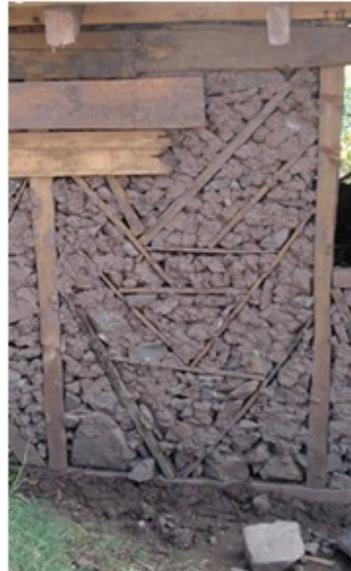
Inverted A-bracing pattern.

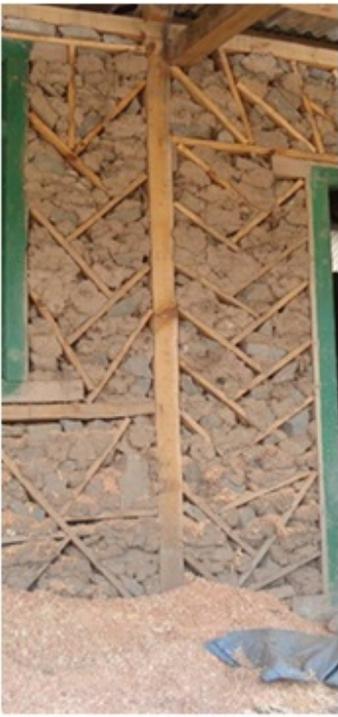
Herringbone bracing pattern.

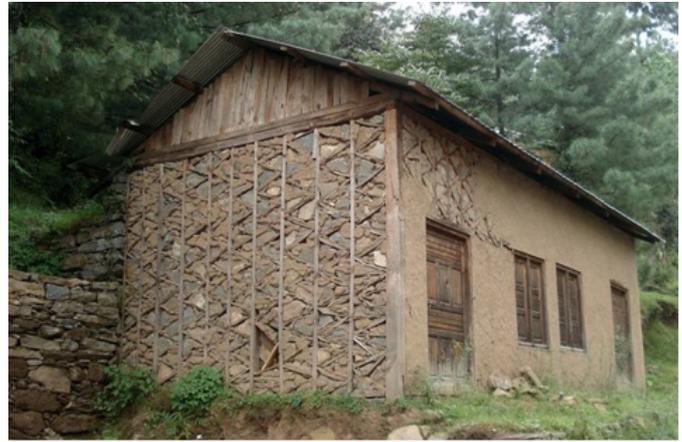
A dhajji building with gable wall with planks.

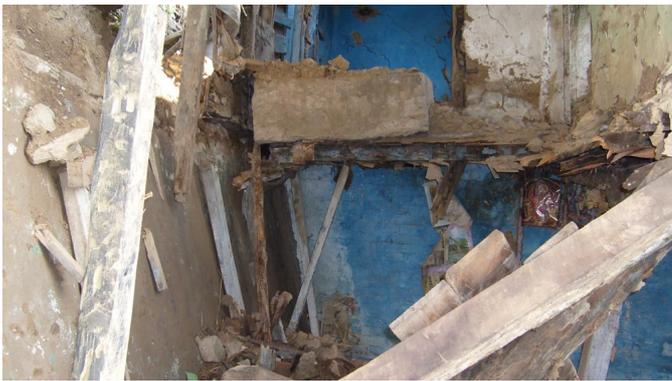
Collapsed timber floor structure of an abandoned house in Simla, India. (Note: Layer of mud laid on floor structure).

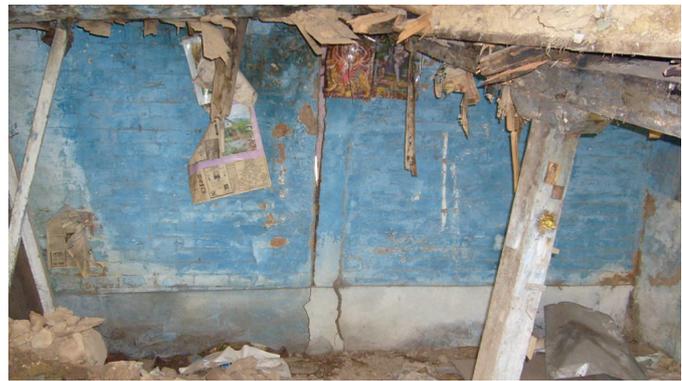
Close-up view of photograph in Figure 3 21, note post at mid room to support floor structure (Simla, India).

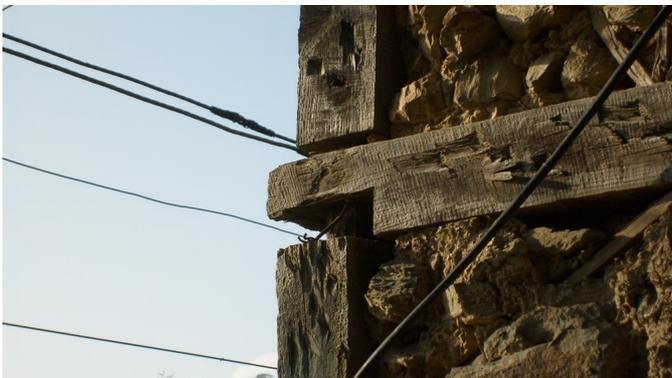
Connection of first storey post with second storey post with a cylindrical wood member passing through floor beam (Simla, India).

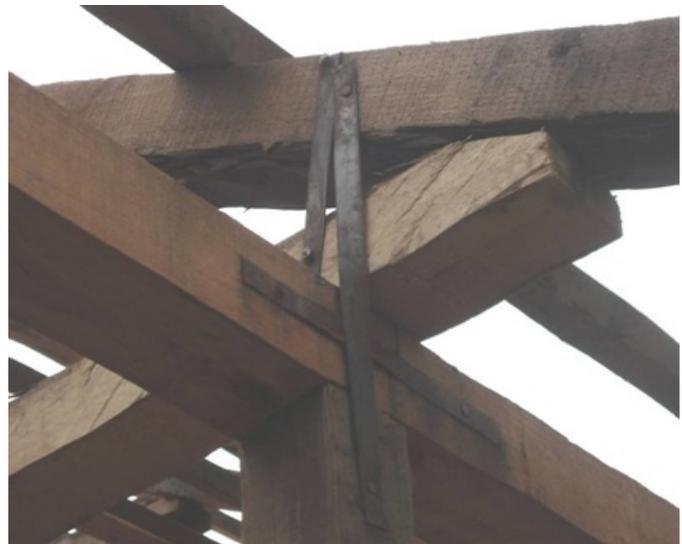
Tie-up of roof with wall structure.

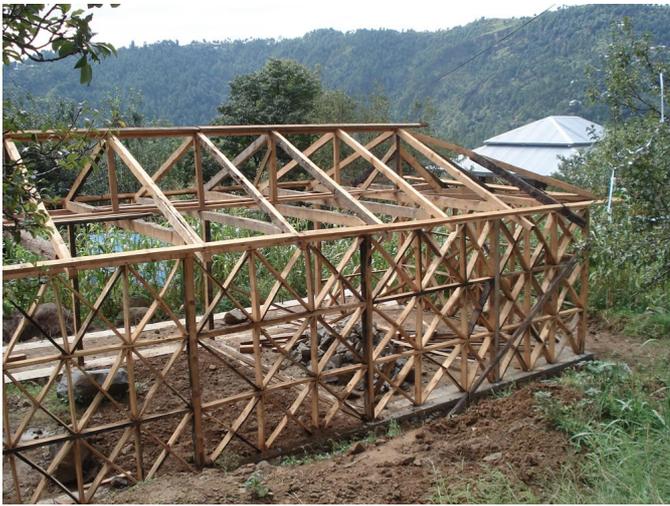
A view showing roof and braced timber frame.

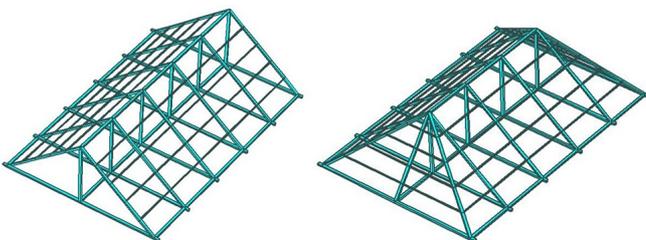
(left) Typical A-frame and hipped roof without any in-plane bracing. (right) The hipped roof is inherently better braced in both directions.

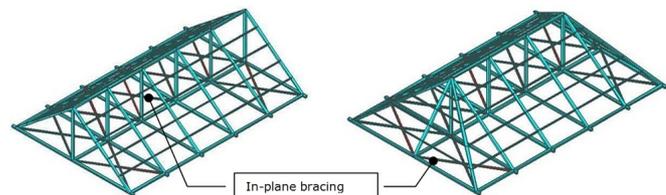
In-plane bracing between trusses at the truss bottom chord level shown in red. Note: It is difficult to cross over two diagonals of timber. It is not usual practice. Even in the dhajji square frames, one will see that they make one diagonal and two short

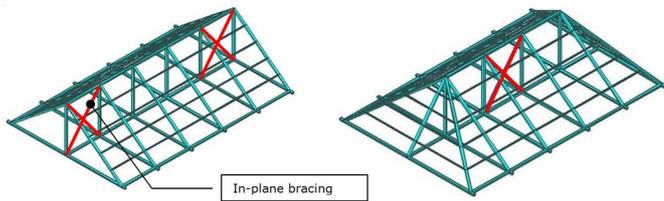
In-plane bracing

Vertical bracing between roof trusses shown in red. Note: Most roofs are occupied so cross bracing as shown here is not favoured and is rarely implemented.

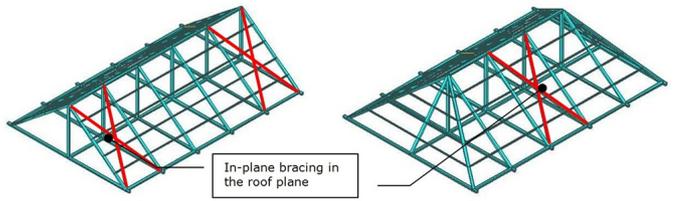
In-plane bracing in the roof plane

In-plane bracing in the plane of the roof incline. Note: If such bracing is used one brace will be continuous the other will be made of two half length braces.

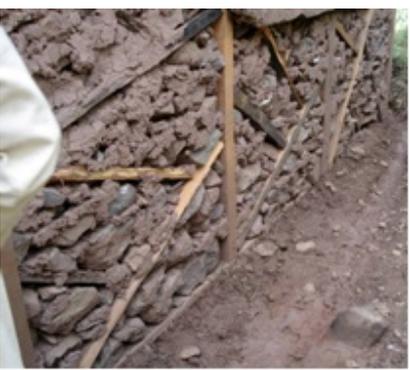
Timber frame that is not protected from moisture a major cause of

timber rotting due to direct contact with the soil.

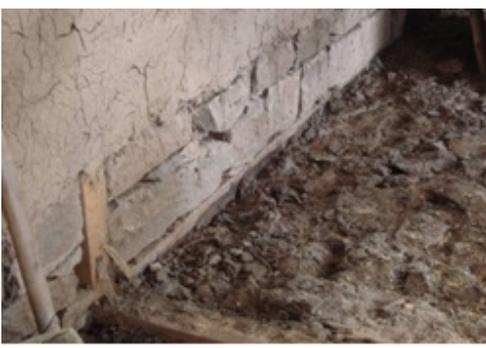
Timber sill beams and columns in direct contact with the ground exposing the timber to moisture.

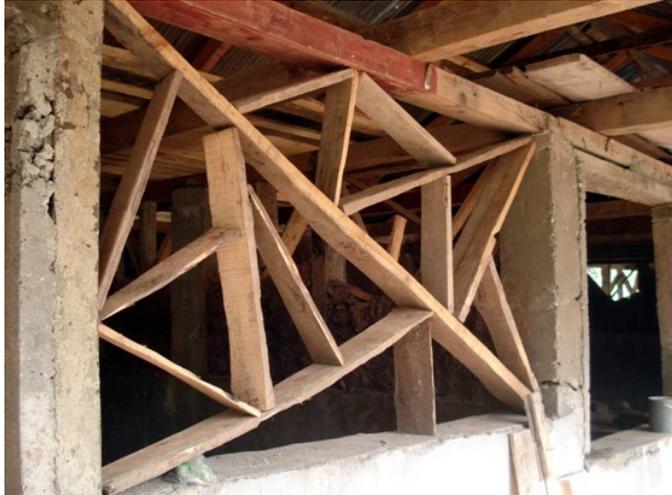
Mix of concrete columns with timber dhajji. Note poor quality compaction of the concrete and large cracks in the concrete column.

Note that the infill looks more like a dry stone wall.

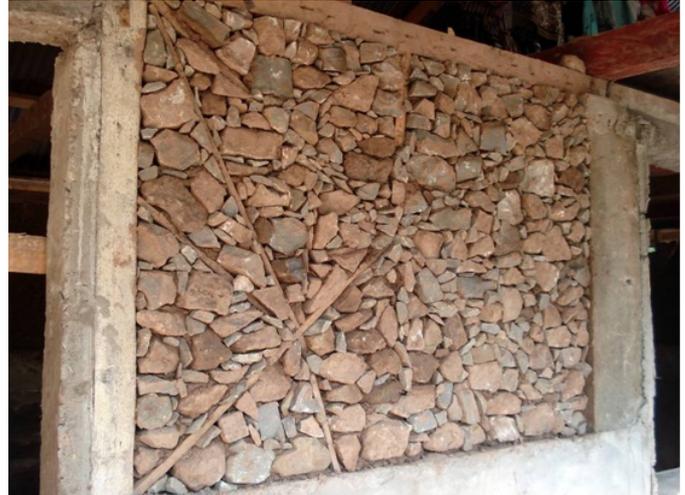
Mix of RC columns, dhajji infill construction (note the large panels of stone infill and limited amounts of timber bracing).

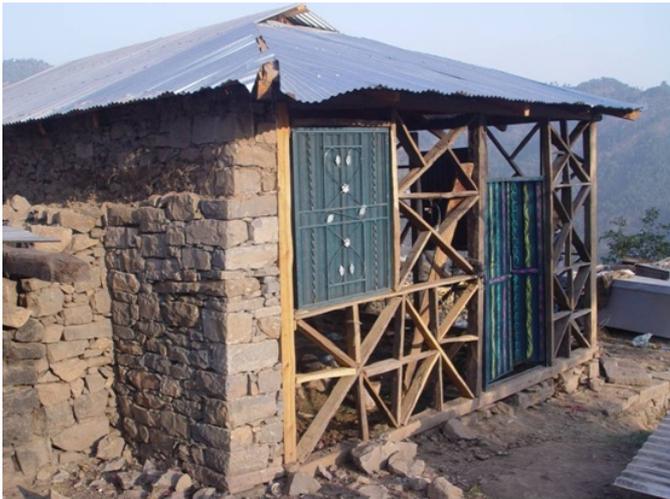
Dhajji in one direction and unreinforced stone masonry in other. Back wall of the house also acts as a retaining wall. It is not known if the wall perpendicular to the back wall of the house has buttresses to give it additional strength

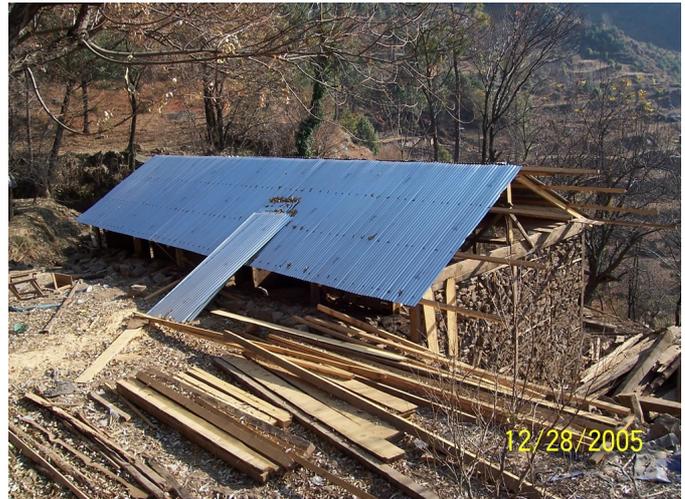
Dhajji house built into the hill side making the building act as a retaining wall. There is likely to be a stone wall at the back called a breast wall locally

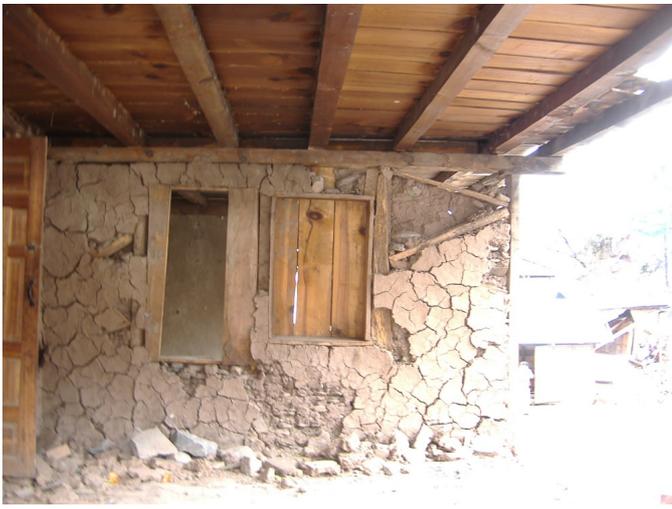
Isolated collapse of infill panel in dhajji house.

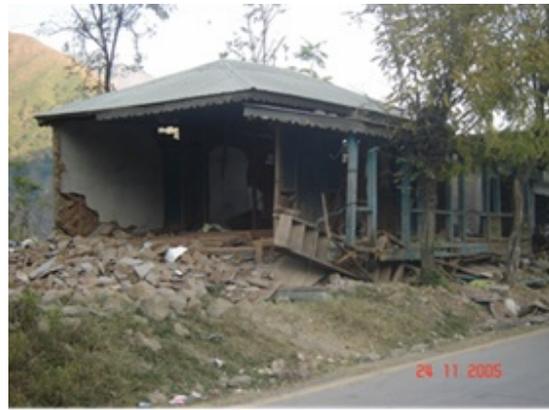
A building with dhajji in one direction, and stone URM wall in orthogonal direction

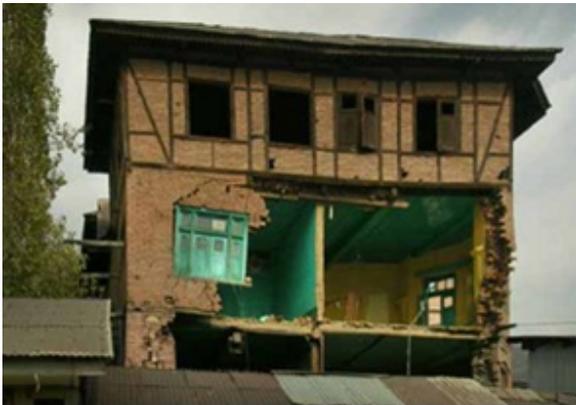
A building with dhajji in one direction, and stone URM wall in orthogonal direction

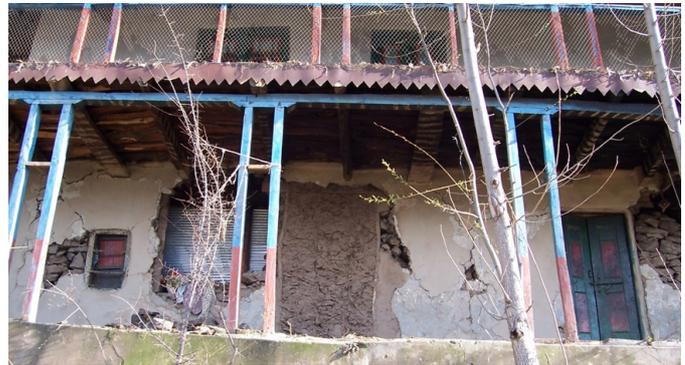
Dhajji wall intact apart from mud plaster that has fallen off. Plain stone masonry walls have partially failed, near Bagh, Pakistani Kashmir.

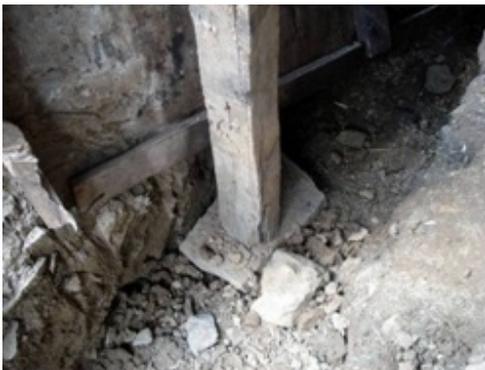
Example of effort to provide foundation to a timber post to reduce the immediate settlements under the post and provide limited protection to the timber end grain from moisture.

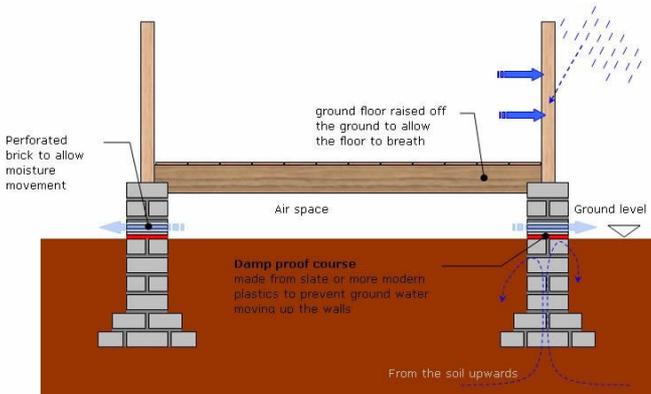
Typical foundation detail and lack of considered protection to the timber frame. Traditionally the floor is always raised on stone and it is 1 ft above ground level.

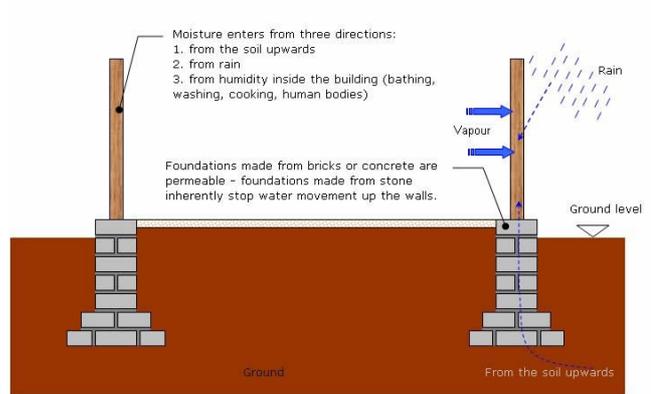
Construction methodology that would help keep the timber frame dry. Note that the introduction of modern materials, such as sand and cement mortar makes the control of moisture harder to achieve as it requires a damp proof course detailed. Note 1: In the

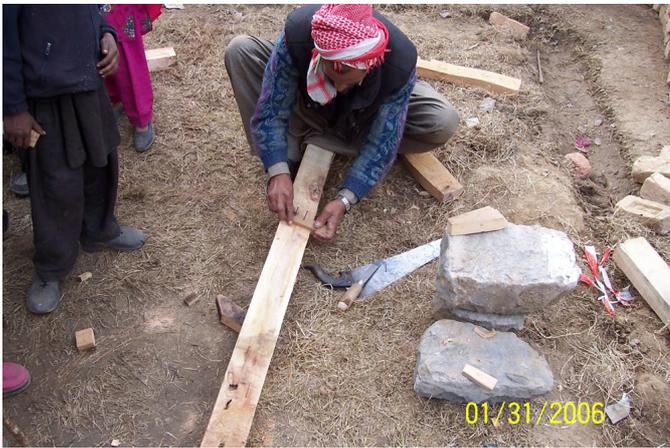
Improved tools to guide the carpenter made from scrap wood and nails on an ad hoc basis.

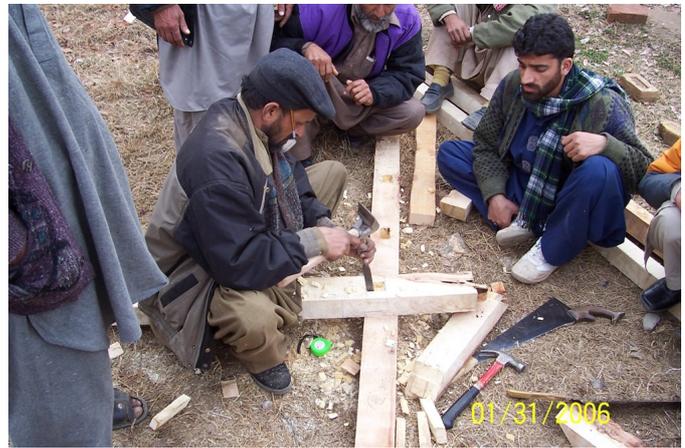
Hammer, chisel and saw are the main tools to construct a dhajji house.

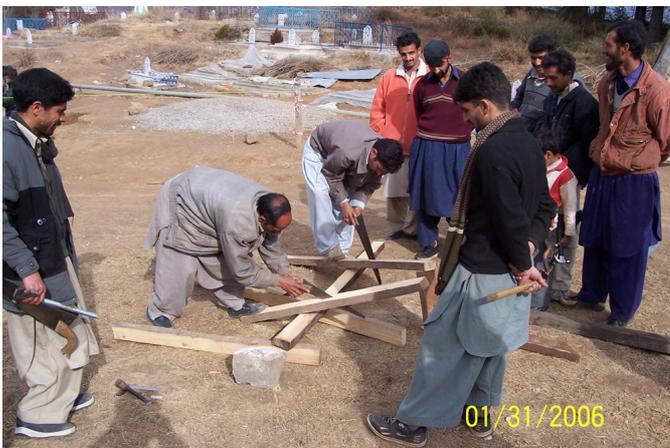
Cutting of timber sections. Note the child watching and learning

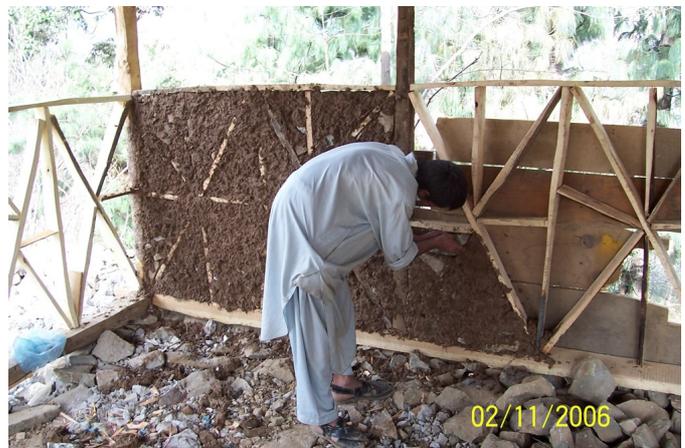
Infill construction from stone, mud and backing board that acts as temporary form work. Note: CGI as sometimes used for the form work these days and sometimes left then as permanent formwork/weather protection (used for this reason rather than to stiffen

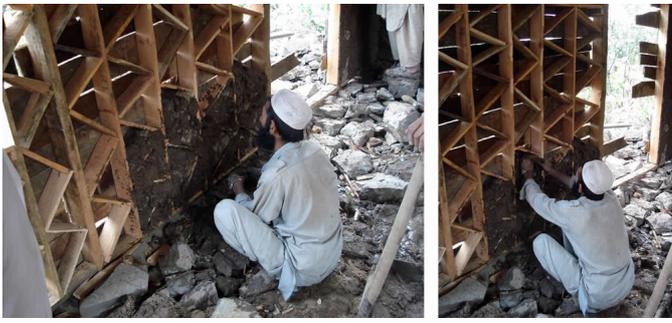
Construction of the infill walls. Note the very thin timber section sizes being used for both vertical and zigzag bracing pieces.

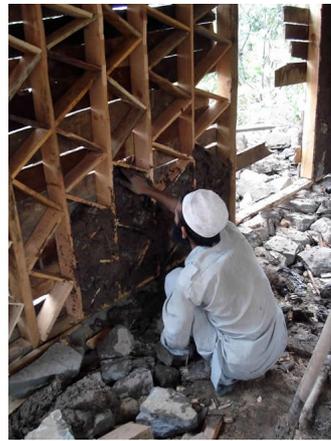
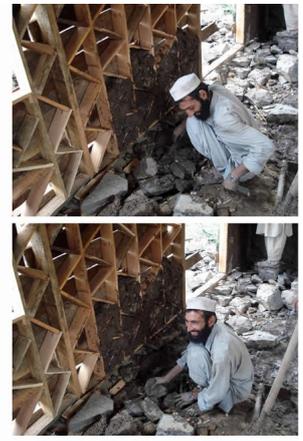
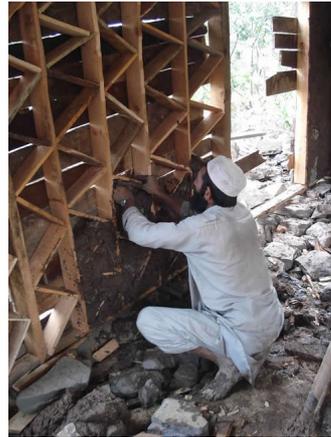
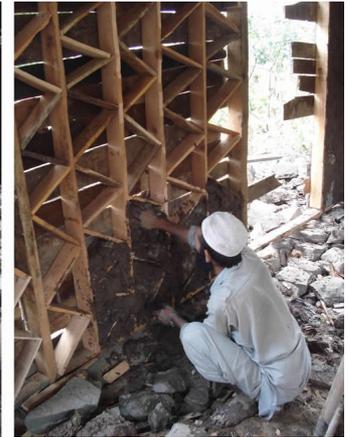
Construction of the infill walls continued.

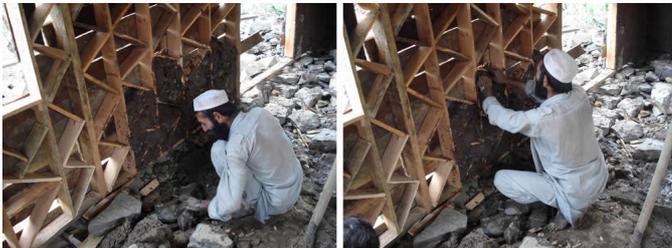
Construction of the infill walls continued. Note: Note he was breaking the stones as he went along. Previously large stones from an old unreinforced stone house on the same site.

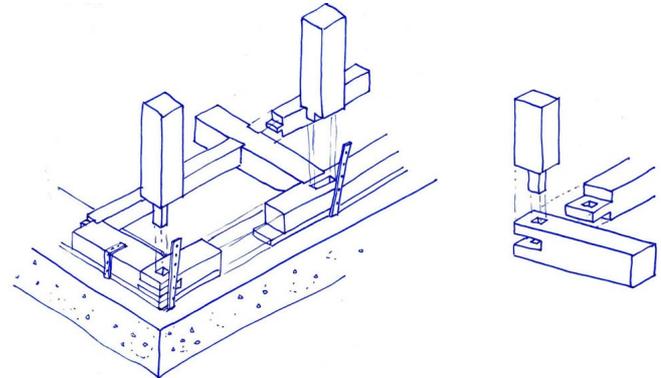
Corner post connection details. Note: This joint is difficult to make but crucial to keeping the dhajji frames together. More work is needed to optimise corner connection details for such traditional construction forms. The corners are potential locations

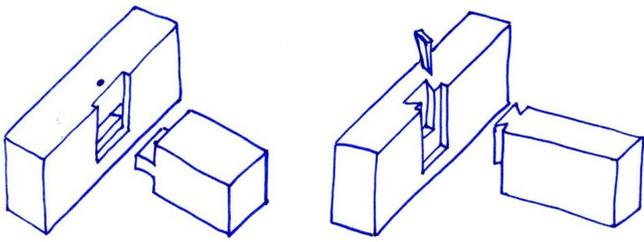
Orthogonal beam to beam connections for base plate, floor beams, and roof level. (left) The use of a peg (timber or metal) would give this connection some limited tension capacity. (right) The dovetail shape gives the connection tensile capacity, an impor

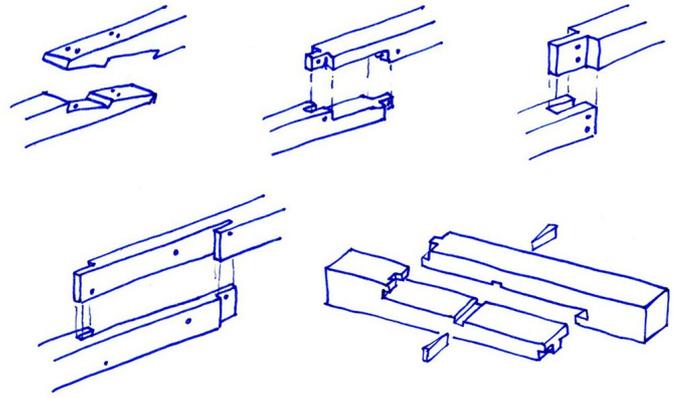
Beam to beam longitudinal connections, the use of wooden pegs is important to pre-stress the connection. Use of metal strapping and or nailing can improve the strength of these connections if done properly. Note: The first joint is used 95% of the time,

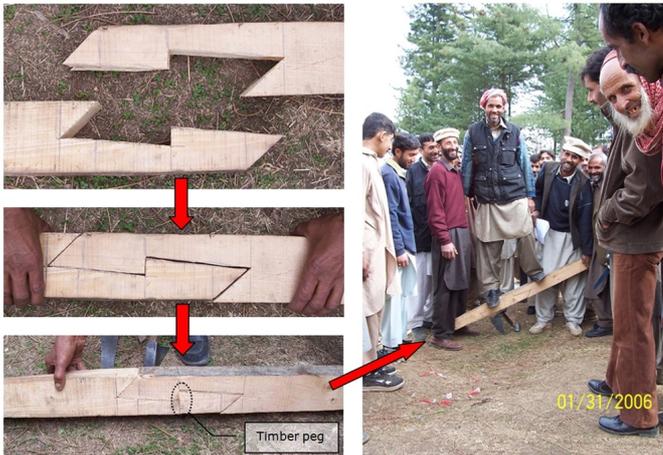
Public demonstration of a Kashmiri Joint in Malot, Bagh district of Pakistani Kashmir.
