World Housing Encyclopedia

HOUSING REPORT Dhajji Dewari

Report#	146
Last Updated	
Country	Pakistan and India
Author(s)	Kubilay Hicyilmaz, Jitendra K Bothara, Maggie Stephenson,
Reviewers	Randolph Langenbach, Dominik Lang,

Building Type:	Dhajji Dewari
Country:	Pakistan and India
Author(s):	Kubilay Hicyilmaz Jitendra K Bothara Maggie Stephenson

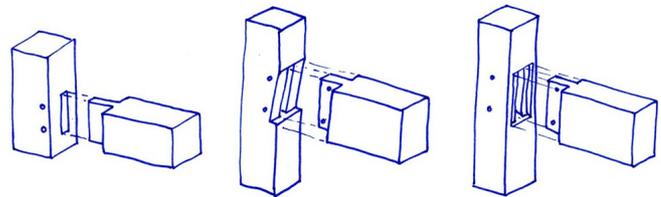
Beam to column connections with increasing levels of beam shear capacity but reduced levels of column capacity. The presence of pegs enables these connections to have a limited amount of tension capacity. Note: Beam/wall plate is fixed directly on top of

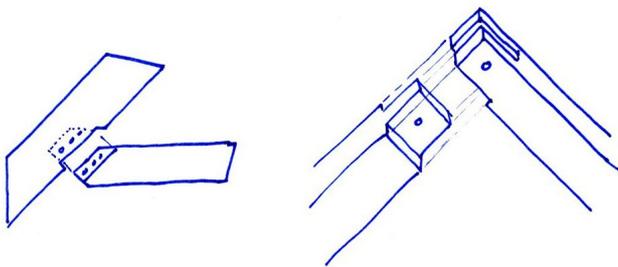
Connections for roof trusses. Note face nailed connections are more likely.

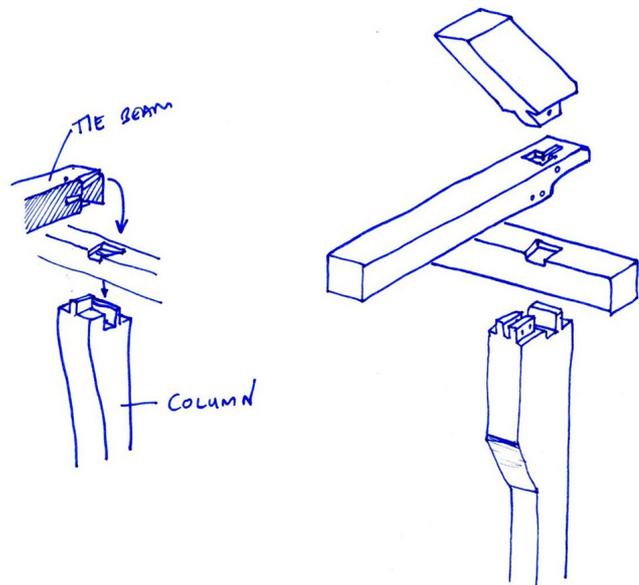
Column to orthogonal timber floor

29 of 34 10/15/2012 10:20
AMbeams and possible connection
to roof truss. Rather than varying
the timber section consider nailing
additional pieces to give larger seat
for beams to connect to.
