World Housing Encyclopedia

HOUSING REPORT

Vivienda de Minifalda (Wooden houses with heavy bases)

Report#	148
Last Updated	
Country	Nicaragua
Author(s)	Dominik Lang, Alvaro Amador, Lisa Holliday, Claudio Romero L, Armando Ugarte, Andrew W. Charleson ,
Reviewers	Andrew W. Charleson,

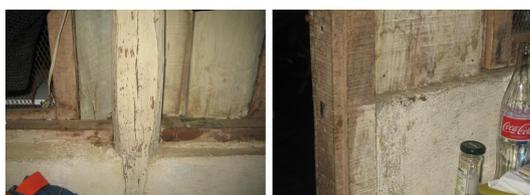
Detailing of the transition zone between the masonry base and upper wooden part of the wall.

Gravity load-bearing & lateral load-resisting systems	The structural system is a mix of a wooden frame standing on walls made of clay bricks, adobe masonry or concrete blocks.
Typical wall densities in direction 1	5-10%
Typical wall densities in direction 2	5-10%
Additional comments on typical wall densities	The typical structural wall density is up to 10 %. Detailed measurements for typical wall density are not available.
Wall Openings	Minifalda houses have few windows, often with very small dimensions (40*40cm; See Figures 1, 8, and 9). The windows are always located in the wooden (upper) part of the walls. The window sill is often formed by the upper edge of the concrete base. Even when the building is used for small retail trade or handicraft business, larger openings for showcases or sales counters do not exist. Compared to the size of the windows, the doors appear to be oversized. At the positions of the doors there are cut-outs in the concrete wall bases, such that the bottom quarter to half of the door frame consists of concrete, while its upper part is framed with wood.

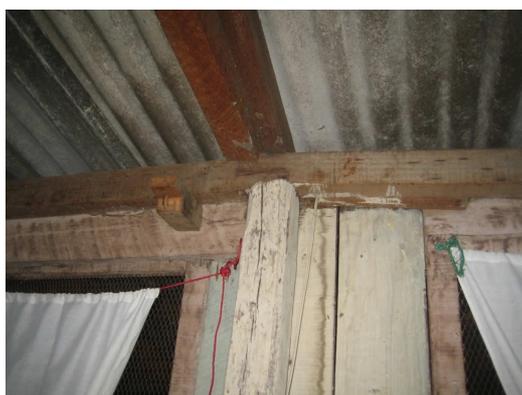
Roof made of asbestos sheets supported by wooden beams which loosely rest on the wooden walls.
