World Housing Encyclopedia

HOUSING REPORT

Timber-reinforced Stone Masonry (Koti Banal Architecture) of Uttarakhand and Himachal Pradesh, Northern India

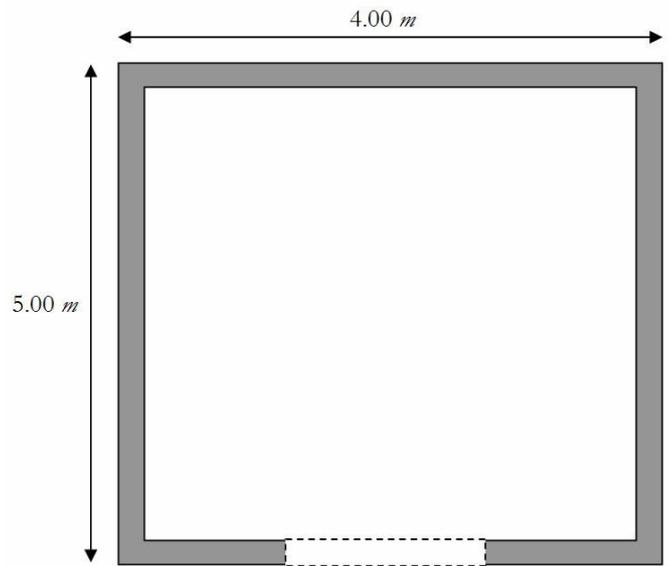
Typical plan shape (of ground floor) of a single-unit building.

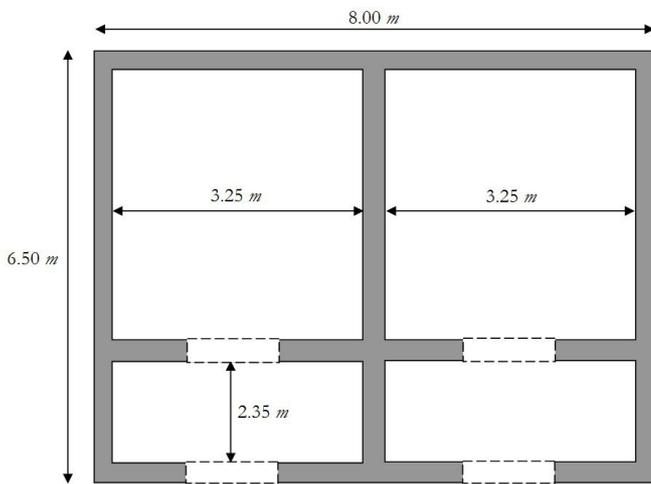
Typical plan shape (of ground floor) of a two-unit building being vertically separated.

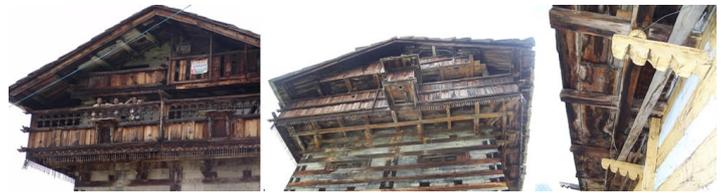
Detailing of the cantilevered balcony construction at the fourth storey level.

additionally have external balconies (wooden verandah) which are constructed with a wooden railing running around the whole building. The balconies are supported by cantilevering wooden logs of the flooring system (Figure 6). According to Middlemiss (1910) it is this projecting balcony which gives the house the false appearance of being top-heavy and unstable. Generally the buildings rest upon a raised and elaborated stone-filled platform out of dry stone masonry which is the continuation of the foundation trench made of field and rubble stones. The height of the platform varies between 2 and 4 m above the ground (Figure 7). Figure 8 exemplarily shows the elevation of a five story structure with interstory heights ranging between 2.20 and 2.50 m. In the lower part, the walls consist of a wooden cribbage configuration with orthogonally arranged wooden logs interconnected at the junctions by wooden pins/tenons (Gujja Khoonta). For the two bottommost layers single wooden logs while for the upper layers double wooden logs are used (Figure 9). The open spaces (height ~ 30 cm) between the horizontal logs are furnished with well-dressed flat stones which are dry-packed or by using a paste of pulses (lentils) as mortar (Figure 10, Figure 11). This wooden cribbage structure is not used for the upper parts of the wall where the dressed stones have a load-bearing function (Figure 9). The thickness of the walls is determined by the thickness of the two parallel arranged wooden logs which is mostly between 50 and 60 cm. The structure is further reinforced by wooden beams which are perpendicular attached to the wooden logs at the middle of the walls connecting two parallel outer walls. These beams provide the joists supporting the floorboards of each story (Figure 12). The walls parallel to the floor beams are supported in out-of plane action by providing a large timber log, longer than the building dimension and having holes at the two ends. A vertical member (shear key) having length equal to several storey heights, is inserted into the hole which provides support to the walls in out-of-plane direction (Figure 13).

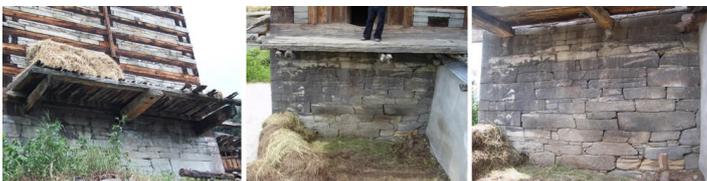
Detailing of the foundation platform made of dry-packed dressed stones.

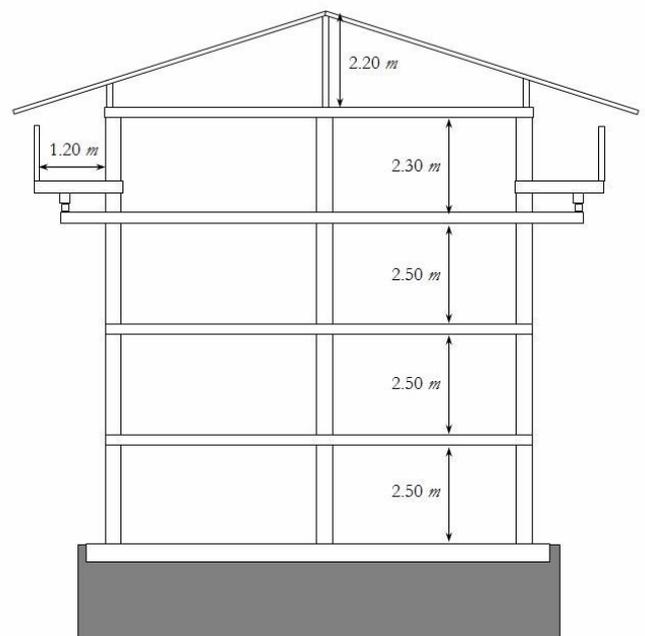
Elevation of a 5-storey Koti Banal building

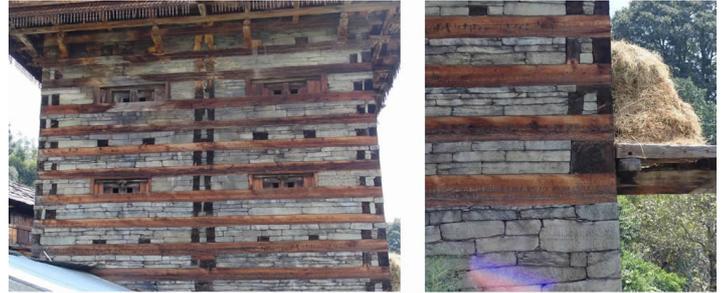
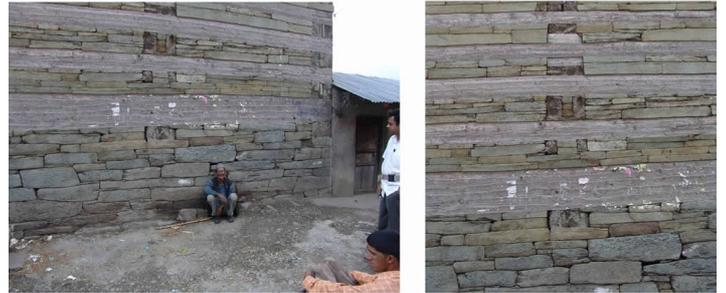
Arrangement of wooden logs and well-dressed flat stones for the walls.

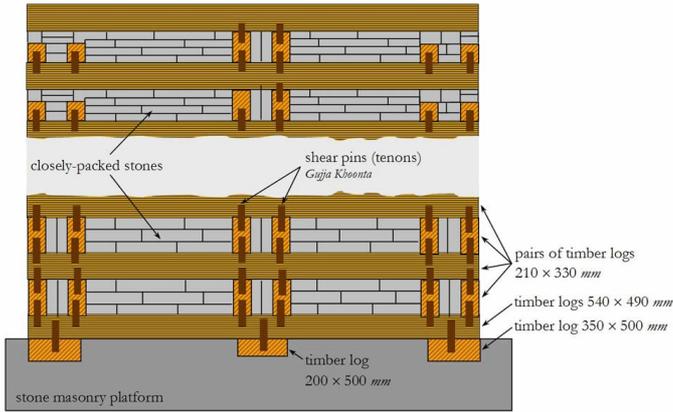
Vertical cross-section illustrating the wall construction principle in the lower #cribbage# part and the upper part.

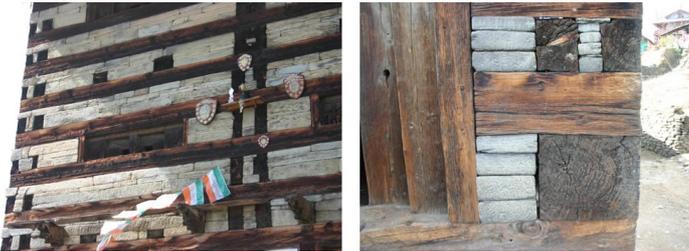
Arrangement of wooden logs and well-dressed flat stones for the walls.

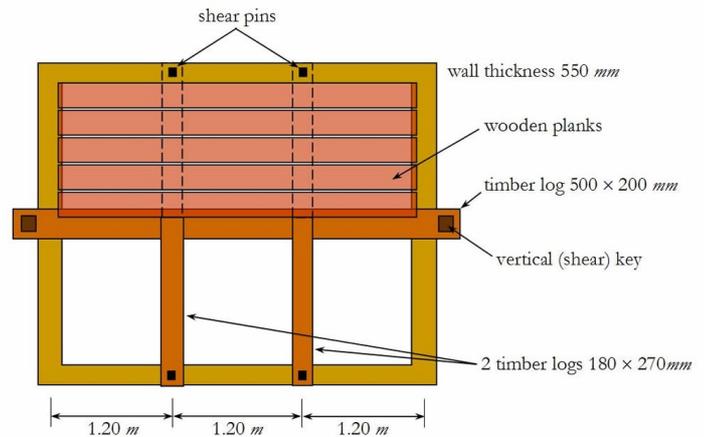
Detailing of the flooring construction.

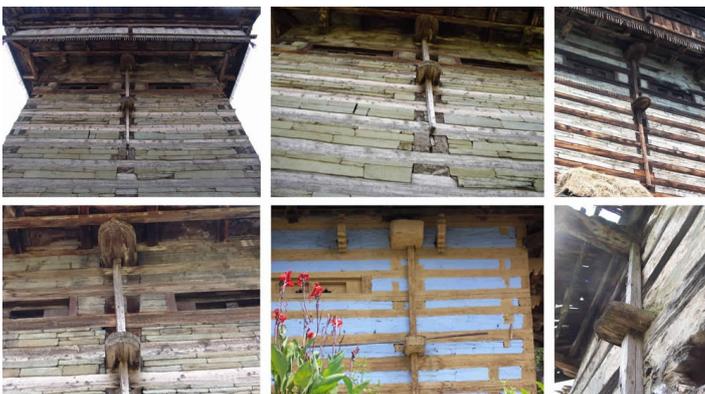
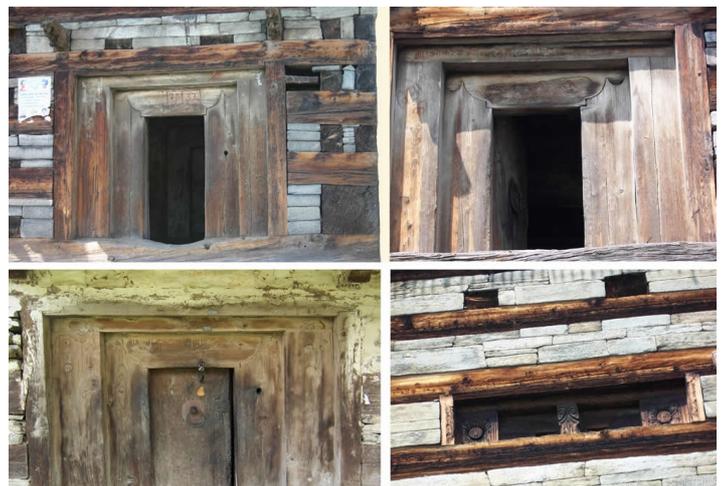
Vertical members (#shear keys#) attached to the outer facade to

prevent out-of-plane failure of the walls.

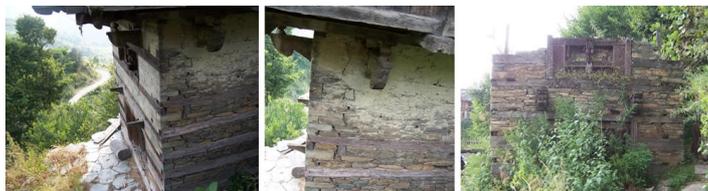
Modification of the Koti Banal construction principle: wooden logs are only arranged as ring beams between layers of stone. The interspacing heights between the layers of wooden logs range between tens of centimeters up to one meter.

reason for this appears to be the unavailability and scarcity of timber. A gradual shift from the closely spaced timber logs to increasing heights between them filled with stones is visible in the local construction (Figure 17). For contemporary constructions in the region, no such logs (ring beams) are used anymore. Recently, many Koti Banal structures face serious adverse effects being caused by the surrounding building development. Unplanned construction directly taking place next to Koti Banal buildings and encroaching upon these old structures as well as the partly demolition in order to use the disassembled building materials for new buildings seriously affect the dynamic behavior of these traditional structures during earthquake shaking. In addition, these negative effects are accelerated by the structural deterioration due to the lack of maintenance and preservation.

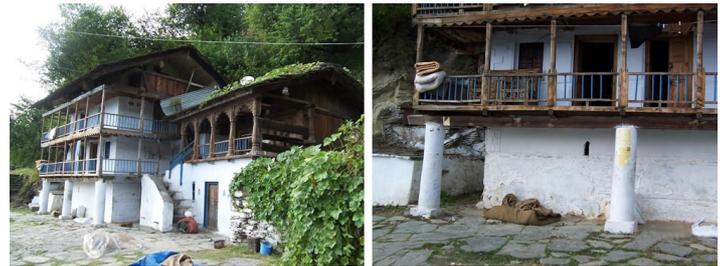
Modification of the Koti Banal construction principle: arrangement of external verandas resting on massive columns.

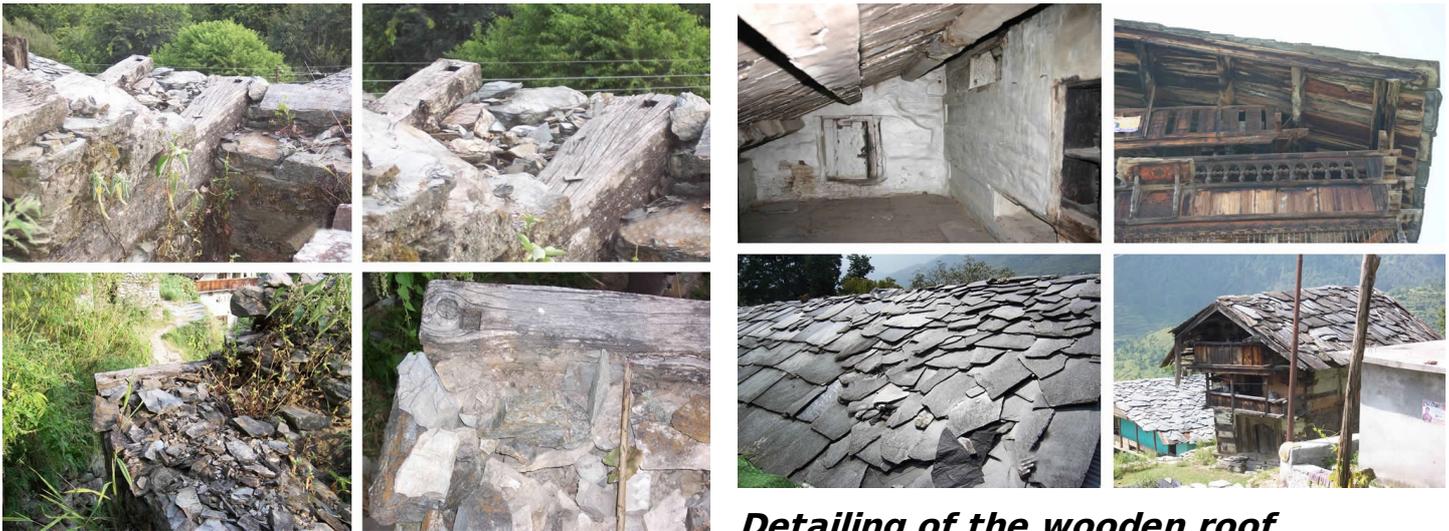
Detailing of the connection means at the wall corner. The horizontally placed wooden logs are connected by rectangular-shaped wooden pins. (Photographs show the rectangular holes foreseen at the log ends.)

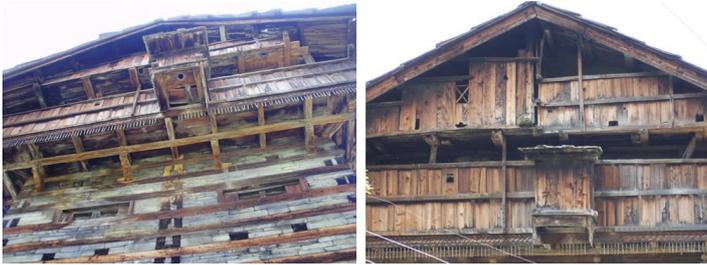
Toilet (outhouse) attached to the balcony at forth floor at the buildings backside.
