World Housing Encyclopedia

HOUSING REPORT Reinforced Concrete Shear Wall Houses

Report#	180
Last Updated	01/19/2016
Country	Chile
Author(s)	Claudia Alvarez Velasquez, Matias Hube Ginestar, Felipe Rivera Jofre, Hernan Santa Maria Oyandanel, Mariana Labarca Wyneken,
Reviewers	Abdelghani Meslem,

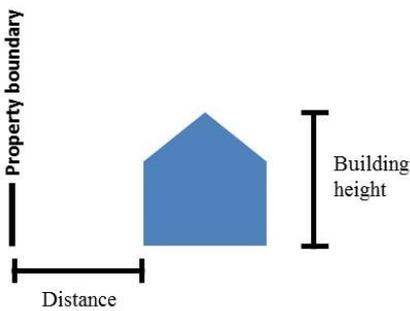
Figure 6. Angle that determines theoretical envelope.

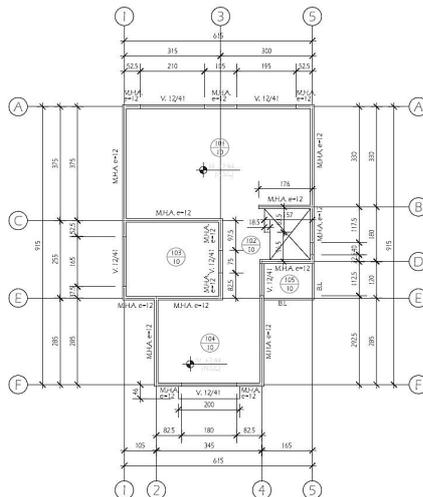
Figure 8. Structural drawing of the

plan view of a reinforced concrete shear wall house (dimensions in cm).

Plan Shape	Unknown plan shapeRectangular, solid
Additional comments on plan shape	Reinforced concrete shear wall houses commonly have regular plan shapes, even though there are no plan shape regulations in the codes. Therefore, an architect can design a house with irregular plan shapes as required by the owner.
Typical plan length (meters)	11.83
Typical plan width (meters)	11.83
Typical story height (meters)	2.5
Type of Structural System	Structural Concrete: Structural Wall: Moment frame with in-situ shear walls Gravity load-bearing system: Reinforced concrete walls provide both the lateral and the gravity load-resisting system. Reinforced concrete slabs and beams transfer the gravity loads to the reinforced concrete walls. Typically, the thickness of reinforced concrete walls ranges between 10 and 25 cm, and the thickness of reinforced concrete slabs vary between 10 and 20 cm. Figure 8 shows the

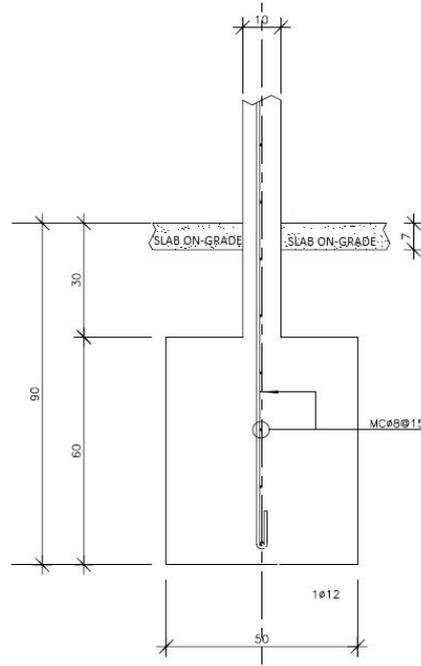
Figure 10. Typical elevation view of a spread footing of reinforced concrete wall (dimensions in cm).

Type of Foundation	Shallow Foundation: Reinforced concrete strip footing
Additional comments on foundation	Strip footings to support the shear walls are used in reinforced concrete houses as shown in Figure 10. Isolated footings are used to support isolated reinforced concrete pillars. Foundation requirements such as dimensions, allowable soil contact stress, minimum area of reinforcement in spread foundations which depends on the number of stories, and minimum buried depth of foundations, are specified in Title 5 (Chapter 7) of the General Planning and Building Ordinance (MINVU, 2014a).
Type of Floor System	Cast-in-place beamless reinforced concrete floor
Additional comments on floor system	
Type of Roof System	Wooden structure with light roof covering Wooden beams or trusses with heavy roof covering
Additional comments on roof system	
	Typical Story Height and Number of Stories: Article 4.1.1 of the General Planning and Building Ordinance (MINVU, 2014a) establishes a minimum interior clearance height of 2.3 m for housing dwellings, except under beams, horizontal
