HOUSING REPORT Confined Masonry

Report#	181
Last Updated	01/20/2016
Country	Chile
Author(s)	Claudia Alvarez Velasquez, Matias Hube Ginestar, Felipe Rivera Jofre, Hernan Santa Maria Oyandenel, David Hernandez Jara,
Reviewers	Yogendra Singh,

Building Type:	Confined Masonry
Country:	Chile
	Claudia Alvarez Velasquez

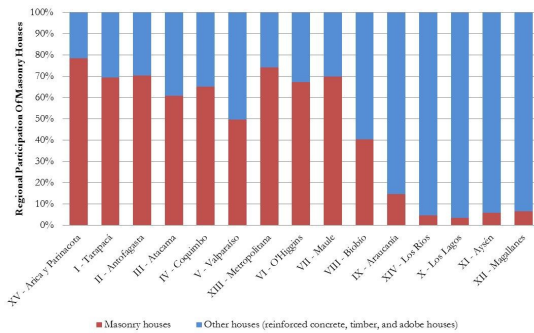
Figure 4. Regional participation of existing masonry houses to the total number of houses in 2012 (INE, 2012).

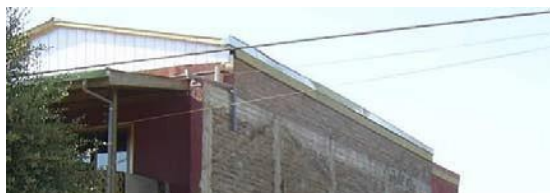
Figure 11. Common damage pattern to confined masonry buildings observed during the 1985 earthquake: Building in Melipilla (left), and building in Santiago (right) (Gent et al., 2008).

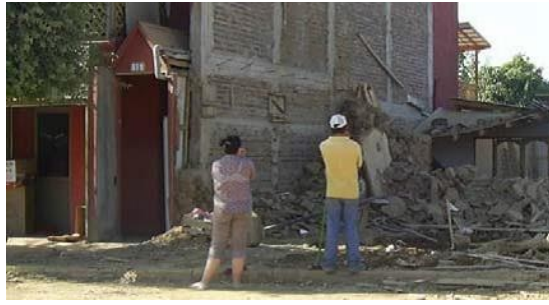
Figure 12. A two story confined masonry house in Curepto after 2010 earthquake which remained virtually undamaged, while the adjacent adobe house collapsed (Meli et al., 2011).

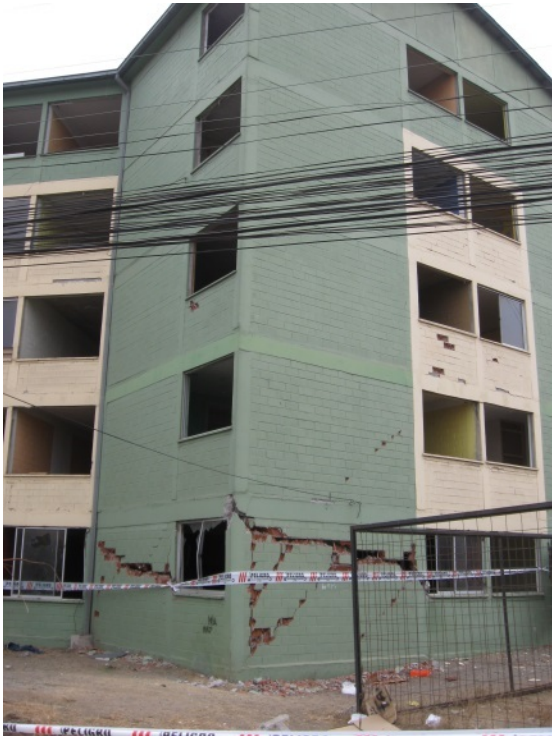
Figure 13. In-plane shear failure in buildings observed in 2010 earthquake in the city of San Antonio.

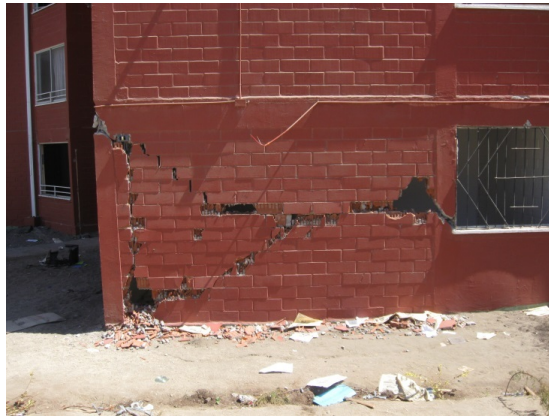
Figure 14. In-plane shear failure in buildings and shear failure at the ends of a reinforced concrete tie-column observed in 2010 earthquake in the city of San Antonio.

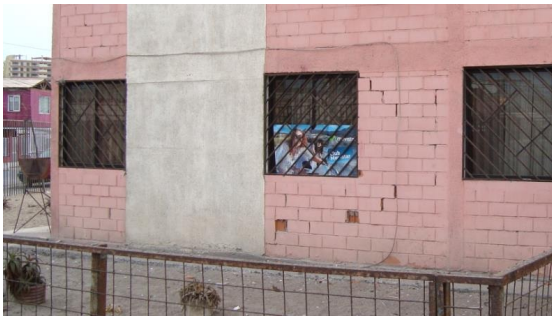
Figure 15. Damages of confined masonry buildings in the 2014 earthquake in the city of Iquique.

In 2010, the Maule earthquake left a total of 4 buildings on the ground, and approximately 50 buildings with demolition order. An example of a reinforced-concrete building that collapsed was the Alto Rio Building in Concepcion. In general, confined masonry houses performed well in the earthquake and did not experience major damages (Figure 12), though some moderate damage was observed in houses (Astroza et al., 2012). The most common damage pattern observed in confined masonry buildings was in-plane shear cracking in walls (see Figure 13), mostly observed at the floor level of three- and four-story buildings. In very few cases, this damage pattern was observed in confined masonry houses at the floor level of two-story structures. In three- and four-story confined masonry buildings, tie-columns of the first story and the masonry walls suffered severe damage, as shown in Figure 14. In a large amount of these buildings, tie-columns had smaller cross sections (14-15 x 14-15 cm) than the dimensions required (14-15 x 20 cm) by the Chilean standard for confined masonry structures (INN, 2003). Inadequate size and/or spacing of stirrups at the end of tie-columns caused buckling of longitudinal reinforcement and severe masonry crushing in all the damaged buildings observed by Astroza et al. (2012). Shear failure at the ends of tie-columns was caused by the absence of stirrups at the joint between tie-beams and tie-columns, and the inappropriate anchorage of the vertical reinforcement in tie-columns (Brzev et al., 2010; Astroza et al. 2012). Some four-story confined masonry buildings built between 1940 and 1960 in Santiago (Metropolitan Region) and Talca (VII region), with solid handmade clay brick and low-strength mortar, and with only tie-columns at the end of walls and not at openings, suffered moderate damage by shear cracking, in the same manner as observed in the 1985 San Antonio earthquake (Astroza et al., 2012). In the Iquique, 2014 earthquake, confined masonry structures performed very well. There were very few cases of confined masonry houses of two and mostly three stories with medium damage. Four-story confined masonry buildings with medium to high damage at the first floor (Figure 15), and five-story confined

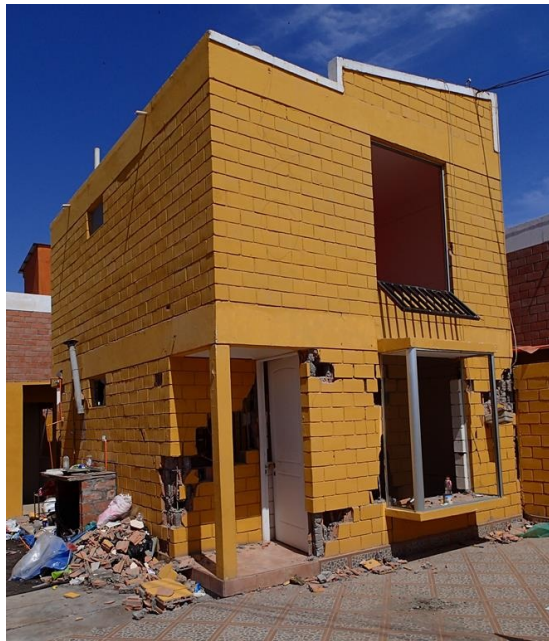
Figure 16. Damages of reinforced masonry houses in the 2014 earthquake in the city of Iquique.

masonry buildings with low to severe damage were observed (CIGIDEN, 2014). Some five-story confined masonry buildings showed shear cracking in the first four stories with loss of section in some tie-columns located at the exterior walls intersections, probably explained by frequency amplification in the foundation ground (Valdebenito et al., 2015). However, confined masonry houses performed well overall, and severe damage in masonry houses was only observed in reinforced masonry houses (Figure 16).
