# World Housing Encyclopedia

## HOUSING REPORT Timber Houses

<b>Report#</b>	182
<b>Last Updated</b>	
<b>Country</b>	Chile
<b>Author(s)</b>	Claudia Alvarez Velasquez, Matias Hube Ginestar, Felipe Rivera Jofre, Hernan Santa Maria OyandeneI, Mariana Labarca Wyneken,
<b>Reviewers</b>	Anna Lang,

<b>Building Type:</b>	Timber Houses
<b>Country:</b>	Chile
<b>Author(s):</b>	Claudia Alvarez Velasquez Matias Hube Ginestar Felipe Rivera Jofre Hernan Santa Maria OyandeneI Mariana Labarca Wyneken
<b>Last Updated:</b>	
<b>Regions Where Found:</b>	Timber houses are mainly distributed throughout the central and southern regions of the country, being predominant between VIII and X regions. These houses represent 37% of all the houses in the country.
<b>Summary:</b>	This housing type is typically one or two stories high with no basement floors. It has regular plan shapes and strip or isolated footings. Timber houses are typically occupied by a single family. In general, this type of construction did not present damage during past strong earthquakes (i.e., Valparaiso 1985, Maule 2010, or Iquique 2014). Every structure must

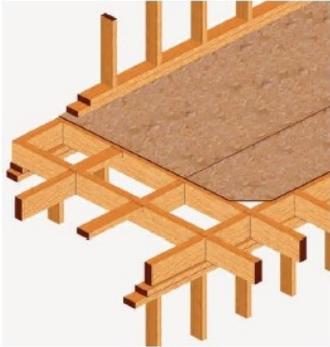
**Figure 9.(a) Platform system: Independent elements; platform and partition walls**

vertical trusses (Figure 9a, Fritz, 2007). The various types of connection elements used are: nails, bolts, screws, lag screws, and metallic connectors. The roof is constructed after all the vertical elements have been set. Figure 24 shows a typical roof framing of a timber house (Fritz, 2007). When all the timber structural elements of the roof are installed, the roofing sheet elements are screwed or nailed onto the roof structure.

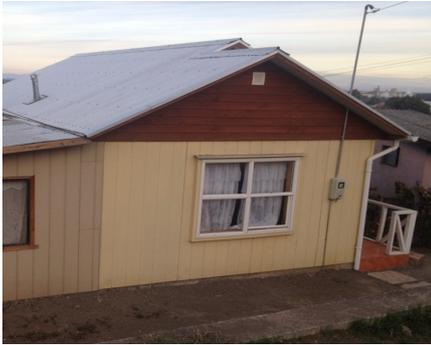
Figure 16. House with reinforced concrete spread footing foundation.

Timber houses in Chile have two principal types of foundations; isolated (reinforced concrete foundation or wooden piles, see Figure 15), or spread footing (see Figure 16). For houses with

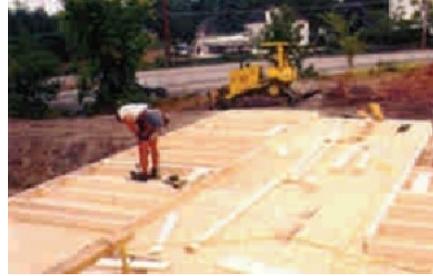
Figure 22. After the floor platform has been built, the construction of external wall and wall-partitions starts (Fritz, 2007).

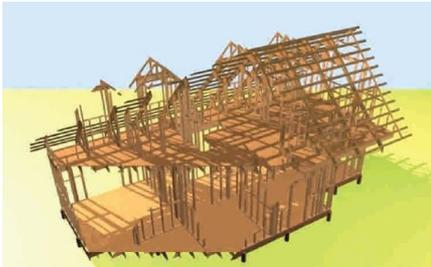
Figure 23. Independent horizontal diaphragms (first and second floor), and external walls and wall-partitions (Fritz, 2007).

<b>Construction process and phasing</b>	The most common type of foundation in timber houses is the use of wooden piles (see Section 3.6). The first relevant step is the excavation for the piles considering the volume of concrete covering (as seen in Figure 17a and Figure 17b), that can have a section of 40 x 40 cm. Then a layer of gravel of 8 to 10 cm of thickness is placed on the bottom of the excavation and the cylindrical wooden pile is installed above it, with steel bars previously introduced into the pile. The next step is the casting of the pile, which is embedded in the concrete. When foundations are finished, main beams are installed connecting the wooden piles and then secondary beams are connected to the main ones (see Figure 18a). Subsequently, the timber board is commonly nailed to the beams conforming the first floor platform. The platform system allows building independently the supporting (external/internal walls) and self-supporting walls (wall-partitions) above the floor platform. The most common type of platform is the timber platform (Figure 22), but concrete platforms also exist (in case that spread concrete foundation was used). Walls can be built externally while platform floor is being built, and then these can be installed through lag screws or bolts (see Figure 9b). The second floor platform consists of horizontal timber elements, which are independent from the external walls and wall-partitions, and are located upon the sills of walls (Figure 23). In general, the beams of the horizontal platform match with the vertical elements of

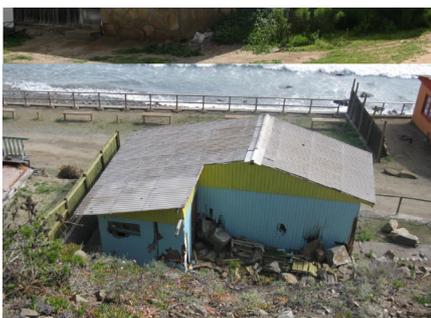
**Figure 19. Timber house damaged due to falling rock, 2015 Illapel earthquake. (Picture from Juan Carlos Obando)**
