World Housing Encyclopedia

HOUSING REPORT

Single-family stone masonry house

Report#	28
Last Updated	
Country	Italy
Author(s)	Dina D Ayala, Elena Speranza,
Reviewers	Miha Tomazevic,

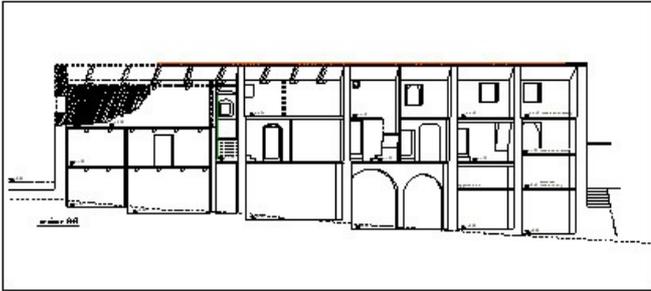
An Elevation of a Typical Building

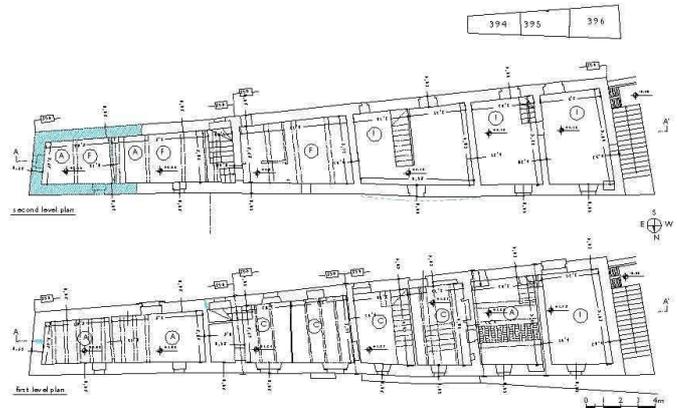
Plan of a Typical Building

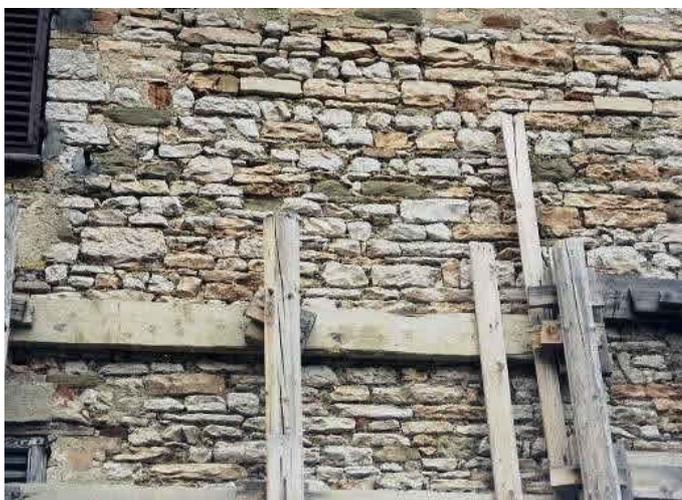
Critical Structural Details Stone Masonry Wall With Irregular Roughly Dressed Stone Blocks of

Varying Dimensions Embedded into Thick Lime Mortar Joints (not properly repointed)

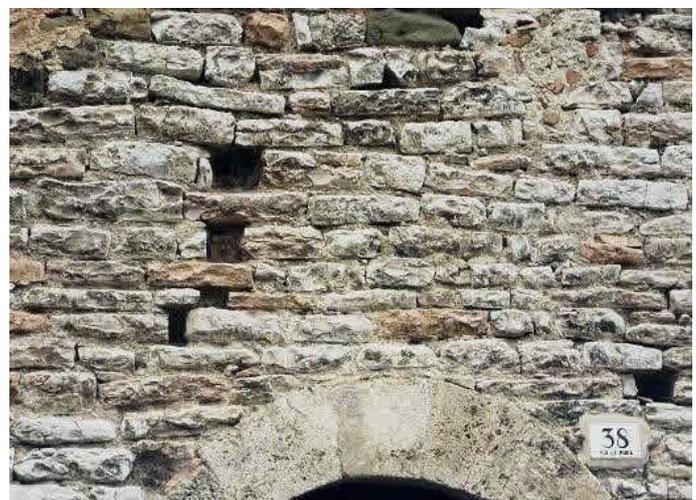
Critical Structural Details-Movement the Blocks, Probably as a Result of Damage in Previous Earthquake and

Visible Loose Stones Around the Arch

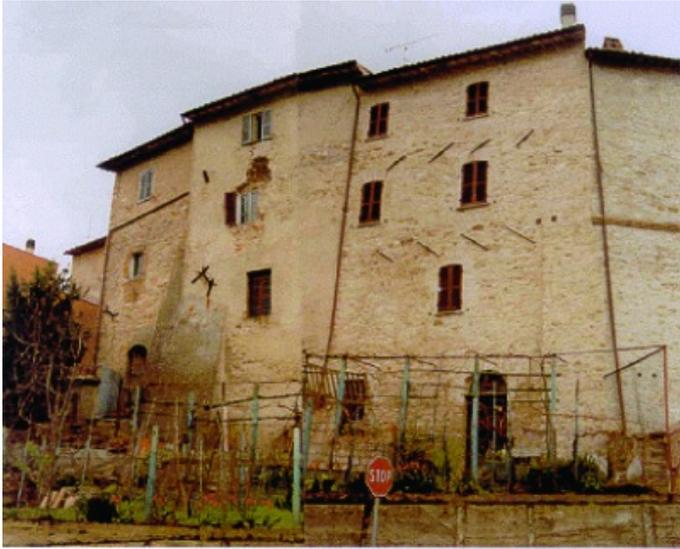
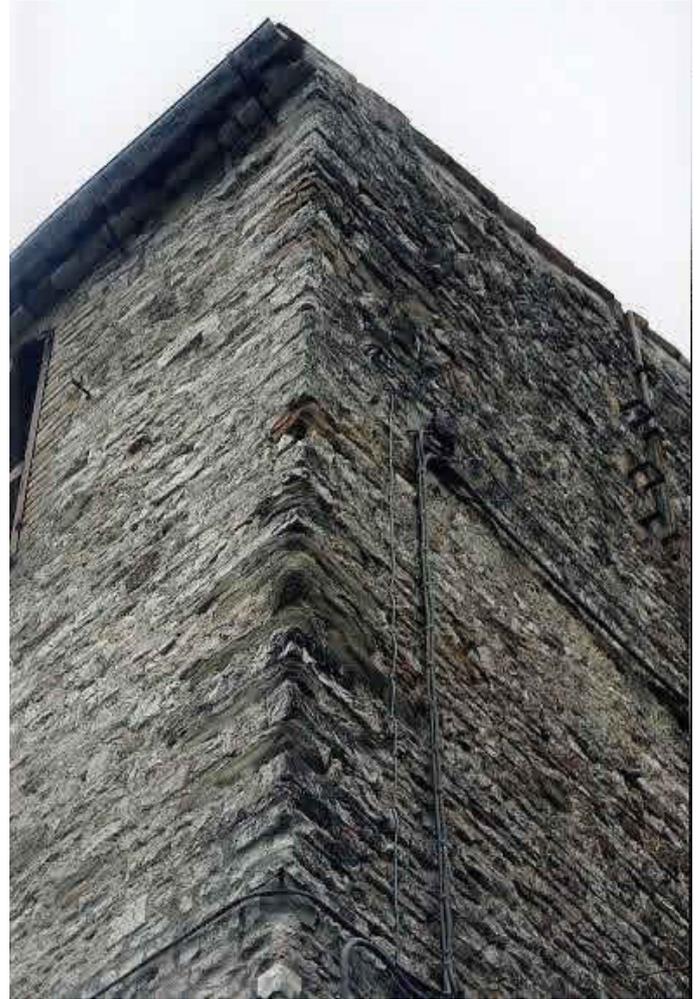
Key Seismic Features and Deficiencies Showing the Regular Arrays of Floor Ties in One the Next One, and Corner Return Return Stones in the Third Unit

Earthquake-Resilient Feature - Corner Returns between the Perpendicular Walls Made of Larger Stone Blocks

Earthquake resilient features in roof and floors	In some cases the main timber structure is laid out orthogonally at different floor level to tie in both sets of walls
Seismic deficiency in foundation	
Earthquake-resilient features in foundation

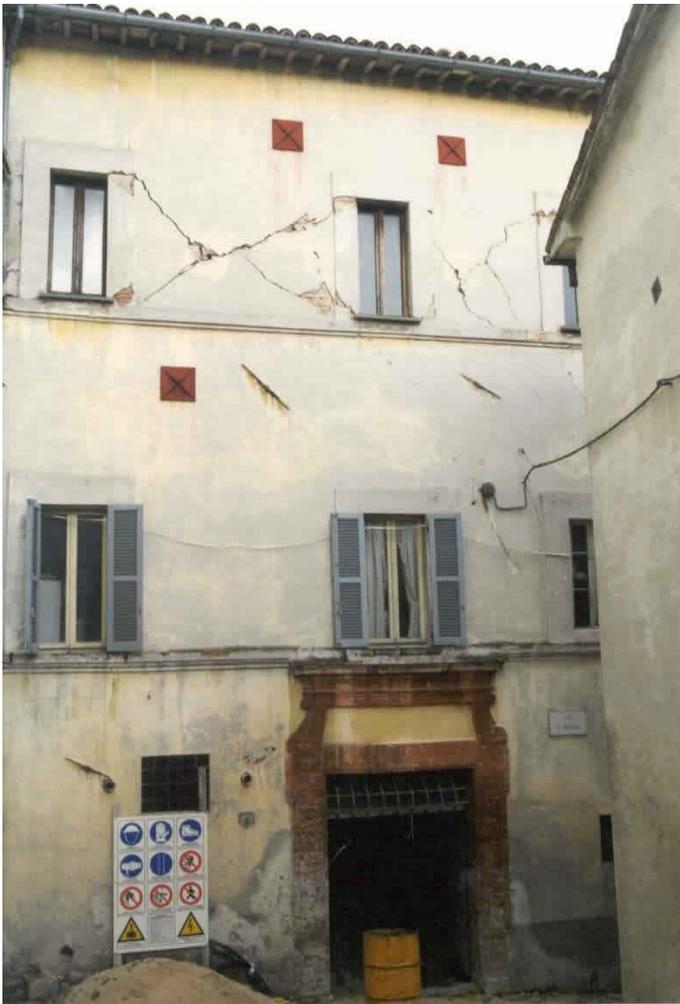
Earthquake Damage to a Retrofitted Building to the Inadequate RC Ring Beam-Wall Connection

Structural Deficiency	Seismic Strengthening
Lack of Structural Integrity	Installation of new RC ring beams with or without concrete slab. A procedure for the installation of a new RC ring beam in an existing stone masonry building is presented in Figure 15. Note the dowels anchored into the existing walls and the new concrete slab atop the existing wood floor. Figure 14 shows an alternative solution, which includes the installation of steel anchors grouted into the existing walls and the installation of new concrete floor slab atop the existing wood floor. Figure 11 shows a building strengthened with new RC ring beams. It is very important to achieve the connection between the new RC ring beam and the existing masonry, otherwise the earthquake damage may be caused, as illustrated in Figure 10.

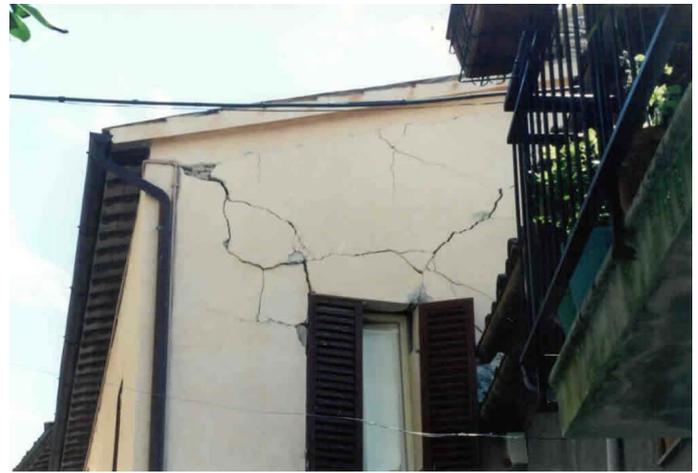
Typical Earthquake Damage - "X" cracking of walls (1997 Umbria-Marche earthquake)

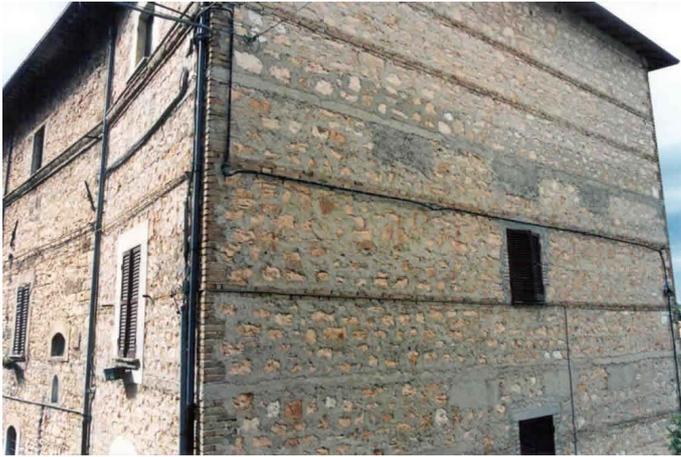
Illustration of Seismic Strengthening Techniques

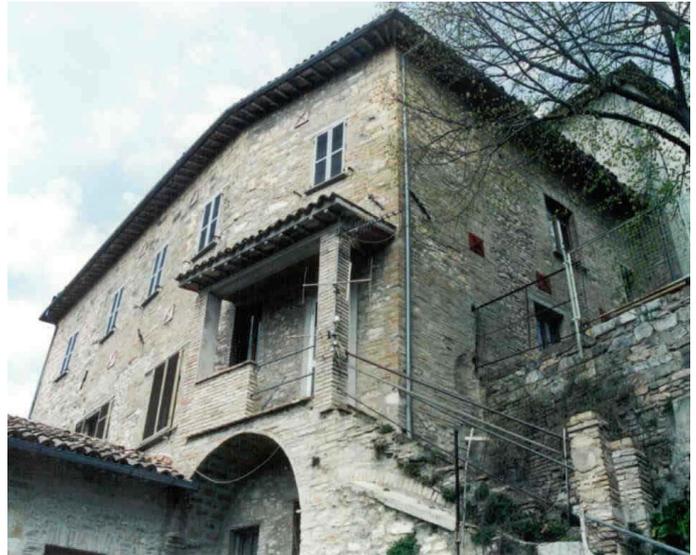
Seismic Strengthening Techniques- Installation of modern anchors with anchorage plates and concrete lintels over openings

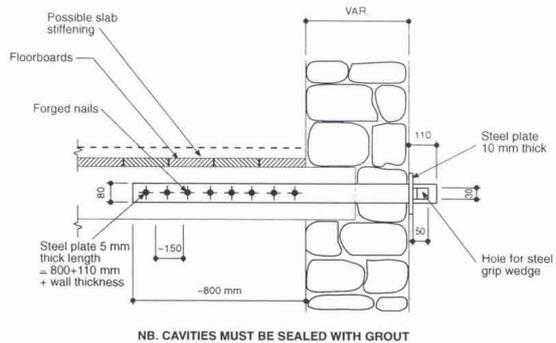
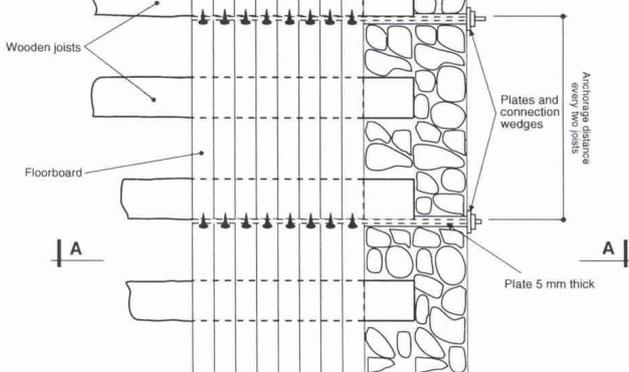
HORIZONTAL SECTION

Seismic Strengthening- Steel Strap Used to Connect an Existing Masonry Wall to Timber Floor Joists

Inadequate Wall-Floor Connection	Installation of new steel ties. Figure 13 shows a steel strap detail connecting an existing stone masonry wall to a timber floor joists. Figure 14 shows a detail of ties with an anchor plate at the exterior face of the wall. A building with the installed ties is shown on Figure 7. It is very important to accomplish a regular distribution of ties - irregular tie distribution may be a cause of earthquake damage, as illustrated in Figure 9.
Low Lateral-Load Resistance of the Walls	Grouting

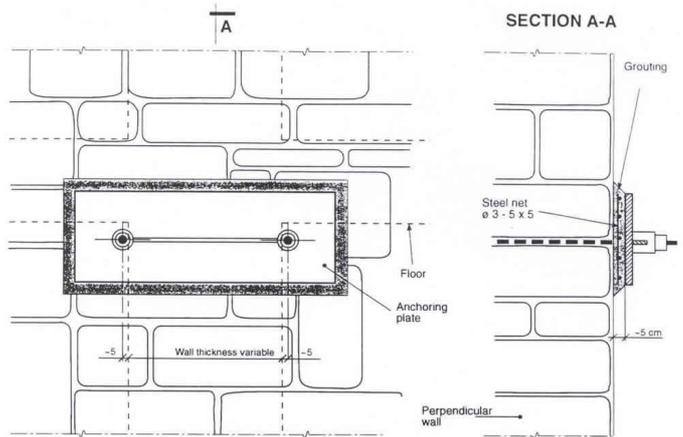
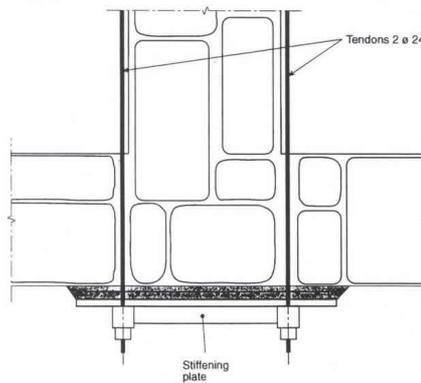
HORIZONTAL SECTION

Seismic Strengthening- Installation of Ties with an Anchor Plate at the Exterior Wall Face

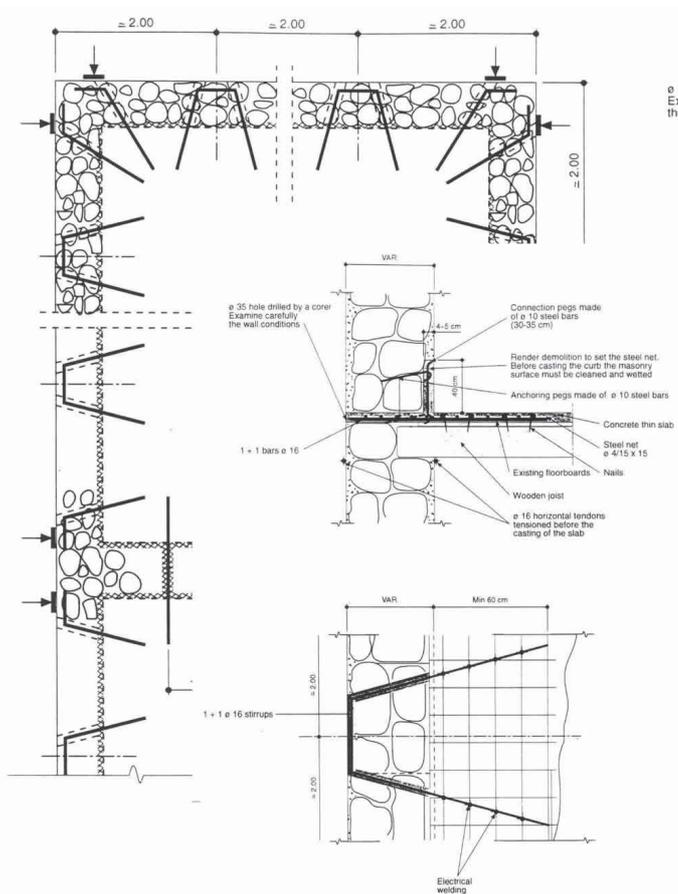
Seismic Strengthening- Installation of New Steel Anchors Grouted Into Existing Walls and the New RC Floor Slabs

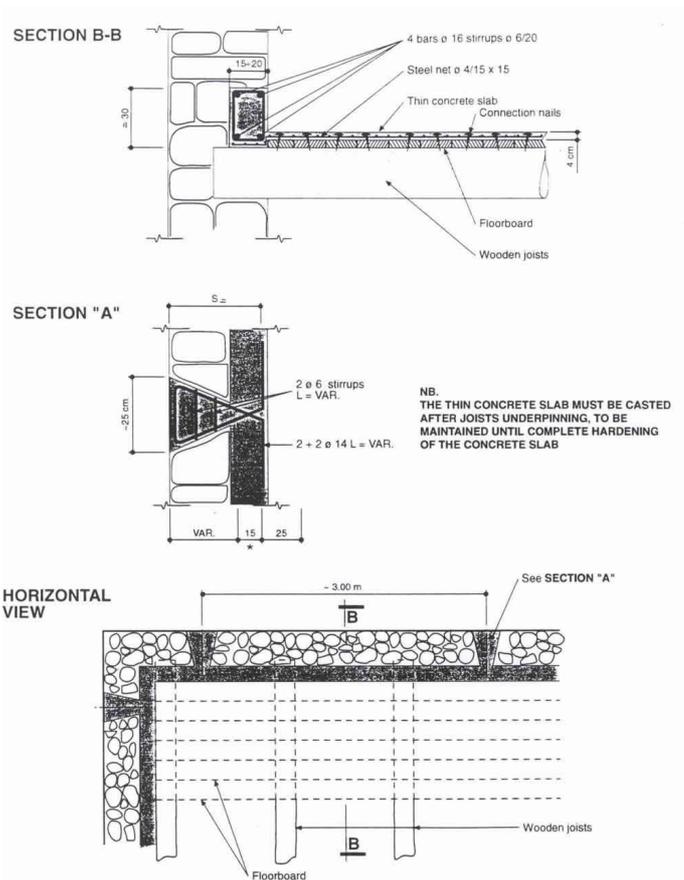
Seismic Strengthening- Installation of New RC Ring Beam
