World Housing Encyclopedia

HOUSING REPORT

Rubble-stone masonry house

Report#	58
Last Updated	
Country	Slovenia
Author(s)	Marjana Lutman, Miha Tomaševič,
Reviewers	Svetlana N. Brzev,

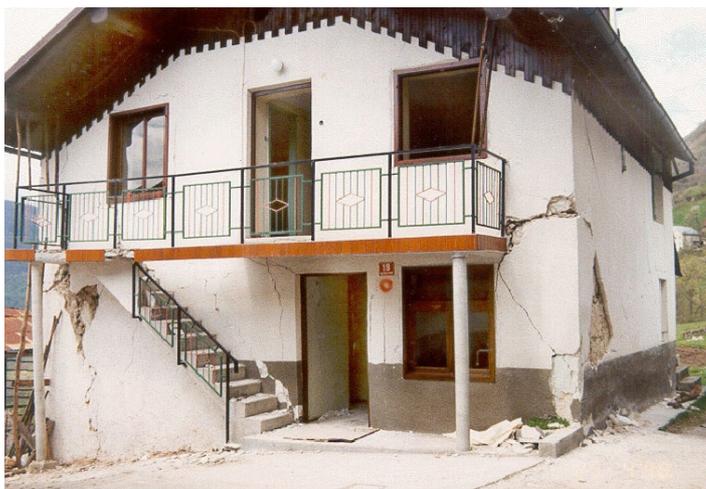
An Illustration of Key Seismic Deficiencies - lack of structural integrity results in wall dislocation and corner damage

damage to traditional stone-masonry houses are: - Cracks along the joints between walls and floors; - Vertical cracks at the corners and wall intersections, separation of walls, collapse of gables; - Cracks in structural walls, falling out of masonry at lintels, closed openings and in corner zones; - Heavy damage to walls, partial collapse of corners, delamination and disintegration of masonry.

Overall damage patterns observed in past earthquakes for this type of construction included: - Cracking: heavy damage of structural walls. Delamination and disintegration of masonry. Dislocation of walls and vertical cracks at corners; partial collapse of wall corners. -Horizontal cracks along the wall-to-floor joints.

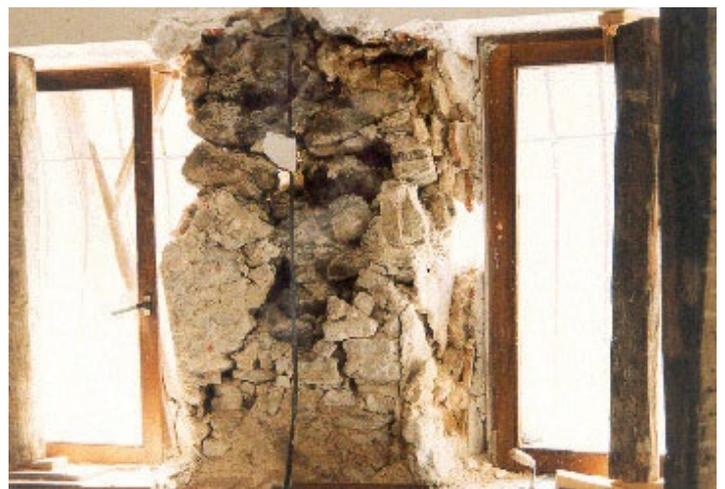
Seismic deficiency: pier failure

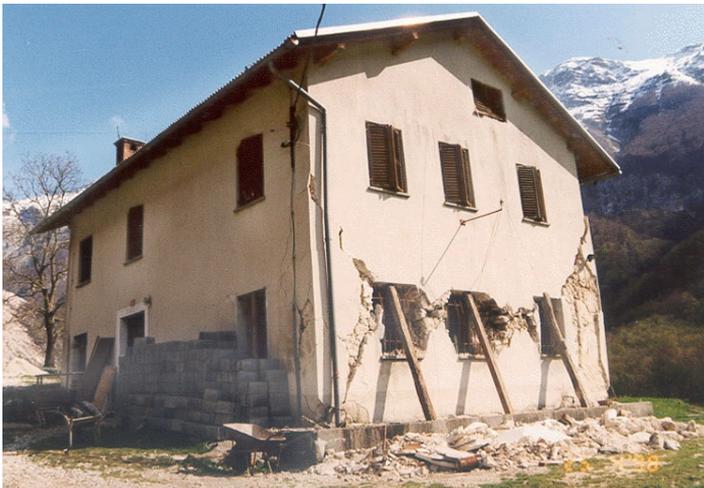
A Photograph Illustrating Typical Earthquake Damage in the 1998 Bovec earthquake

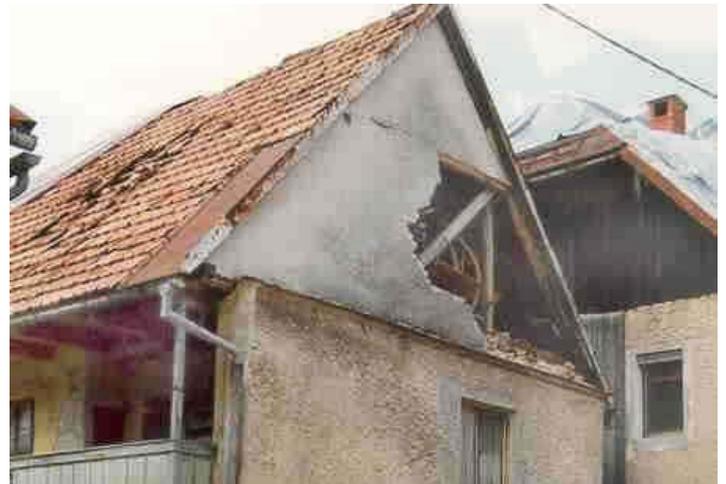
Out-of-plane gable collapse

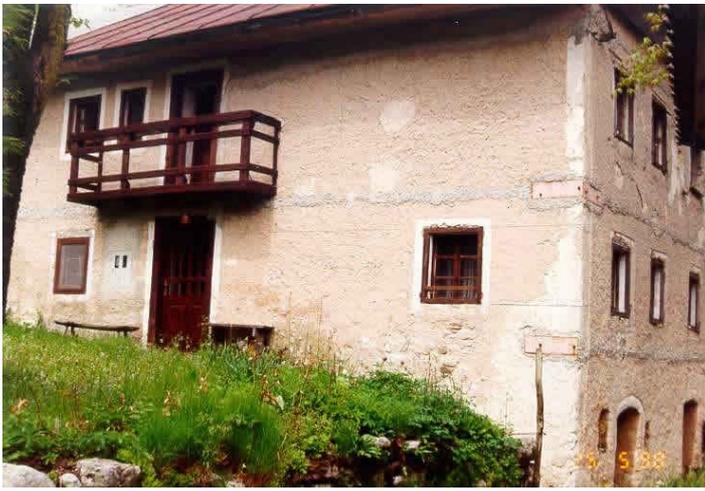
A building strengthened after the 1976 Friuli earthquake remained undamaged in the 1998 Bovec earthquake

Many buildings have been adequately repaired and strengthened after the 1976 Friuli earthquake. The walls were grouted, the old timber floor structures were replaced with new reinforced concrete slabs in many cases and houses were completely tied. The effectiveness of these measures was confirmed during the 1998 Bovec earthquake. Adequately repaired and strengthened structures suffered almost no damage in the earthquake.
