# World Housing Encyclopedia

## HOUSING REPORT

### Confined block masonry building

<b>Building Type:</b>	Confined block masonry building
<b>Country:</b>	Chile
<b>Author(s):</b>	Ofelia Moroni Cristian Gomez Maximiliano Astroza
<b>Last Updated:</b>	
<b>Regions Where Found:</b>	This housing type is used all over Chile.
<b>Summary:</b>	<p>This construction practice started during the 1940s, after the 1939 earthquake that hit Chillan in the mid-south of Chile. It is mainly used for dwellings and apartment buildings up to four-story high. Buildings of this type are found in all regions of Chile. This is a confined masonry construction, consisting of load-bearing unreinforced masonry walls (commonly made of clay units or concrete blocks) confined with cast-in-place reinforced-concrete vertical tie-columns. These tie-columns are built at regular intervals and are connected with reinforced concrete tie-beams cast after the construction of masonry walls. Tie-columns and tie-beams prevent damage due to out-of-plane bending effects and improve wall ductilities. Floor systems generally consist of cast-in-place reinforced slabs with a thickness between 100 to 120 mm. Confined masonry walls ha

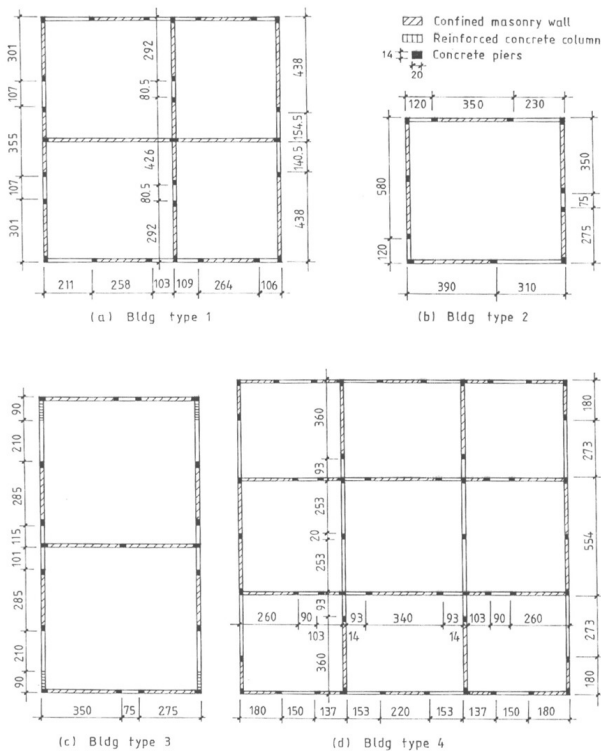
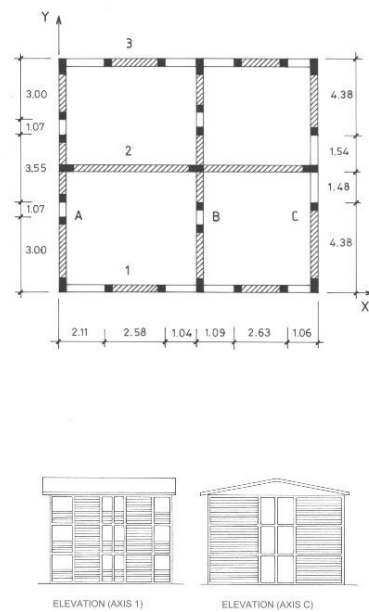
**Plan of a typical building**

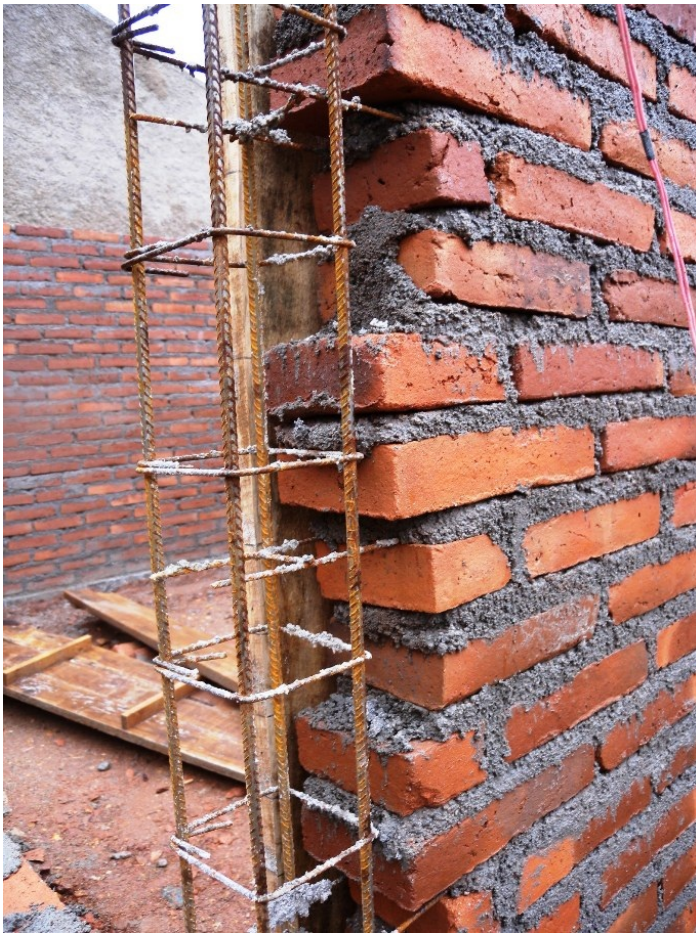
***a toothed wall-to-tie-column interface***

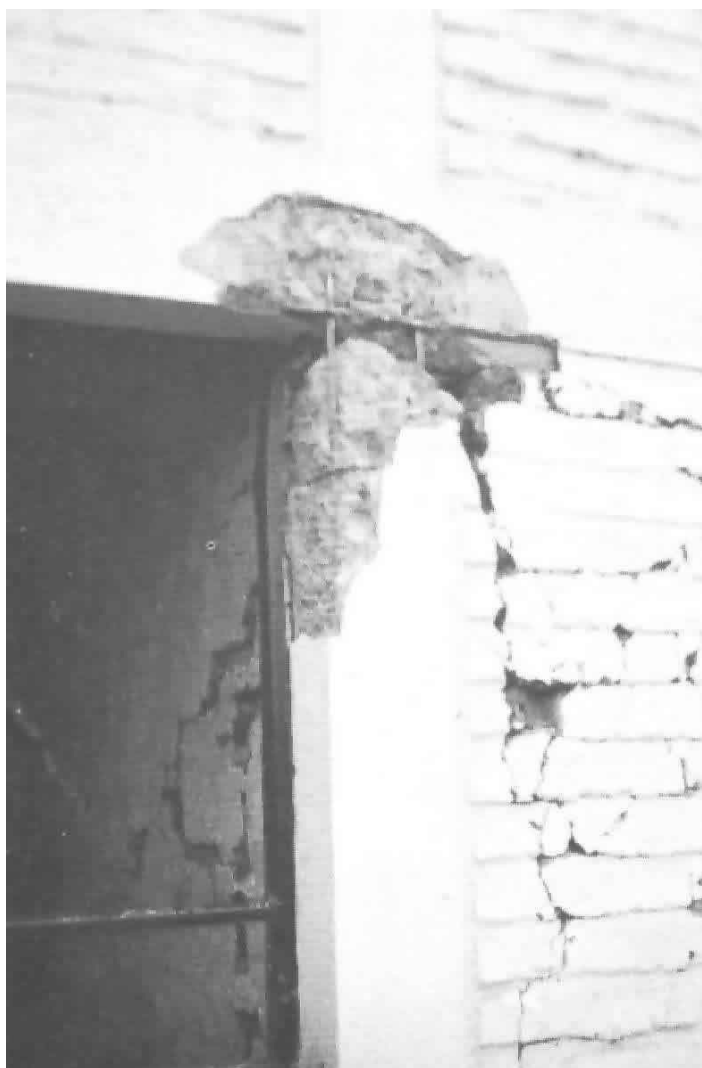
***Typical earthquake damage:  
cracking of concrete posts (1985  
Lilloe earthquake)***

blocks, which were very rigid and the earthquake had a very important high frequency content. Typical patterns of damage were: in-plane shear failure, out-of-plane bending failure, lack of bond between masonry and concrete elements, damage in column-beam joints and separation between walls. (Monge, 1985). After the 1985 earthquake, the Ministry of Housing appointed a special committee to review the seismic effects on social dwellings (Flores, 1993). About 84,000 units, mostly located in Santiago, were reviewed concluding that 50% of the units had some structural damage. Confined masonry buildings represent 16% of the total and 74% of them were lightly damaged, but no collapses occurred. In most of the damaged buildings tie-columns were missing at one end of the walls or at the opening extremes. The following characteristic damage patterns were observed: - shear cracks in walls that propagate into the tie-columns. Most of them passed through mortar joints and the initiation of crushing of masonry units has been observed in the middle, most stressed part of the walls. - horizontal cracks at the joints between masonry walls and reinforced concrete floors or foundation - cracks in window piers and cracks in walls due to out-of-the-plane action when they are not properly confined or the separation between tie-columns is too large. - crushing of concrete at the joints between vertical tie-columns and horizontal bond-beams when their reinforcement was not properly connected. - inadequate quality of material and construction.

Overall damage patterns observed in past earthquakes for this type of construction included in-plane shear failure, out of plane bending failure, lack of bond between masonry and concrete elements, damage in column-beam joints and damage in the connection of perpendicular walls. These type of damages occur when requirements of NCh2123.of97 are not totally considered

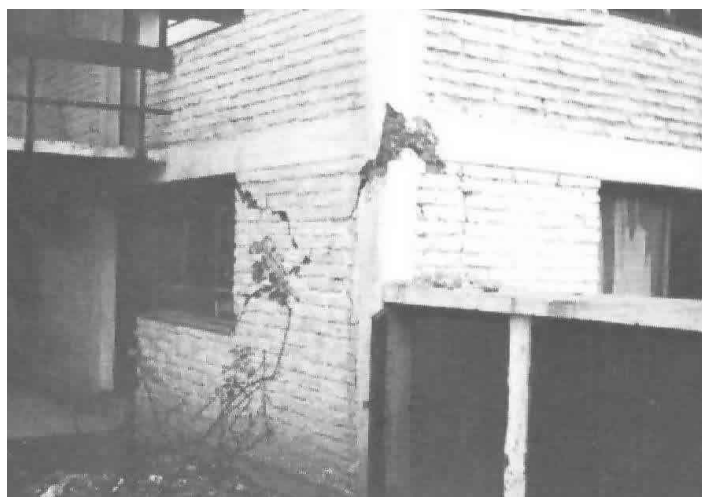
***Typical earthquake damage:  
cracking of concrete posts and  
masonry walls (1985  
Lilloe earthquake)***

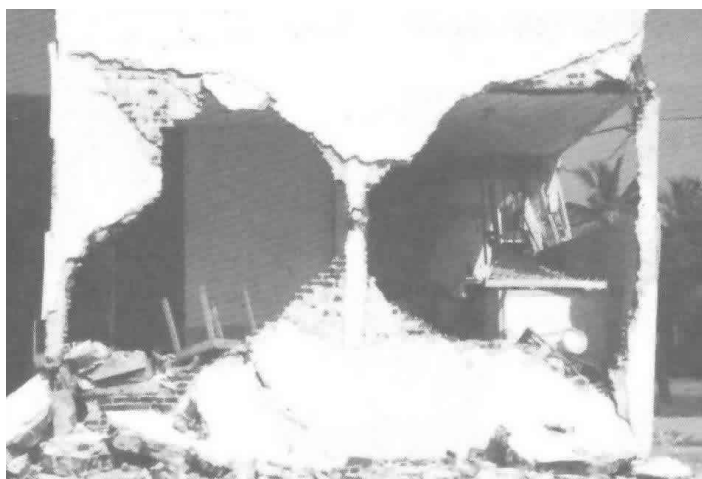
***Typical earthquake damage:  
collapse of a confined wall ( 1985 Lilloe  
earthquake)***

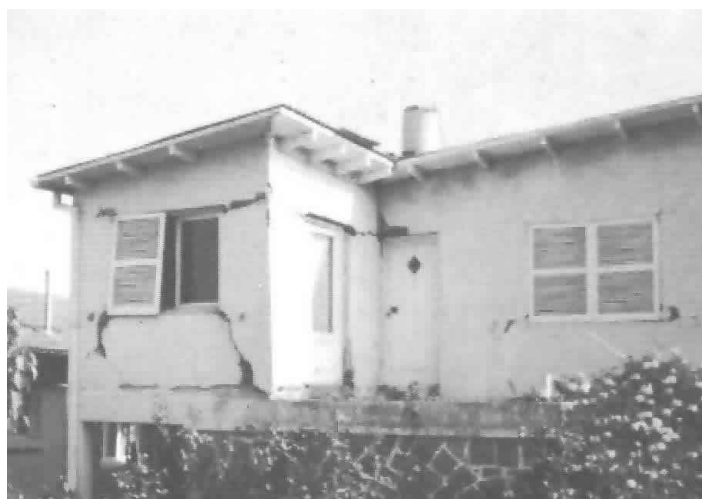
***Typical earthquake damage:  
cracking of masonry walls (1985  
Lilloe earthquake)***

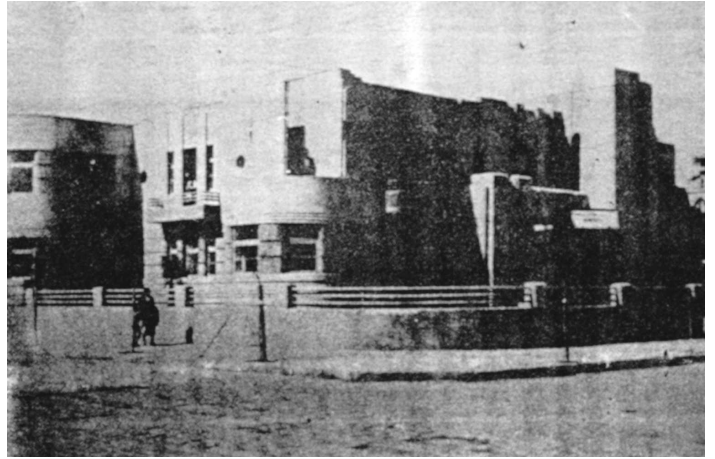
**Picture taken after 2010 earthquake**

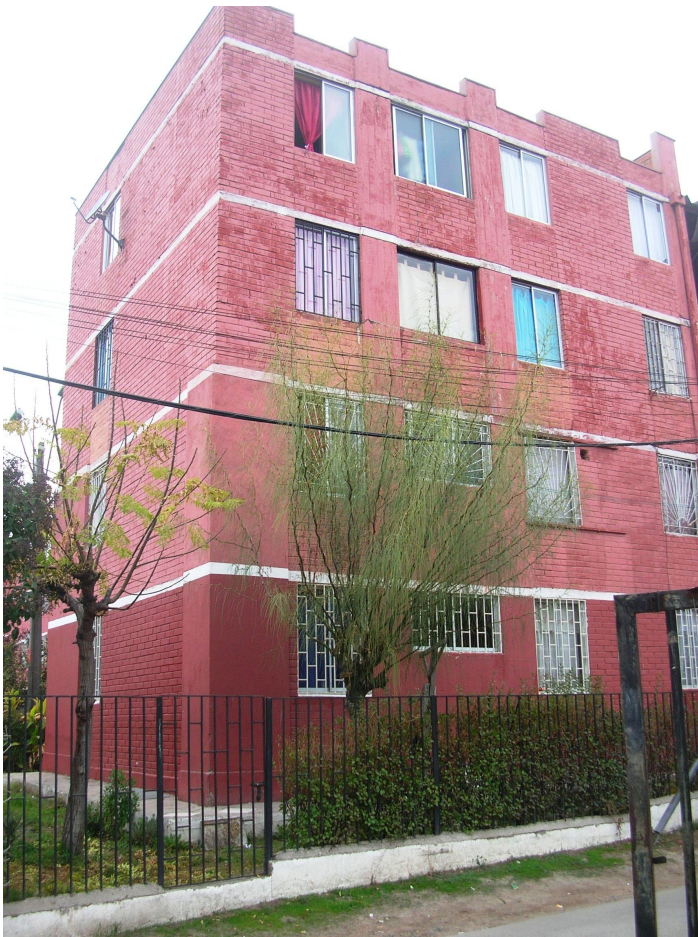
***Building retrofitted after 1985 earthquake, without damage. Conjunto Alberto Larraguibel. Comuna de Lo Prado, region Metropolitana***

<b>Was the work done as a mitigation effort on an undamaged building or as a repair following earthquake damages?</b>	Repair following earthquake damage
<b>Was the construction inspected in the same manner as new construction?</b>	Yes
<b>Who performed the construction: a contractor or owner/user? Was an architect or engineer involved?</b>	A constructor performed the construction, an engineer was involved
<b>What has been the performance of retrofitted buildings of this type in subsequent earthquakes?</b>	Retrofitted buildings performed quite well during 2010 earthquake.
<b>Additional comments section 6</b>

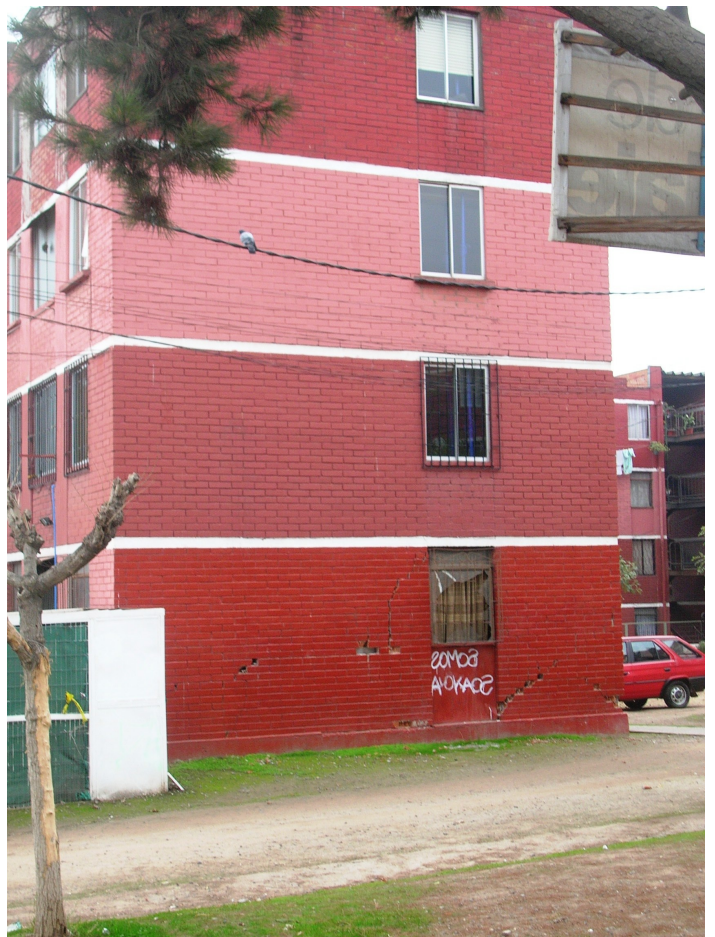
***Unrepaired building with damage after 2010 earthquake. Conjunto Alberto Larraguibel. Comuna de Lo Prado, region Metropolitana***

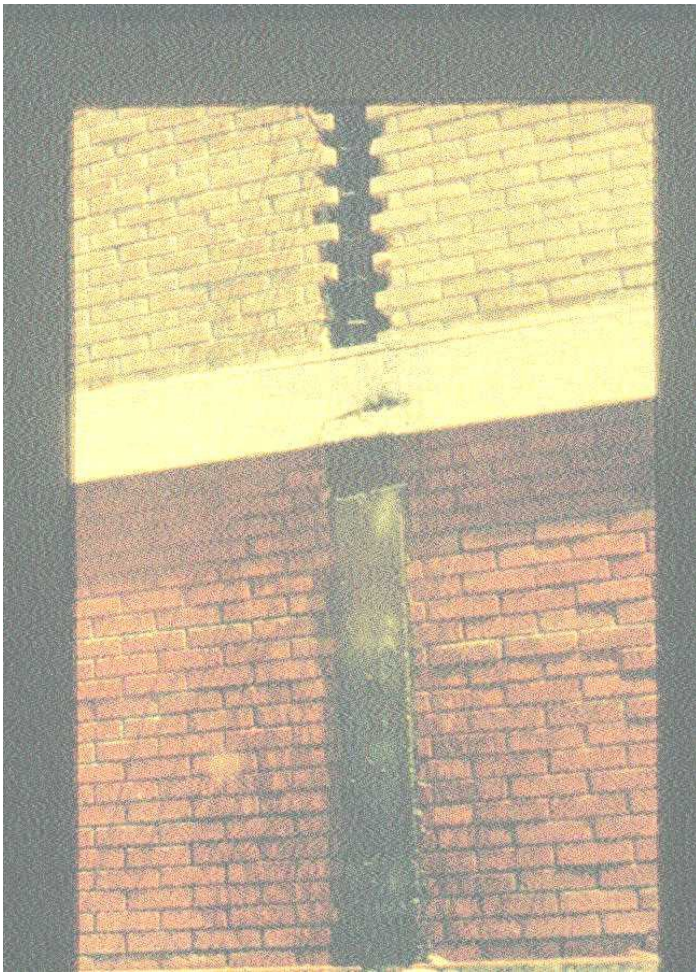
***Illustration of seismic-strengthening techniques***

<b>Structural Deficiency</b>	<b>Seismic Strengthening</b>
Partial confinement	New tie-columns are built.

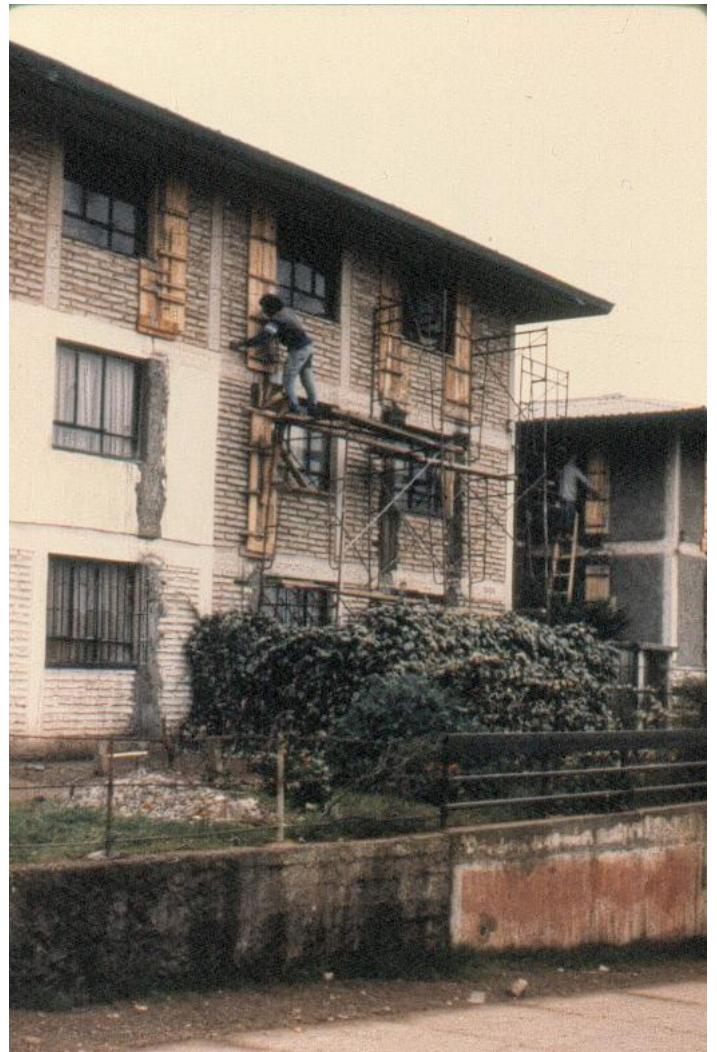
***Illustration of seismic-strengthening techniques***
