HOUSING REPORT Unreinforced Masonry Building

Report#	73
Last Updated	
Country	SLOVENIA
Author(s)	Marjana Lutman, Miha Tomazevic,
Reviewers	Dina D'Ayala,

Building Type:	Unreinforced Masonry Building
Country:	SLOVENIA
Author(s):	Marjana Lutman Miha Tomazevic
Last Updated:	
Regions Where Found:	<p>Buildings of this construction type can be found in all Slovenian towns, and it constitutes up to 30 % of the entire housing stock in Slovenia. This construction type was also practiced in other countries in the region, in particular Montenegro and Macedonia, which were part of the former Yugoslavia. This type of housing construction is commonly found in urban areas.</p>
Summary:	<p>This construction was commonly used for residential buildings in all Slovenian towns, and it constitutes up to 30% of the entire housing stock in Slovenia. The majority of these buildings were built between 1920 and 1965. They are generally medium-rise, usually 4 to 6 stories high. The walls are unreinforced brick masonry construction laid in lime/cement mortar. In some cases, the wall density in the longitudinal direction is significantly smaller than in the transverse direction. In pre-1950 construction, ther

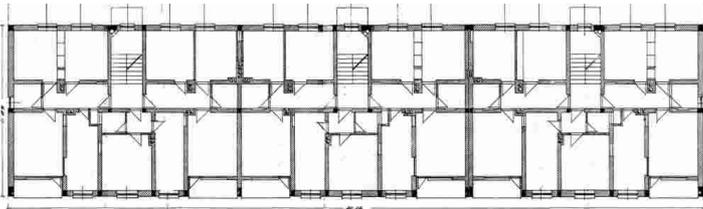
Plan of a Typical Building

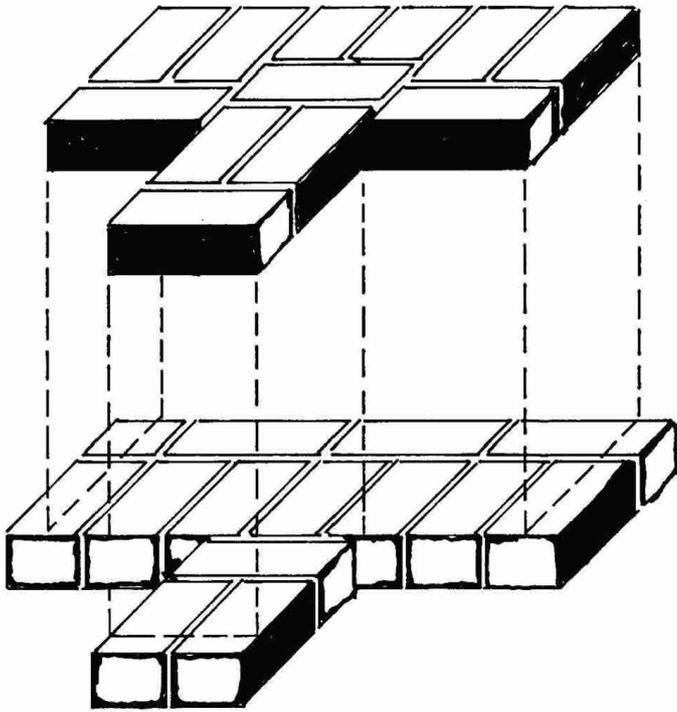
Critical Details-Bonding arrangements of masonry units

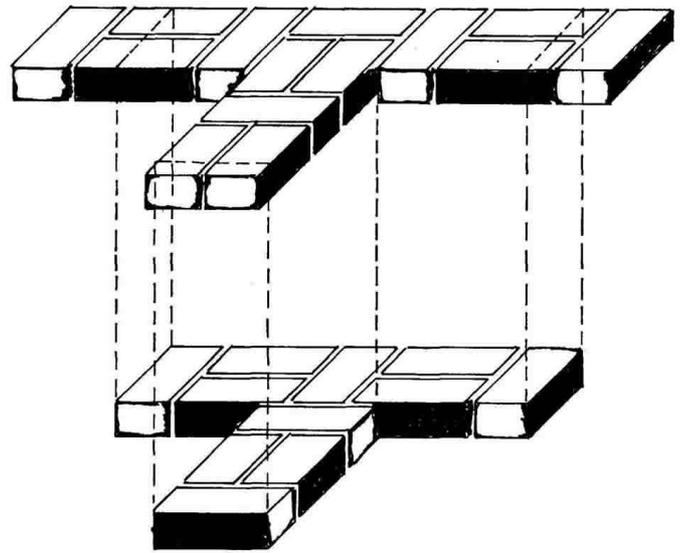
Critical Details-Bonding arrangements of masonry units

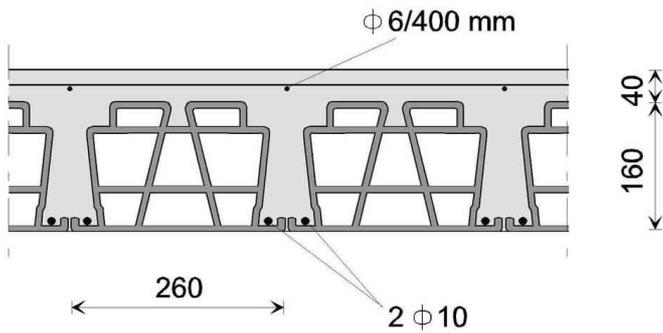
Critical Details - Hollow -Clay Tile Floor Structure

size is l/w /h=250/120/65 mm. The mortars used are (a) 1: 3 (lime:sand), (b) 1 : 3 : 9 (cement:lime:sand), and (c) 1 : 4 (cement:sand)
Foundations	Plain concrete	C10 - C15 (cube compressive strength 10-15 MPa)
Floors	Hollow clay tile masonry blocks Concrete Steel reinforcement	C25 grade concrete is used with cube compressive strength of 25 MPa. The steel used has properties fy and fu of 240 MPa and 360 MPa, respectively
Roof	Hollow clay tile masonry blocks Concrete Steel reinforcement	C25 grade concrete is used with cube compressive strength of 25 MPa. The steel used has properties fy and fu of 240 MPa and 360 MPa, respectively
Other

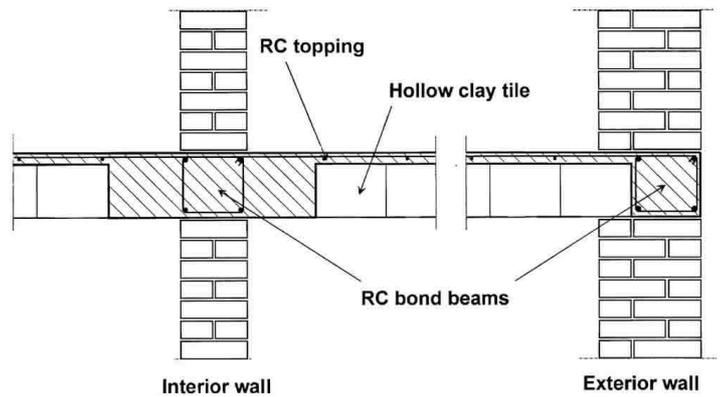
Critical Details - Wall to Hollow - Clay Tile Floor Connection

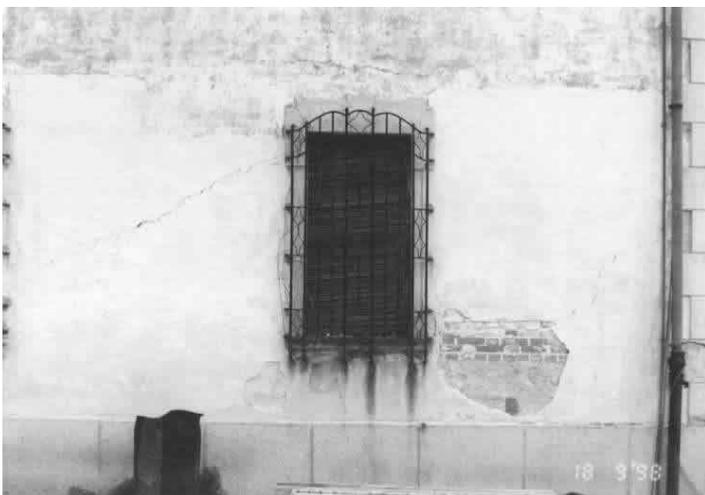
Seismic Deficiencies - Typical diagonal cracks developed in wall piers

typically found in this construction type	Other
Horizontal irregularities typically found in this construction type	Other
Seismic deficiency in walls	Masonry shear strength is not adequate to sustain larger seismic effects. The normal stresses due to gravity loads are often high and brittle wall failure can be expected.
Earthquake-resilient features in walls	The mortar mix is variable through the building height: pure cement mortar used at the lowest two floor levels, composite lime/cement mortar used in the middle portion, and pure lime mortar for the upper floors.
Seismic deficiency in frames	
Earthquake-resilient features in frame	
Seismic deficiency in roof and floors	If the roof and floor structures are one-way systems (i.e. carry load in one direction only), the walls in longitudinal and transverse directions are not equally loaded.
Earthquake resilient features in roof and floors	
Seismic deficiency in foundation

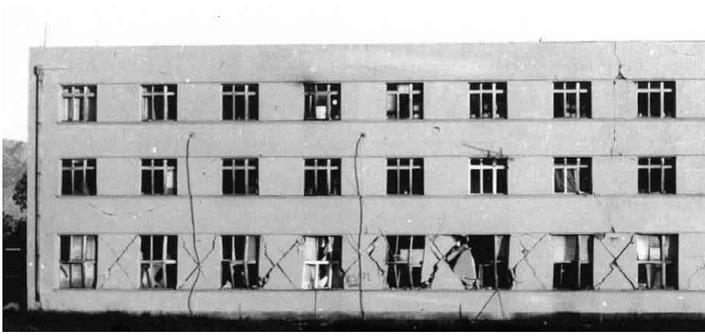
A Photograph Illustrating Typical Earthquake Damage- Diagonal "X"-type shear cracks in wall piers

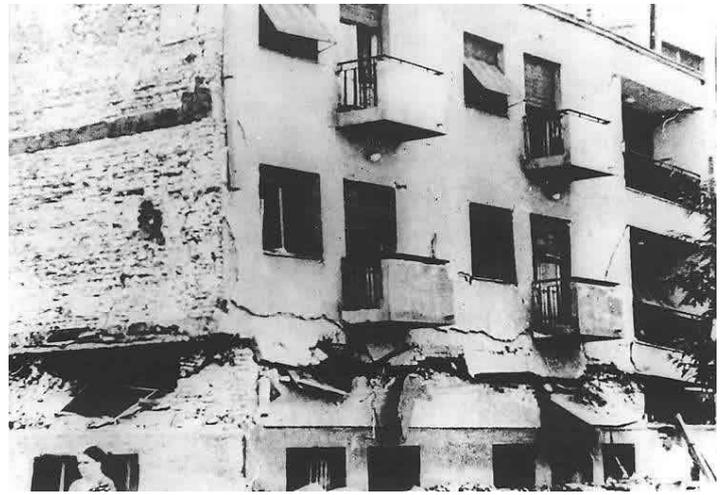
Typical Earthquake Damage- Severely Damaged Building with Inadequate Wall Density in Predominant Earthquake Direction (1963 Skopje earthquake)

enormous damage was caused. In Slovenia, the maximum intensity was VIII EMS. Out of 6,175 damaged buildings, 1,709 had to be demolished and 4,467 were retrofitted. ** The strongest earthquake with the epicenter in Slovenia in the 20th century occurred on April 12, 1998. The epicenter was approx. 6.3 km South-East from the town of Bovec, and the focal depth was between 15 and 18 km. No building collapses were reported; however, out of 952 inspected buildings, 337 were found to be unsafe, out of which 123 buildings were beyond repair. The majority of damaged buildings were rubble-stone masonry houses. Brick masonry buildings of this construction type remained undamaged or just a few cracks (mostly diagonal shear) were developed (Plain masonry building in Bovec: Fig.9). *** This construction was also practiced in Montenegro and Macedonia, which used to be, like Slovenia, part of the former Yugoslavia. Many buildings of this type were seriously damaged in the 1979 Montenegro earthquake (typical shear cracks in wall piers of a building in Budva, see Fig.10), and the 1963 Skopje earthquake (severely damaged building with inadequate wall density in predominant earthquake direction: Fig.11). Over 1,500 people died in the 1963 Skopje earthquake.

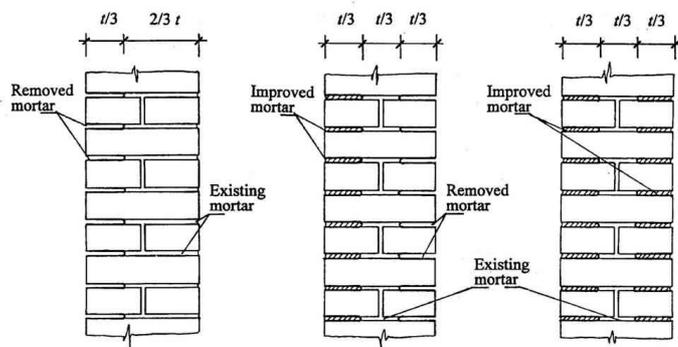
REPOINTING OF A BRICK-MASONRY WALL

Illustration of Seismic Strengthening Techniques-Repointing

Structural Deficiency	Seismic Strengthening
Cracks caused by the differential foundation settlement	Repair of cracks: Cracks are injected with cement grout which contains anti-shrinkage admixtures. After cleaning the wall surface, the grout is injected into the cracks through injection tubes and nozzles, which are drilled into the wall along the crack at 300 to 600 mm spacing. The grout is injected under low pressure. Epoxy grout is recommended instead of the cement grout in the case of fine cracks.
Poor mortar quality	Repointing (Fig.12): In the case of poor mortar quality and good quality brick masonry units, the existing mortar can be partially replaced with a cement or lime/cement mortar of significantly better quality. The existing mortar is removed from the joints up to 1/3rd of the wall thickness on each wall surface. After cleaning the surface and the joints, the joints are repointed using cement or lime/cement mortar. In addition, steel reinforcement can be placed in the bed joints to improve the wall ductility characteristics.

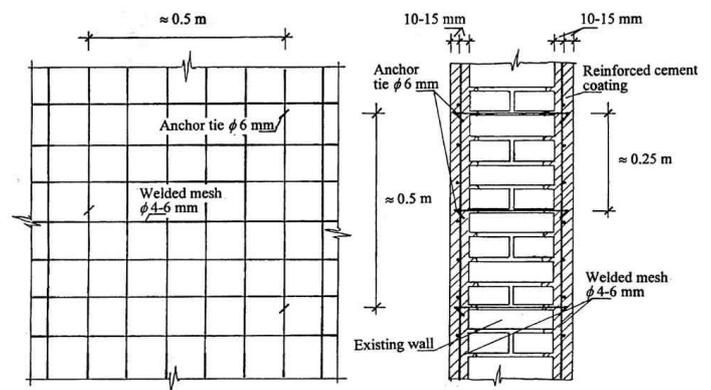
REINFORCED-CEMENT COATING

Inadequate lateral load resistance of the walls	Reinforced-cement coating (Fig. 13): After removing the old plaster and cleaning the wall surface, new reinforced coating (two-layer
