# World Housing Encyclopedia

## HOUSING REPORT

**A single-family, two-storey house with brick walls and timber floors**

<b>Report#</b>	84
<b>Last Updated</b>	
<b>Country</b>	Romania
<b>Author(s)</b>	Maria D. Bostenaru, Ilie Sandu,
<b>Reviewers</b>	Dina D'Ayala,

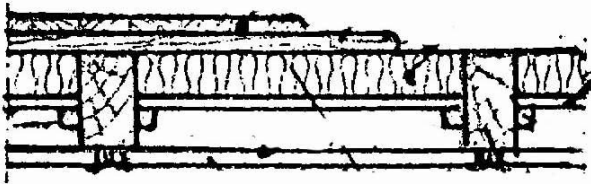
**Wooden floor with finishing**

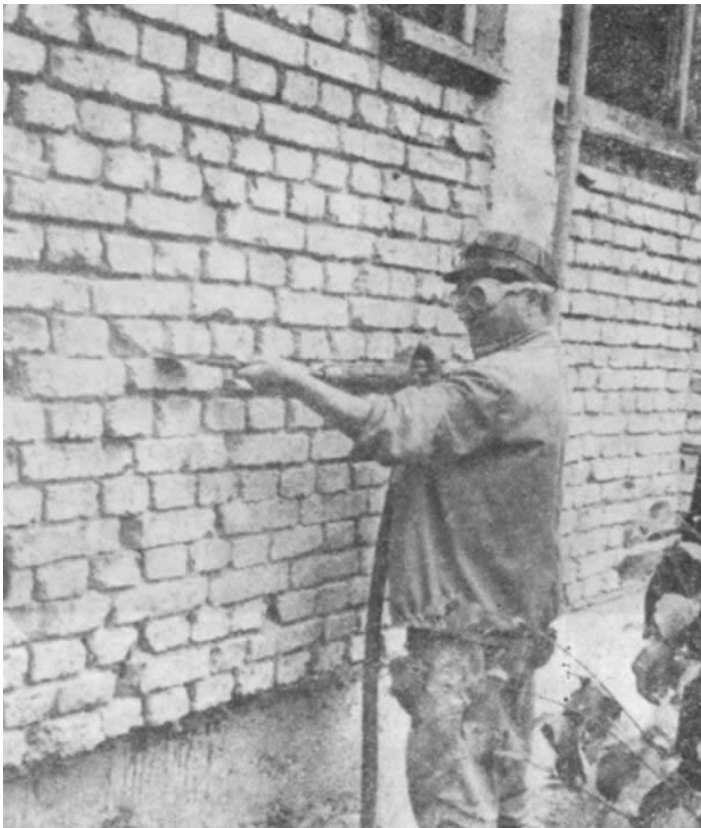
### **Torcrete method - step 1: cleaning of the wall surface with compressed air**

of housing applications for this method; however, several public buildings, including the Architecture Institute, were repaired using this method. The torcrete method was used for repairing diagonal large cracks or dislocations.

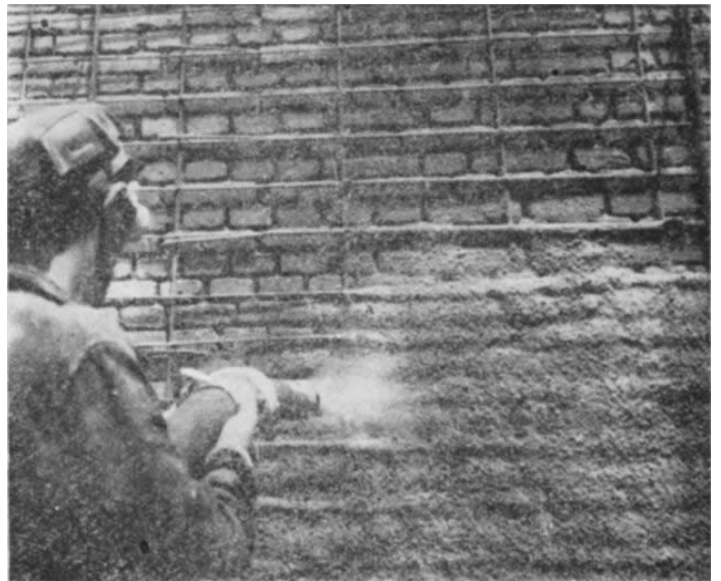
### **"Torcrete" retrofit : application of torcrete overlay on the steel net attached to the wall**
