World Housing Encyclopedia

HOUSING REPORT Single-family wooden house

Report#	86
Last Updated	
Country	Japan
Author(s)	Norio Maki, Satoshi Tanaka,
Reviewers	Sajal K. Deb,

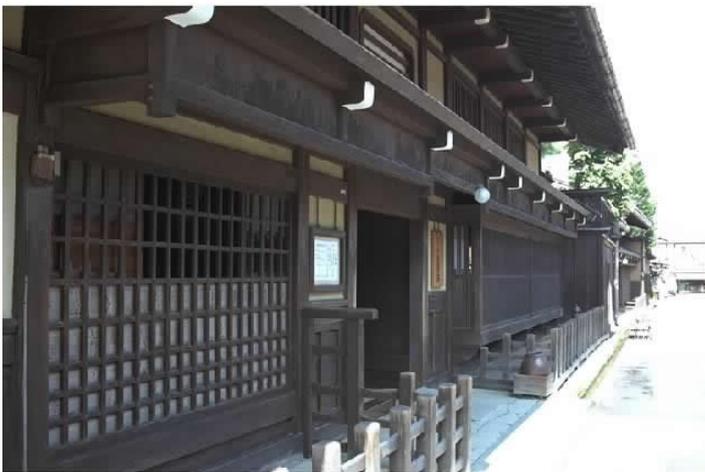
Traditional housing for wealthy merchant 1 (Yoshijima family house in Takayama)

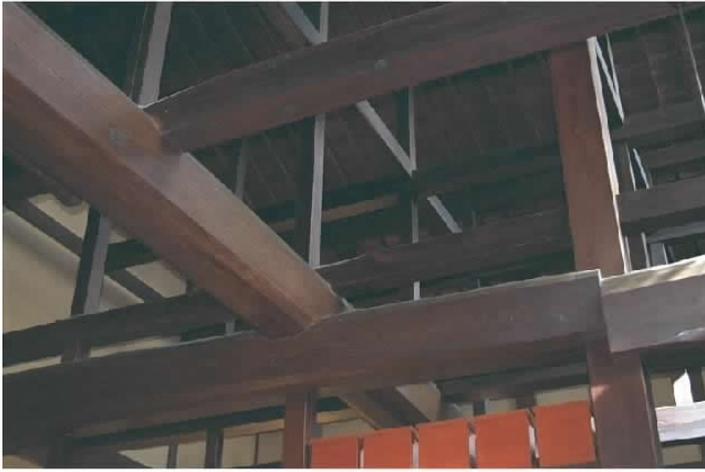
Traditional housing for wealthy merchant 2 (Yoshijima family house in Takayama)

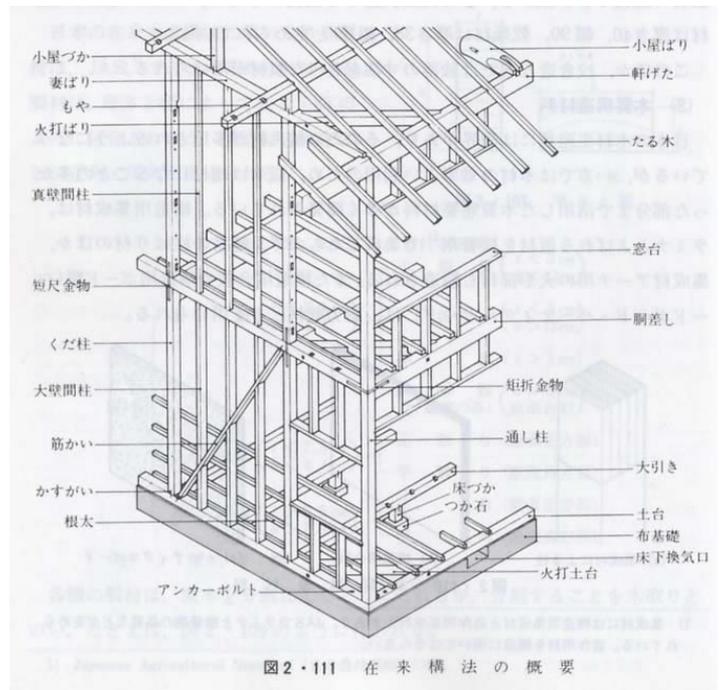
Structural system (source: Uchida, 2001)

<p>recent wooden housing. However, the traditional Japanese house did not have a diagonal brace. A thin lumber running through posts, called Nageshi, and a thick wood post, provide lateral resistance. The traditional Japanese carpenter was reluctant to use a diagonal brace because it could cause a diagonal crack in a mud-plastered wall.</p>
Gravity load-bearing & lateral load-resisting systems	<p>There are several structural systems that are used in Japanese wood housing. While post and beam construction is most common, some buildings of this type are of balloon frame construction.</p>
Typical wall densities in direction 1	>20%
Typical wall densities in direction 2	>20%
Additional comments on typical wall densities	<p>The typical structural wall density is none. There is a wide variation in wall density.</p>
Wall Openings	
Is it typical for buildings of this type to have common walls with adjacent buildings?	No

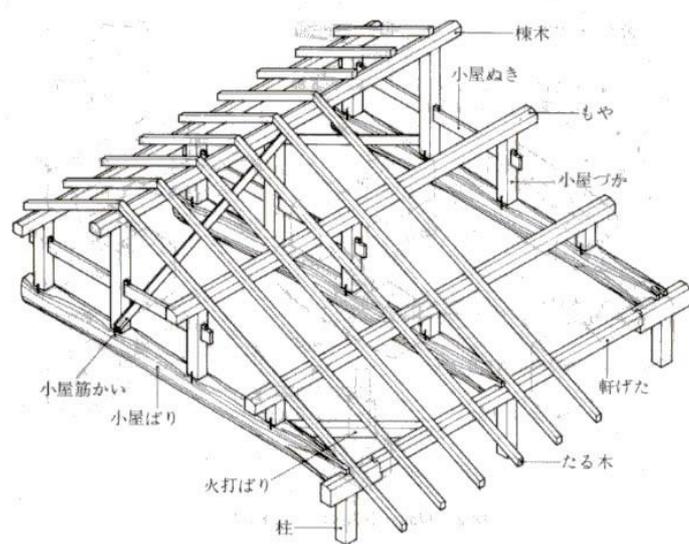
Roof (Source: Uchida, 2001)

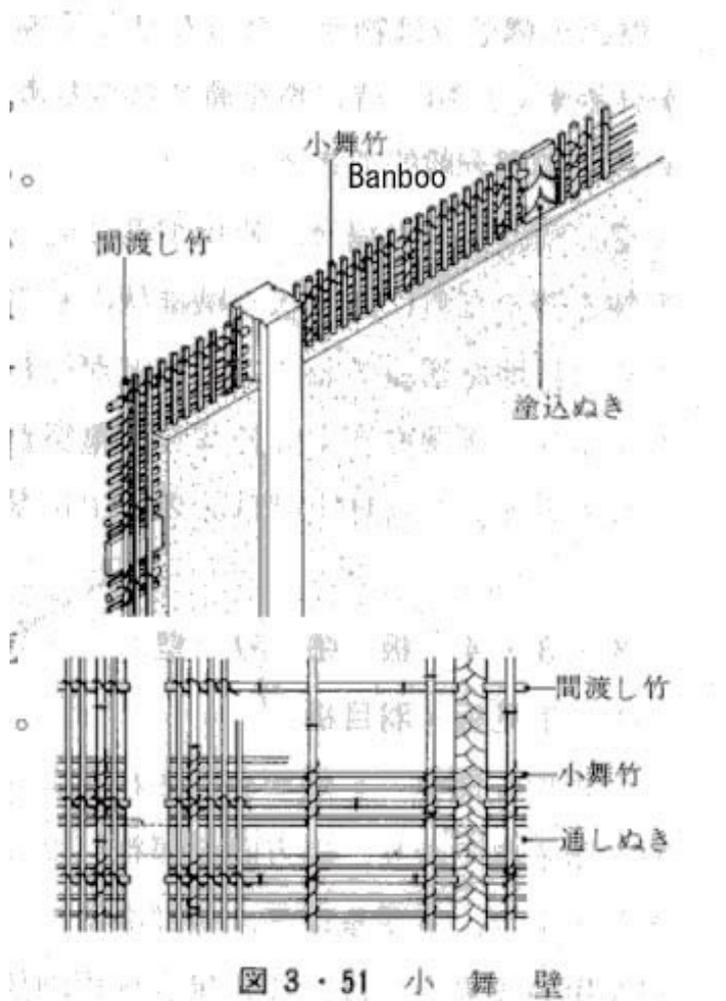
Traditional walls (source: Uchida, 2001)

Wall/Frame	Siding (synthetic resin, metal, ceramic) plywood mortar+wood mud + bamboo	The most traditional wall of Japanese wooden housing was made from mud on bamboo frame. Though mortar finish on wood frame was popular in modern wooden structure, now siding on plywood becomes most popular in ordinary wooden structure housing.
Foundations	RC No foundation (just foundation stone)	Traditional Japanese wooden structure does not have foundation. It is just put on foundation stone.
Floors	Roof tile on mud Slate Wood RC	
Roof	Roof tile on mud Slate Wood RC	Heavy roof made of mud and roof tile caused collapse of housing at the time of 1995 Kobe earthquake.
Other	Wood RC Steel	Usage of metal joint is encouraged by a present building code. However, metal joint was not used in traditional Japanese housing.

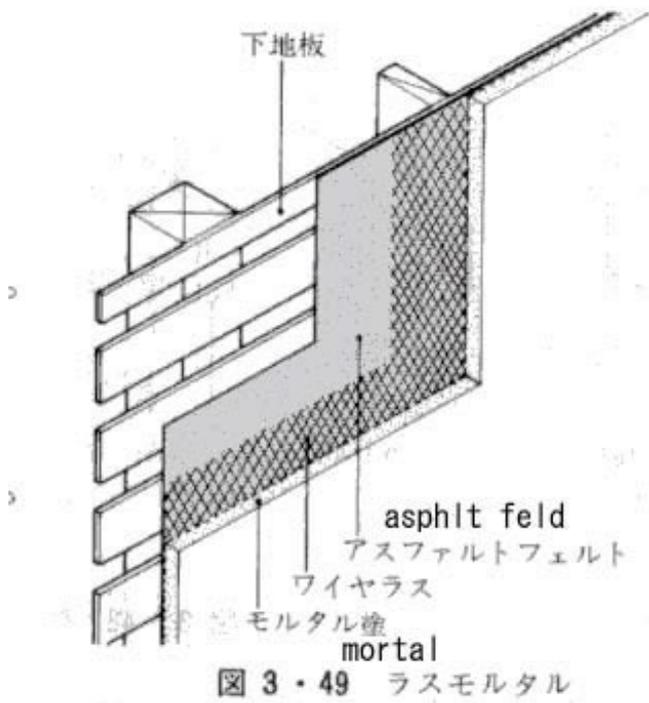
Wall (source: Uchida, 2001)

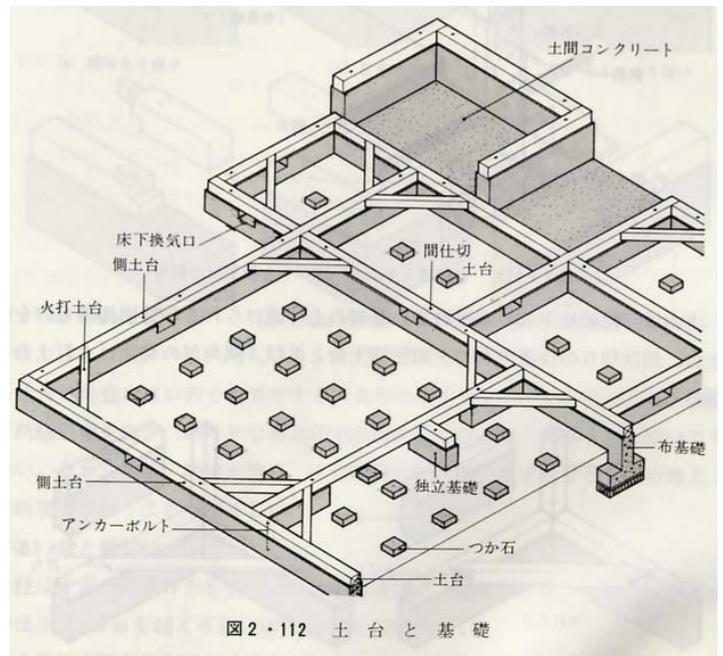
Basement (source: Uchida, 2001)

Modifications of buildings	<p>Modification of utilities in the kitchen and bathroom, or extension of the living space is common. However, seismic retrofitting is not very common.</p>
Type of Foundation	<p>Shallow Foundation: Rubble stone, fieldstone isolated footing Shallow Foundation: Reinforced concrete strip footing</p>
Additional comments on foundation	<p>Infrequently, deep foundations are also used.</p>
Type of Floor System	Other floor system
Additional comments on floor system	<p>Timber: Thatched roof supported on wood purlins ; Wood planks or beams that support clay tiles</p>
Type of Roof System	<p>Cast-in-place beamless reinforced concrete roof Cast-in-place beam-supported reinforced concrete roof Wooden beams or trusses with heavy roof covering</p>
Additional comments on roof system	
	<p>There is no specific data on a typical separation distance between buildings. Minimum separation distance is decided mainly by building code</p>

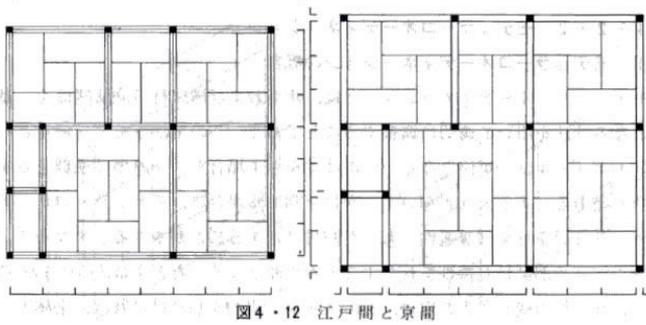
Modular coordination (source: Uchida, 2001)

regulation for the insulation duration within a room. The Civil Code also regulates a minimum distance of at least 50 cm. Traditional shop houses in Japan, Machiya, do not have a separation distance between buildings. When separated from adjacent buildings, the typical distance from a neighboring building is 0.5 meters. Plan Dimensions: There is a wide variation in dimensions. Typical Number of Stories: Building code regulations limit the height of wooden structures to a maximum of three stories. A special permit is necessary for wooden buildings with four or more stories. Typical Story Height: This story height measurement does not include the height of the basement. Therefore, the story height of first floor includes the typical story height, plus the height of basement and is usually 3.4 meters. Typical Span: Modular coordination is conducted according to Tatami mat size in Japanese housing. The typical module dimension in Japanese housing ranges between 0.9-1 meter. The typical span (distance between the posts) is equal to two modules (i.e. 1.8-2 m). The typical storey height in such buildings is 2.8 meters.

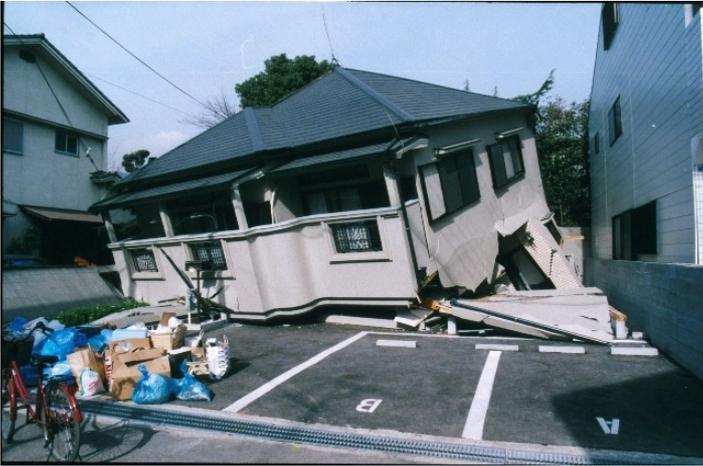
***Wooden structure housing damage
at the 1995 Kobe earthquake
(photo by Michio Miyano)***

The magnitude of each earthquake is JMA magnitude. The 1923 Kanto earthquake killed more than 140,000 people, heavily damaged 120,000 buildings and burned 440,000 buildings. Fire following earthquake was the most prevalent cause of damage. There were many earthquakes during the 1930s and 40s, such as the Tottori in 1943, which killed 1,083 people, the East Nankai in 1944, the Nankai in 1996, and the Fukui in 1949, which killed 3,769 people. There was a reduction in the number of earthquake disasters during 1950s-80s. However, the Niigata earthquake in 1964 spotlighted damage by liquefaction and the Miyagiken-oki earthquake in 1978 spotlighted damage by a landslide occurring at a hillside housing complex. The 1995 Hyogo-ken Nanbu earthquake killed 6,435 people. They died mainly from the collapse of wooden housing. In 2001 during the Tottori-ken Seibu earthquake, many wooden housing units were damaged by ground motion and liquefaction.

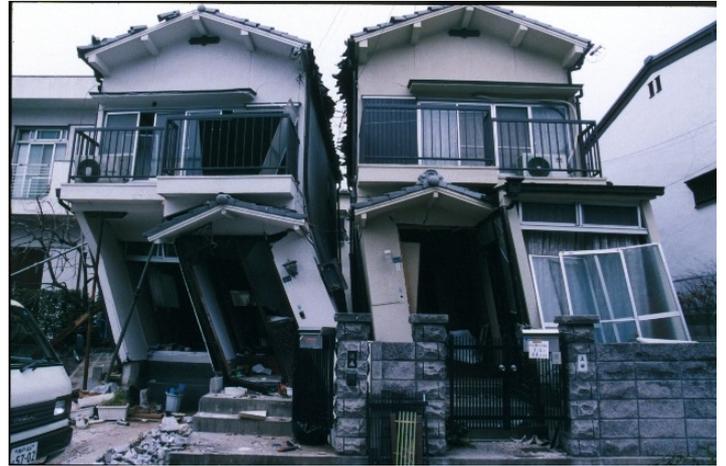
***Wooden structure housing damage
at the 1995 Kobe earthquake
(photo by Michio Miyano)***

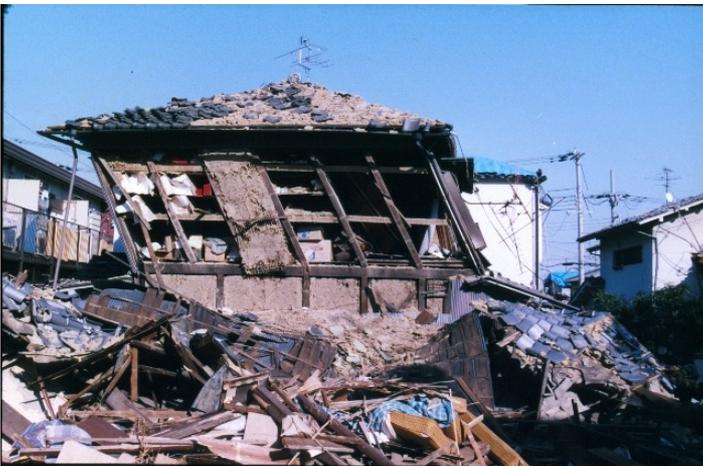
***Wooden structure housing damage
at the 1995 Kobe earthquake
(photo by Michio Miyano)***

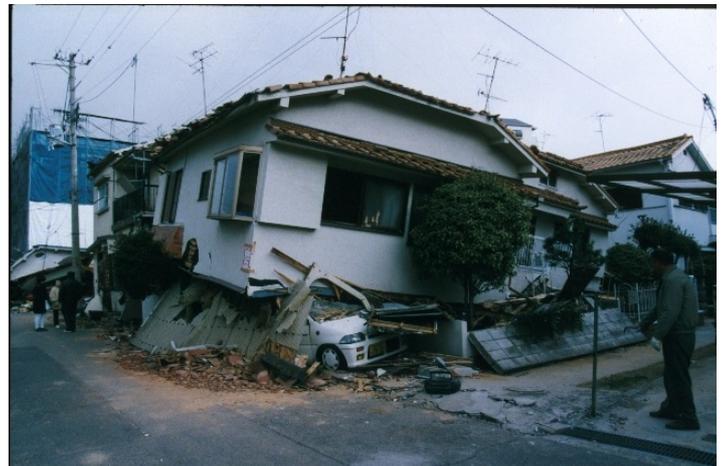
***Wooden structure housing damage
at the 1995 Kobe earthquake
(photo by Michio Miyano)***

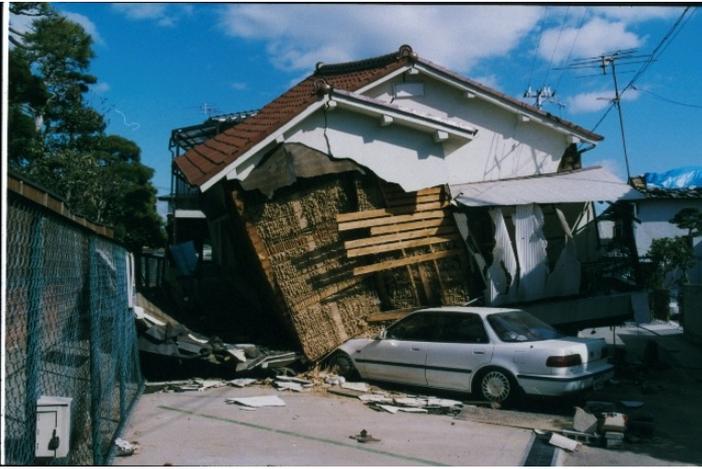
Wooden structure housing damage at the 1995 Kobe earthquake (photo by Michio Miyano)

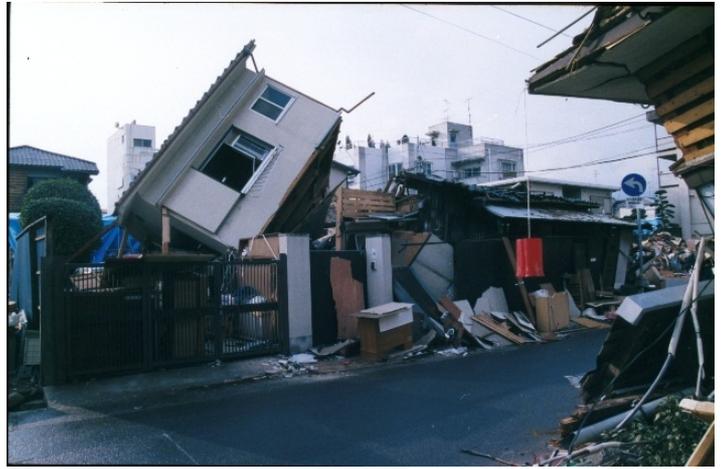
Wooden structure housing damage at the 1995 Kobe earthquake (photo by Michio Miyano)
