# World Housing Encyclopedia

## HOUSING REPORT

**Block of flats with 11 floors out of cast-in-situ concrete, gliding frameworks**

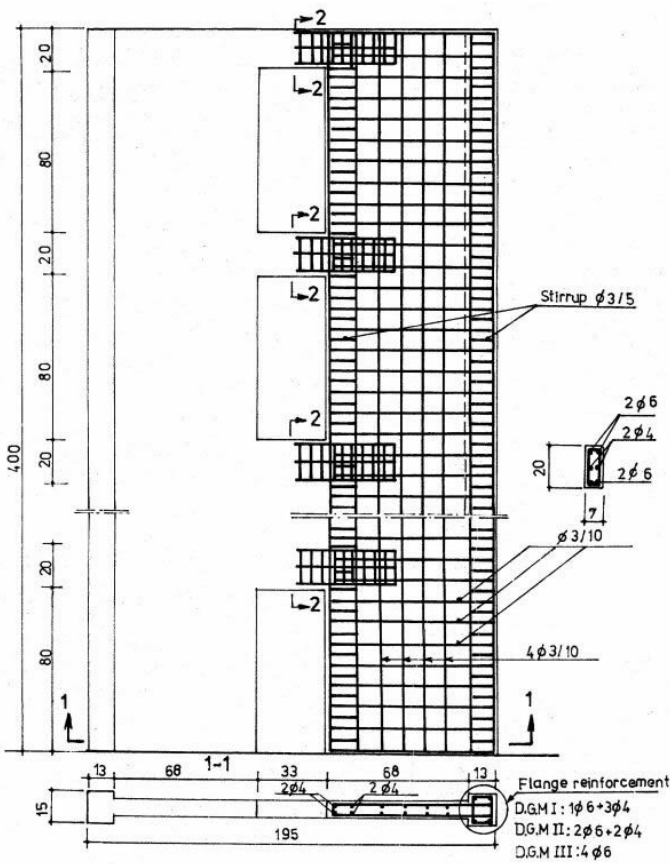
Fig.1  
564

**Model of a typical wall for a building of this type but 4 floors high (after Ciuhandu and Mihaescu in Aroni and Constantinescu, P. 564)**

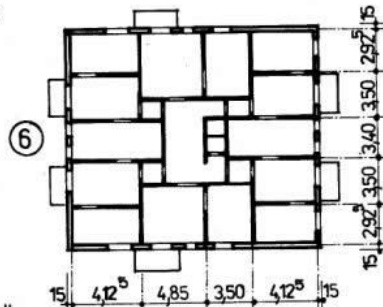
BUILDING „X” „G”  
DESIGN-CODE P13-63

**TOP: Plan of a building of related type: cast-in-place, gliding formworks walls, cast-in-place slabs, foundation raft; MIDDLE: Plan of another building of this type: cast-in-place shear walls with gliding formworks, cast-in-place slabs, foundation raft (after**

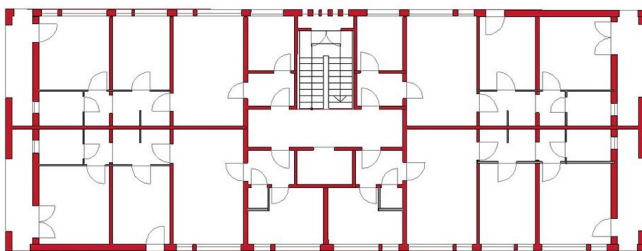
**Architectural plan of current floor (from Bostenaru, 2004)**

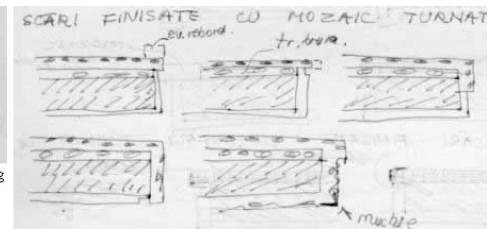
Stair finishing – transversal section

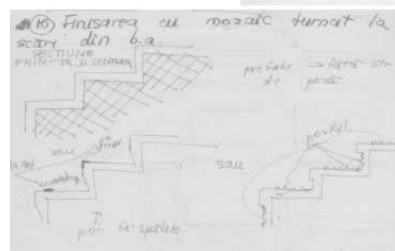
Finishing of the stair

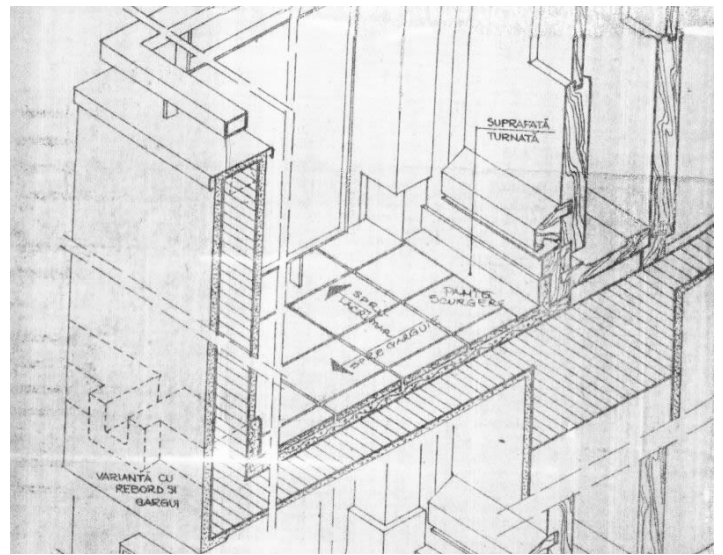
Axonometric view of balcony finishing (from Stan)

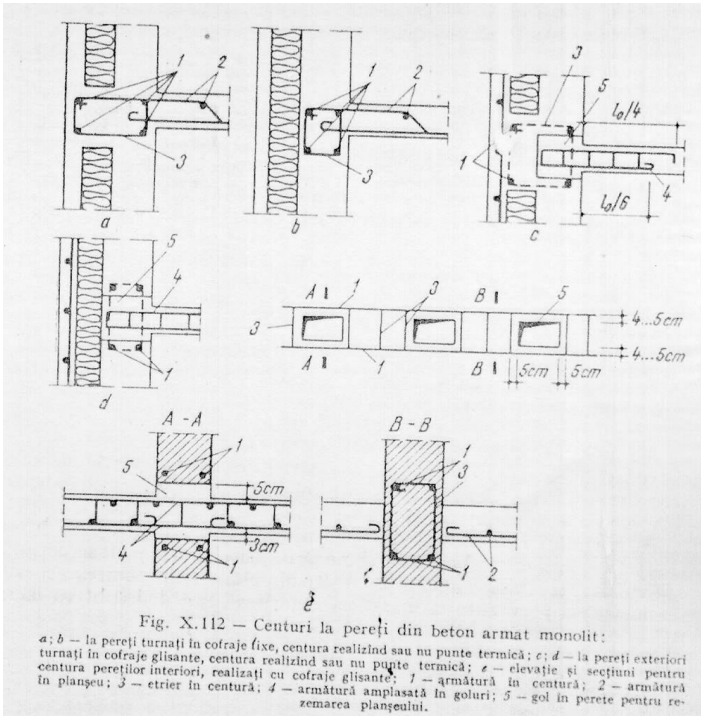
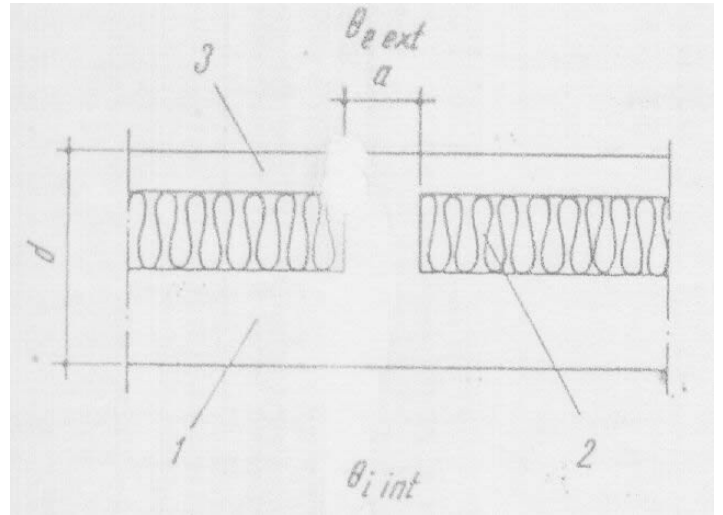
Horizontal section through a facade wall (from additional notes to finishings course): 1 - layer with big mass; 2 - thermoisolating layer; 3 - protection layer.

**Ringbeams at cast-in-place RC walls (after the additional notes to finishings course, source unknown):**  
 a, b: - walls cast in fixed formwork, the ringbeam constitutes or not thermalbridge;  
 c, d - walls cast in gliding formwork, the ringbeam constitutes or not

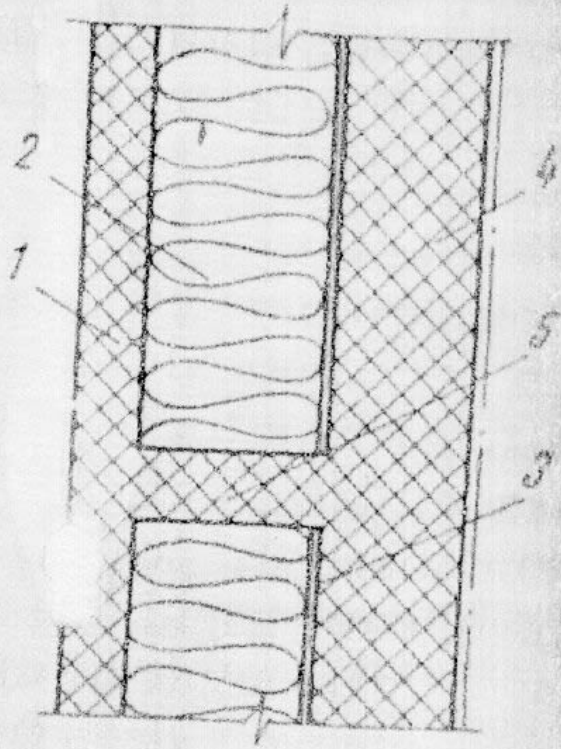
Fig. IX.25 – Alcătuirea pereților din panouri mari de beton armat în trei straturi sau din beton monolit în cofraje glisante:

1 – strat exterior de protecție din beton armat; 2 – strat din plăci termoizolatoare; 3 – barieră contra vaporilor; 4 – strat de beton armat portant; 5 – nervuri de legătură între stratul exterior și interior.

**Composition of big panels or cast-in-place with gliding formwork RC walls: 1 - external protection layer out of RC; 2 - layer out of the thermoinsulating plates; 3 - barrier against vapors; 4 - layer out of load bearing concrete; 5 - connecting ribs between the ex**

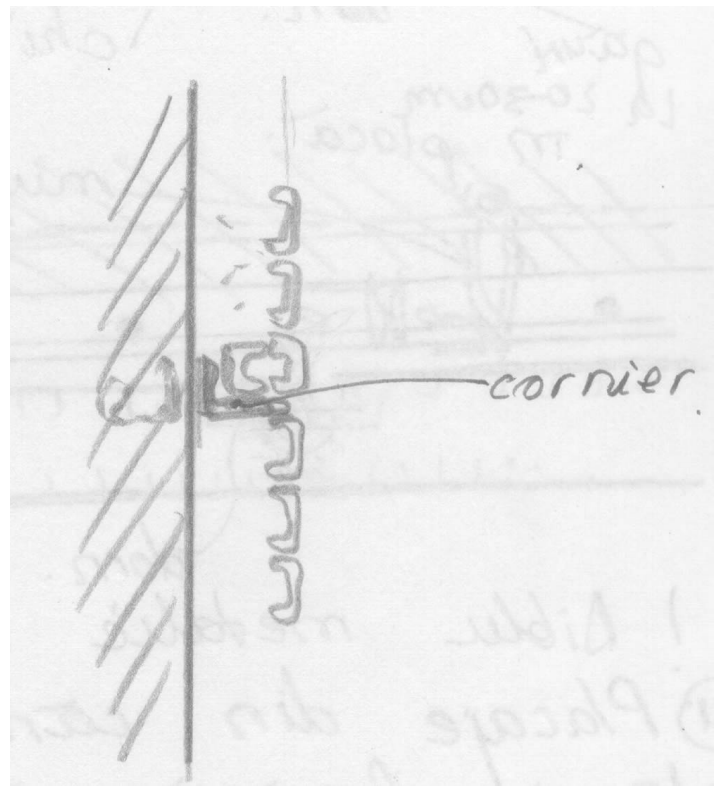
**Detail of the facade wall finishing with brick plates, 60mm wide on cement mortar.**

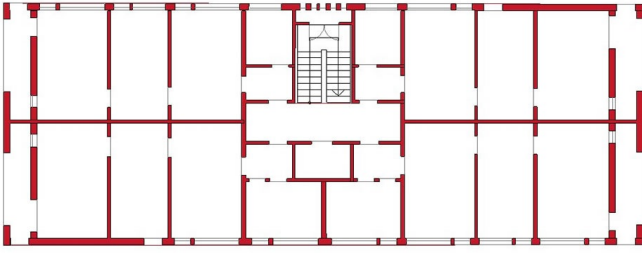
**Layout of load bearing walls and their openings in a current floor**

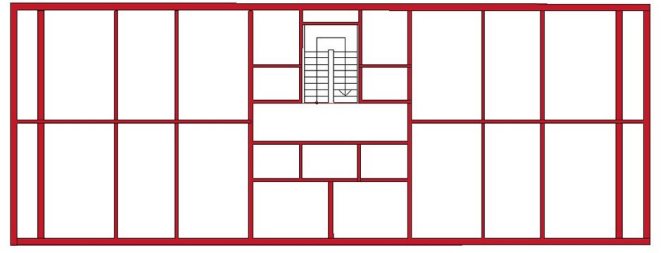
**Reinforced concrete shear walls - planlayout (from Bostenaru, 2004)**

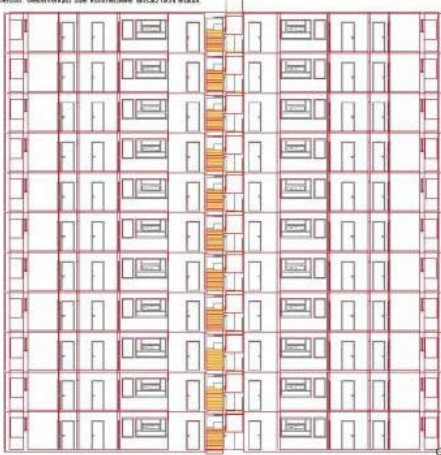
**Longitudinal section (top) and transversal section through the living room (bottom)**

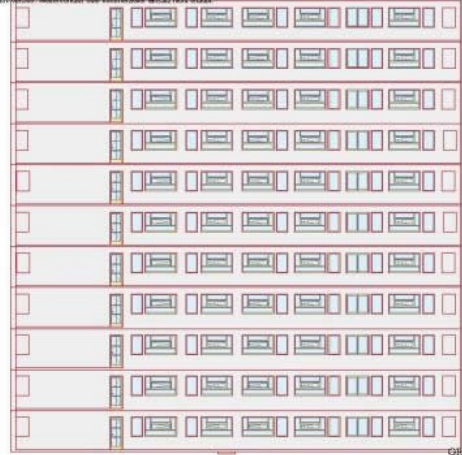
**Drawing of the south facade (top) and of north facade (bottom)**

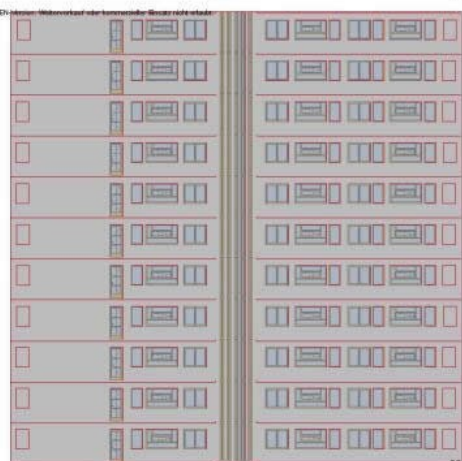
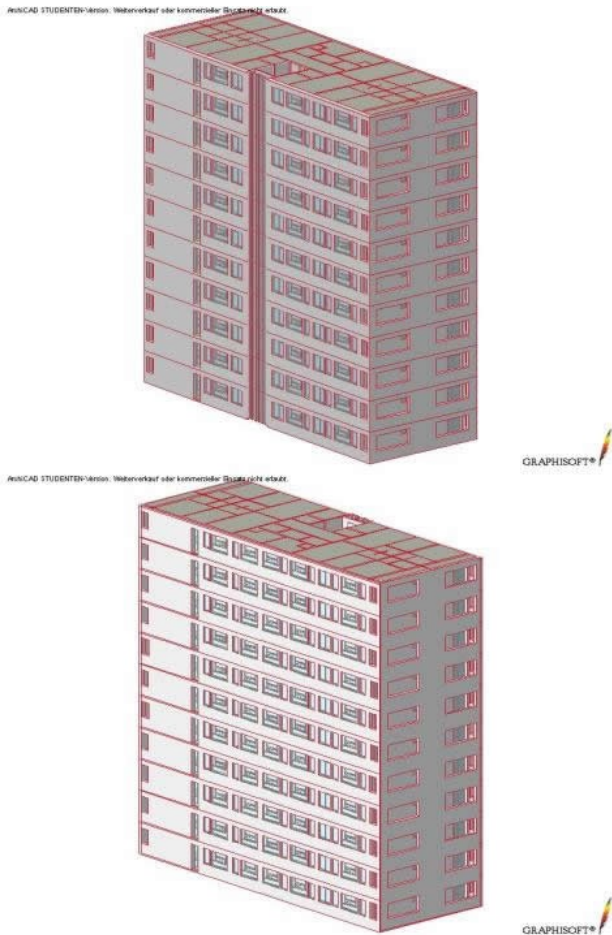
**Axonometric view of the N and W side (top) and of S and E side (bottom)**

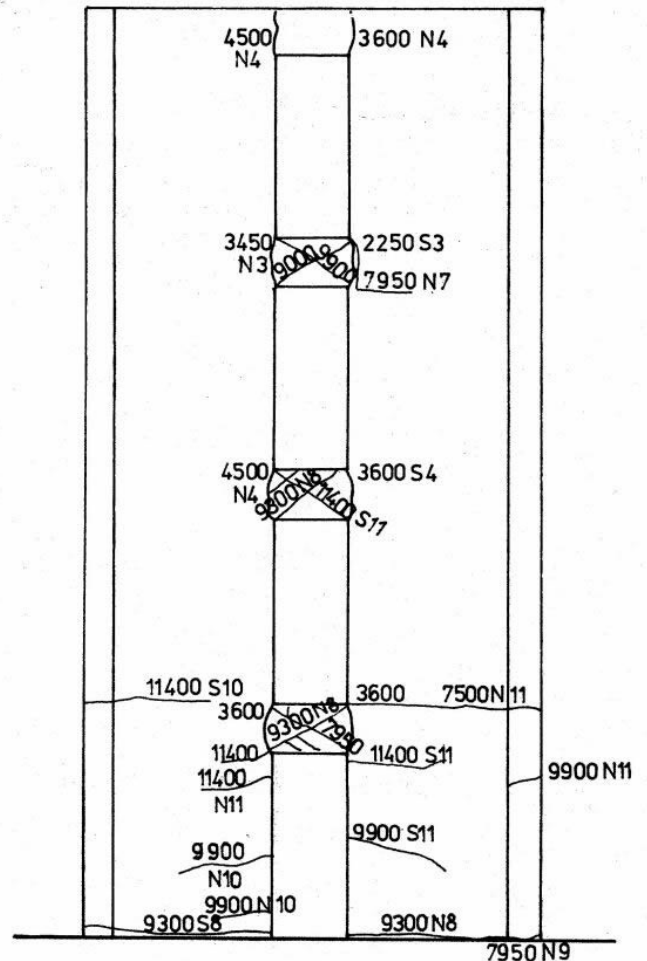
Fig.4

**Damages on the model of a typical wall for a building of this type but 4 floors high (after Ciuhandu and Mihaescu in Aroni and Constantinescu, P. 568)**

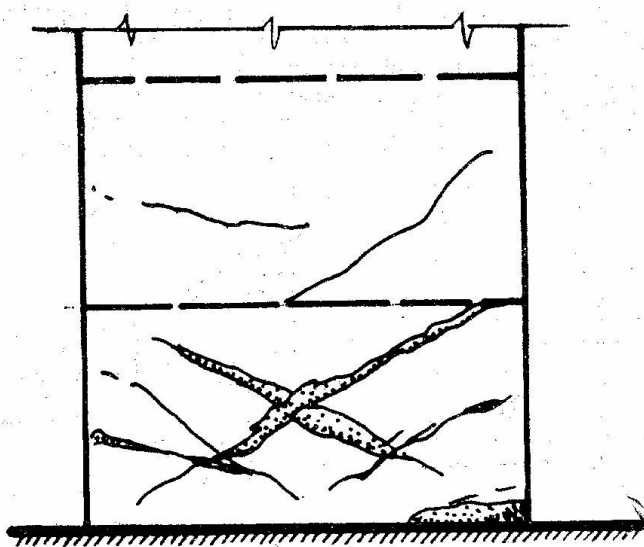
Fig. VII.24. — Ruperi ale bazei diafragmelor.

**Typical damages at the basis of shearwalls (after Balan)**

the profound rifts in the 1977 earthquake. In 1977 there were horizontal rifts as well. Typical damages at buildings of this kind were: - brittle failure at the basis of the shear wall, from combined bending, axial compression and shear failure (see figure); - brittle failure of the lintels in shear, as first post-elastic adaptation possibility (see figure); - multiple rifts in vertical, diagonal and horizontal direction \* diagonal or X rifts, from bending, are not characteristic for the "honeycomb" type (they are to be found in "cellular" type) \* vertical rifts appear at all levels, at the connection between transversal and longitudinal shear walls \* diagonal rifts appear in the zones weakened by the gliding formwork. At upper floors the kitchen plates, glasses etc. broke.

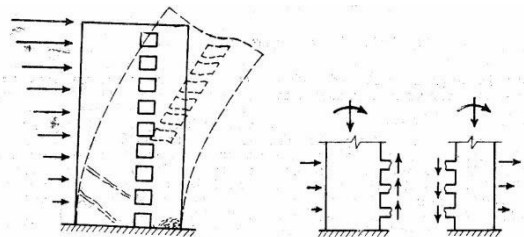
Fig. VII.25. — Efectul forțelor tăietoare din bulandrugii asupra montanților.

**Typical damages in lintels (after Balan)**

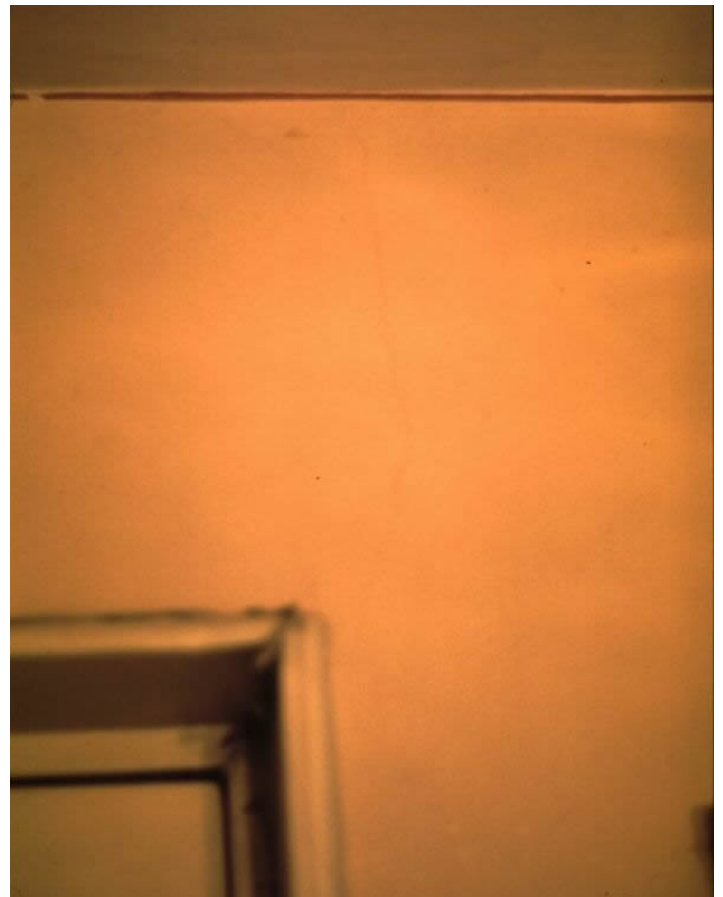
**Vertical rift in shear wall going out**

**vertical rift in shear wall going out from door opening corner**

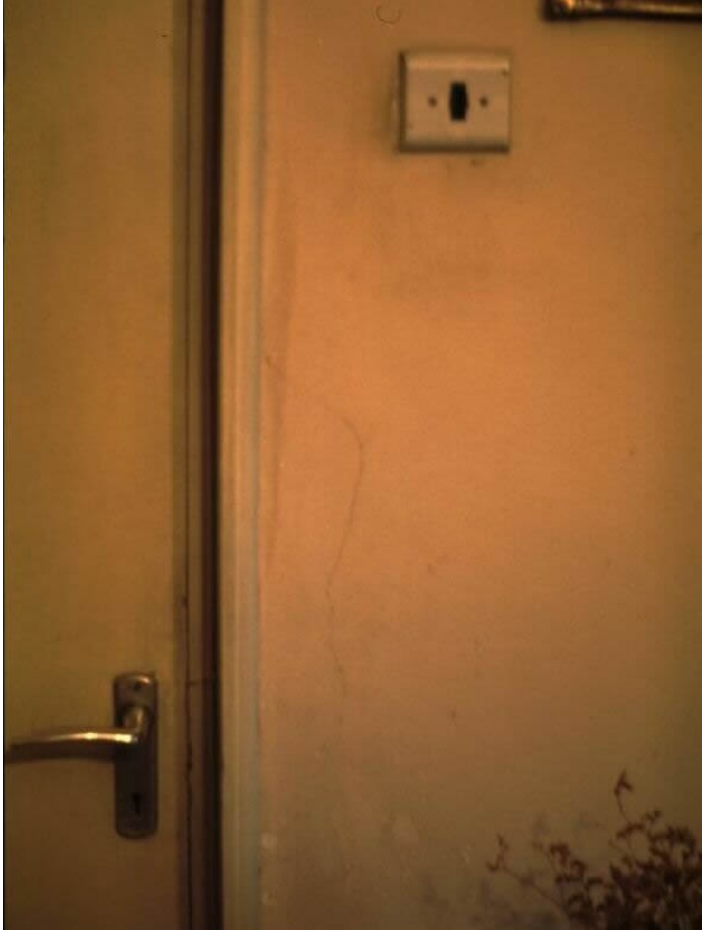
**Vertical rift near door.**

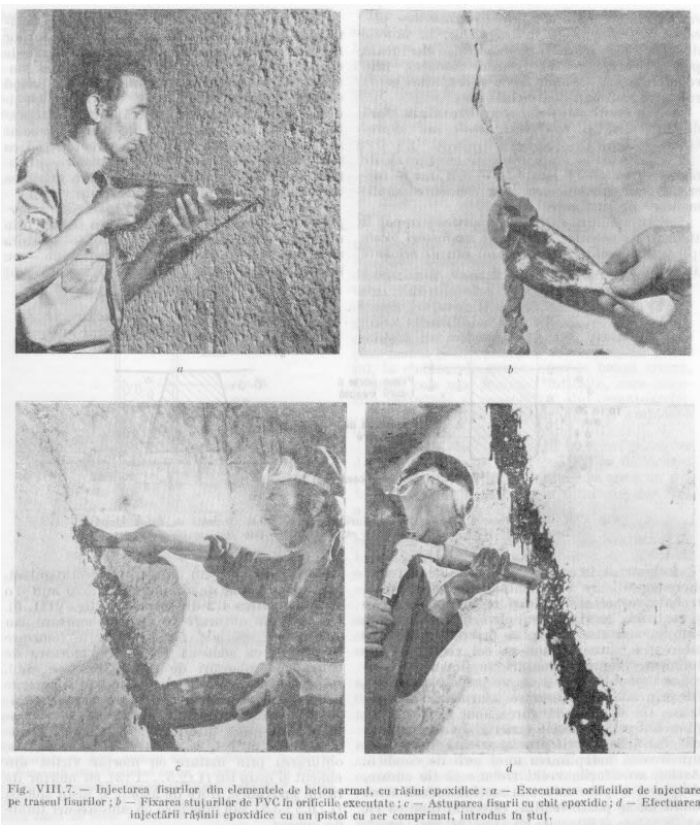
***Epoxy resin injections (after Balan, P. 416)***

| <b>Structural Deficiency</b> | <b>Seismic Strengthening</b> |
|--|---|
| Small cracks in structural walls and lintels | Epoxy resin injections and plating with Roofing layers ("Folie") 1. Dismantling the plastering; 2. Mechanical execution of 2cm wide holes (4 in a square metre); 3. injections of the cracks with epoxy resin; 4. Plating of the elements with Roofing-type weaving; 5. Plastering with M50-T mortar. More details can be seen at INCERC. |
