HOUSING REPORT

Historic, braced frame timber buildings with masonry infill ('Pombalino' buildings)

Report#	92
Last Updated	
Country	Portugal
Author(s)	Rafaela Cardoso, Mario Lopes, Rita Bento, Dina D'Ayala,
Reviewers	Paulo B. Lourenco,

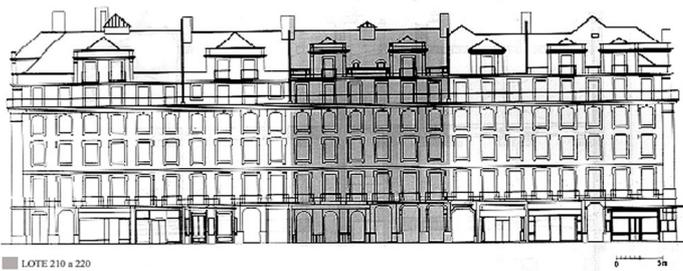
Plan of the facades of a typical block of buildings (Santos, 2000)

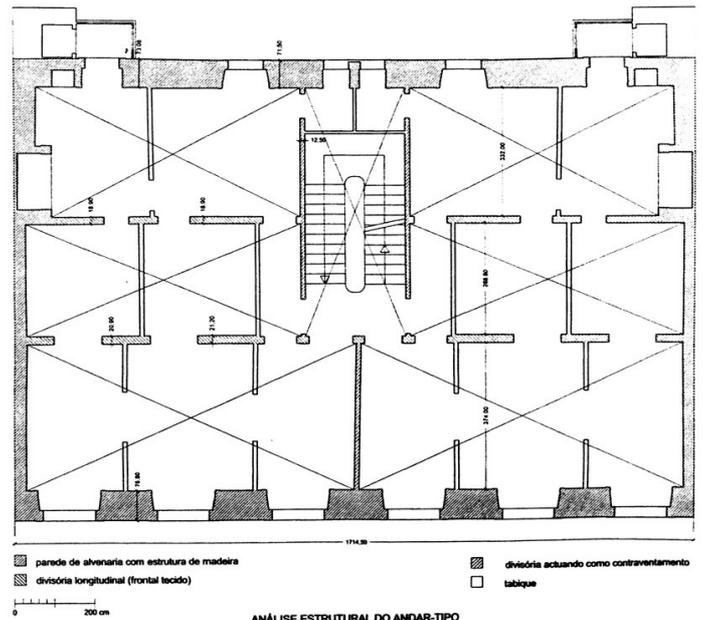
Plan of a typical building (Santos, 2000)

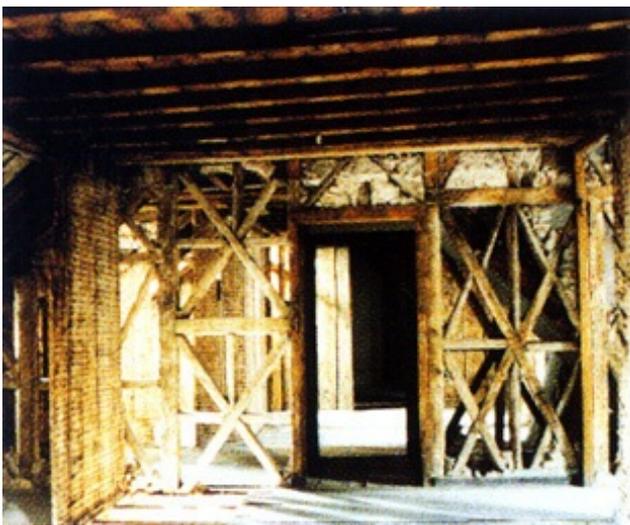
Wood braced frame of 'gaiola' after the removal of cover masonry (Museum of BCP, 2000)

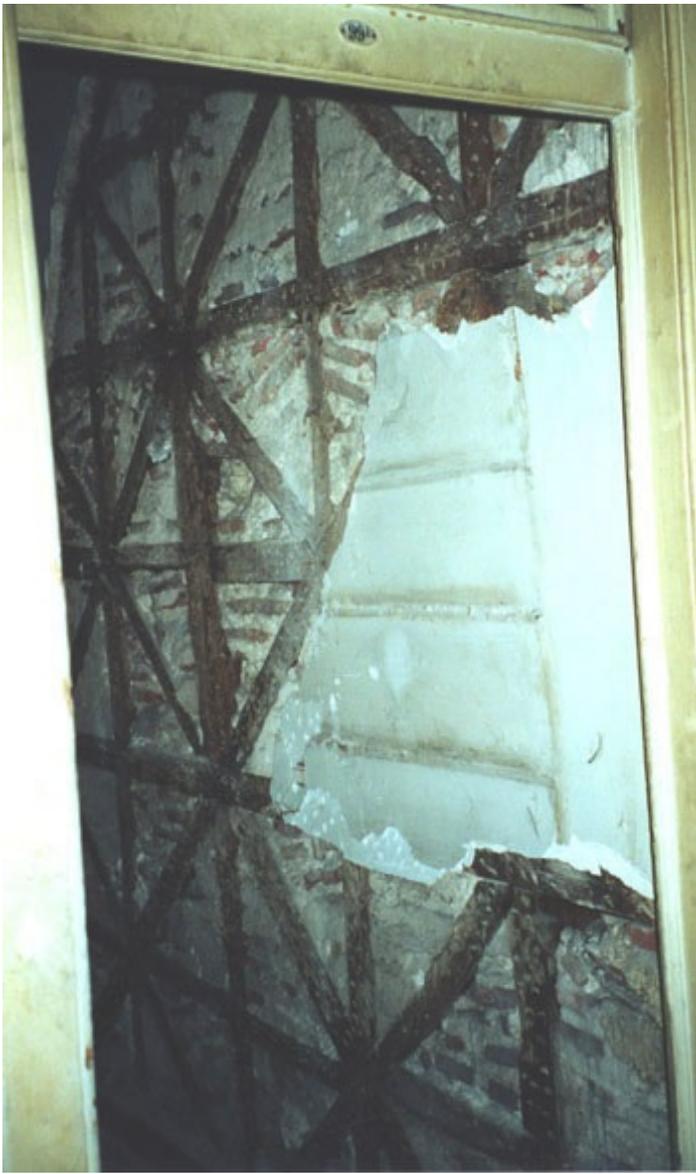
***Timber structure enclosed in
interiormasonry wall***

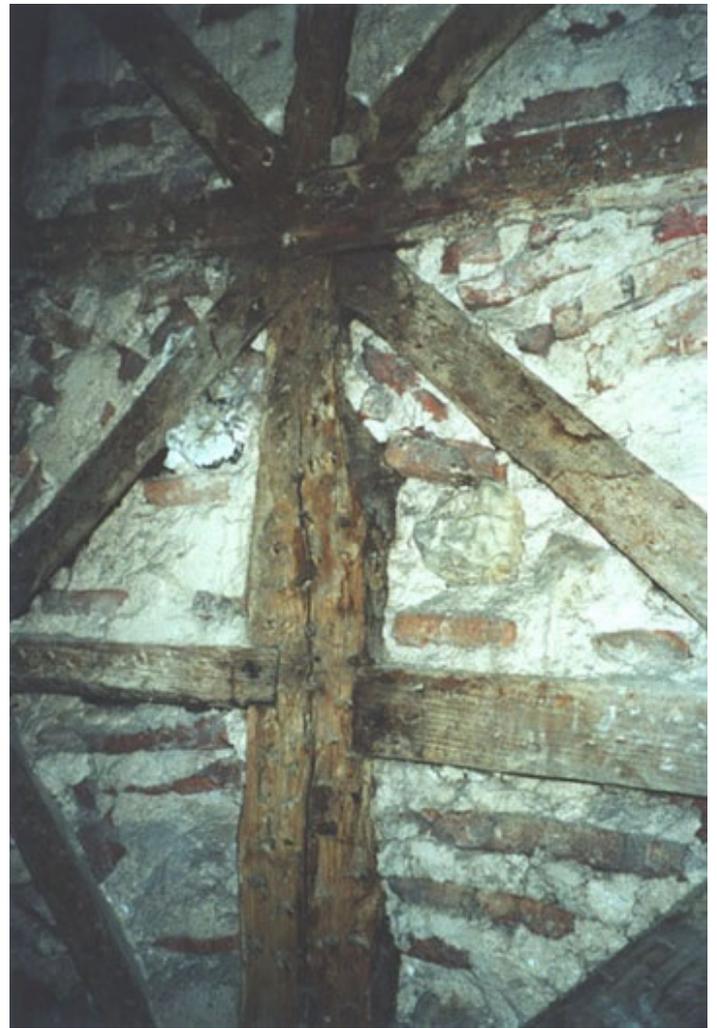
***Timber structure enclosed in
interiormasonry wall (detail)***

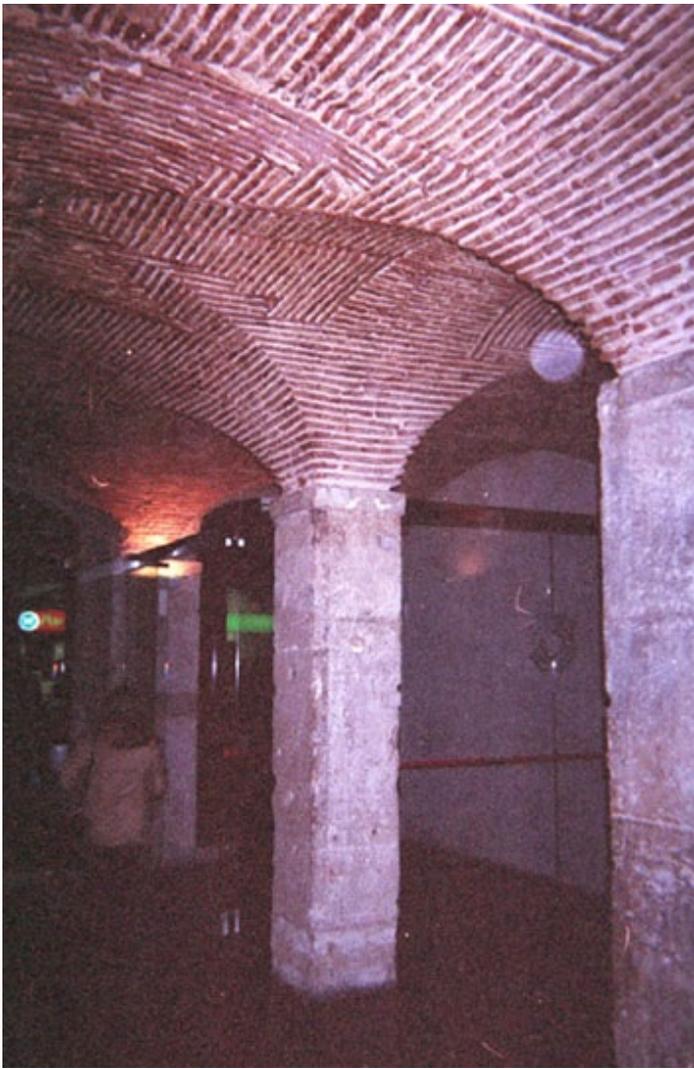
Masonry vaults at ground floor

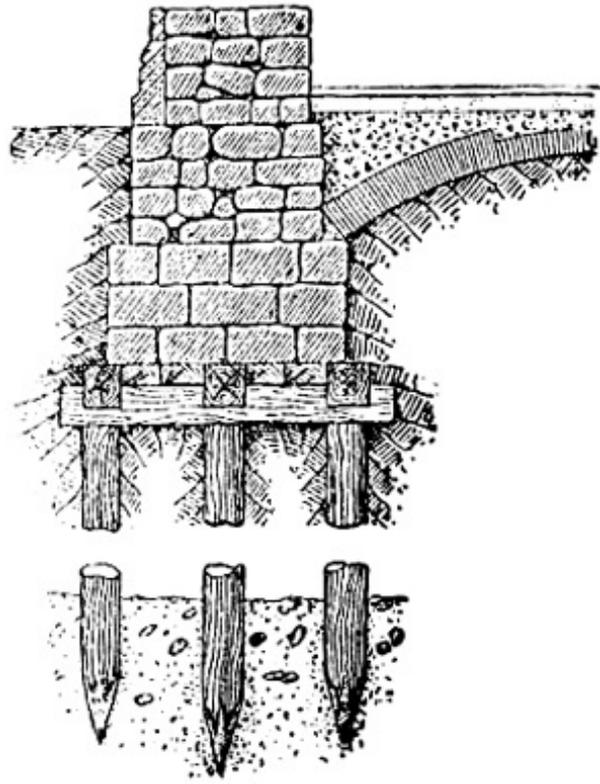
Wood pile foundations (Santos, 2000)

Timber pile damage due to water level changes may cause building settlements.

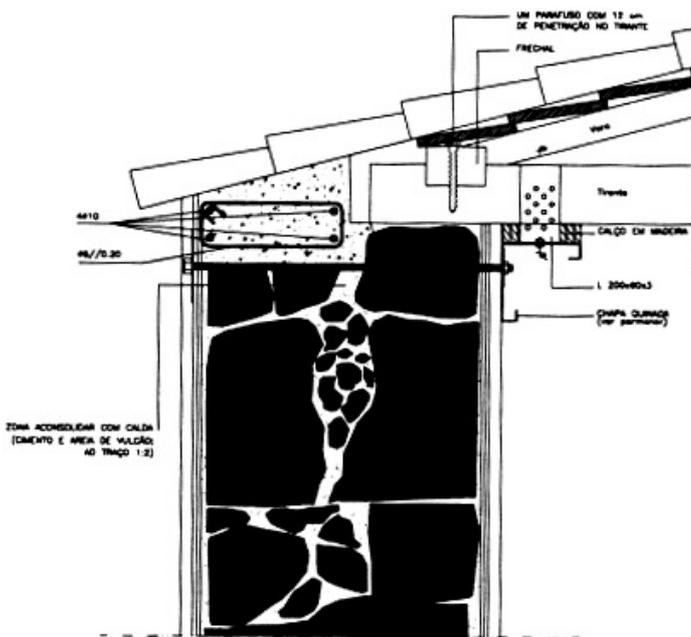
Reinforcement of the connections between roof and masonry walls by a concrete beam (Costa et al, 2001)

Low strength connections between timber elements of roof and floor and masonry walls; timber decay due to water ingress.

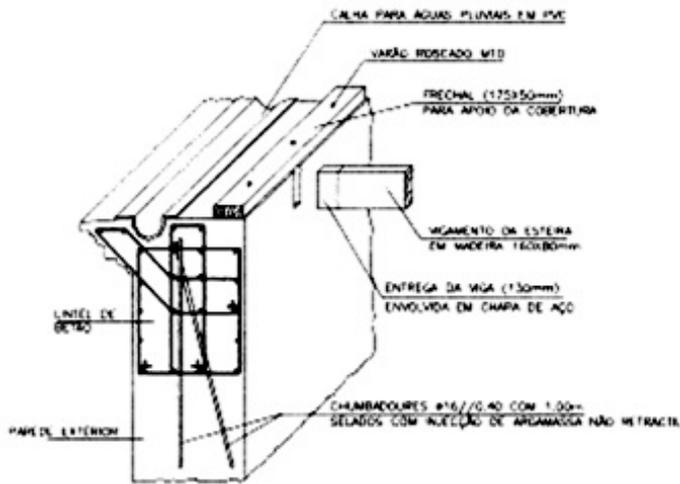
Reinforcement of the connections between roof and masonry walls by a concrete beam

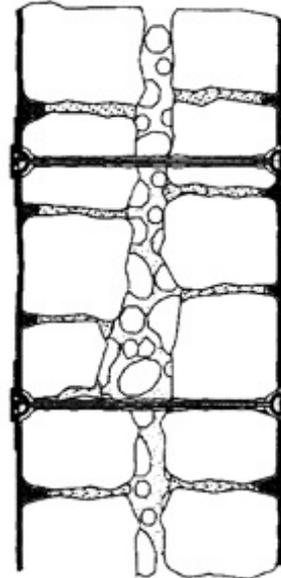
Shear reinforcement of masonry structural elements using steel elements (Silva, 2002)

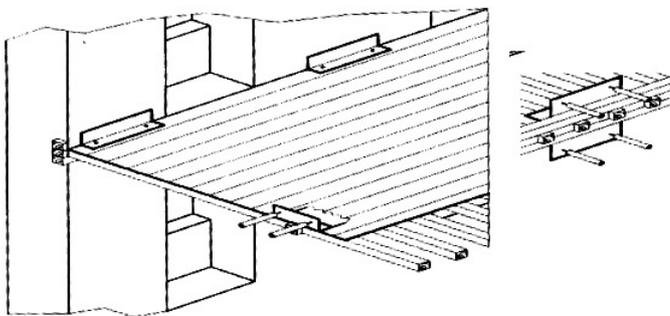
Reinforcement of the connections of wood floors to masonry walls by steel elements (Silva, 2002)
