World Housing Encyclopedia

HOUSING REPORT

**Building of the Modern Movement - Reinforced concrete frame designed
for gravity loads with no commercial ground floor**

Report#	96
Last Updated	
Country	Romania
Author(s)	Maria Bostenaru Dan,
Reviewers	Vanja Alendar,

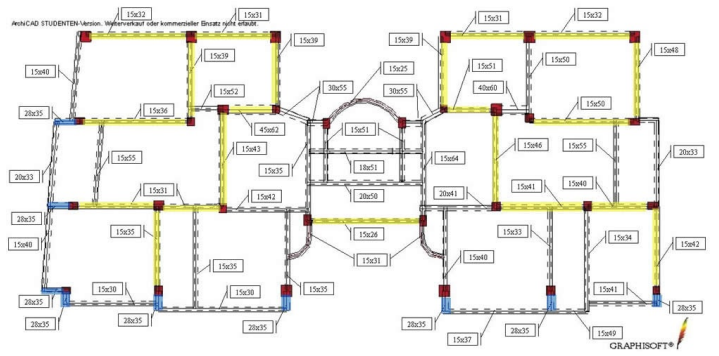
Layout of beams and columns in a typical building. Note that only few (the yellow ones) form frames.

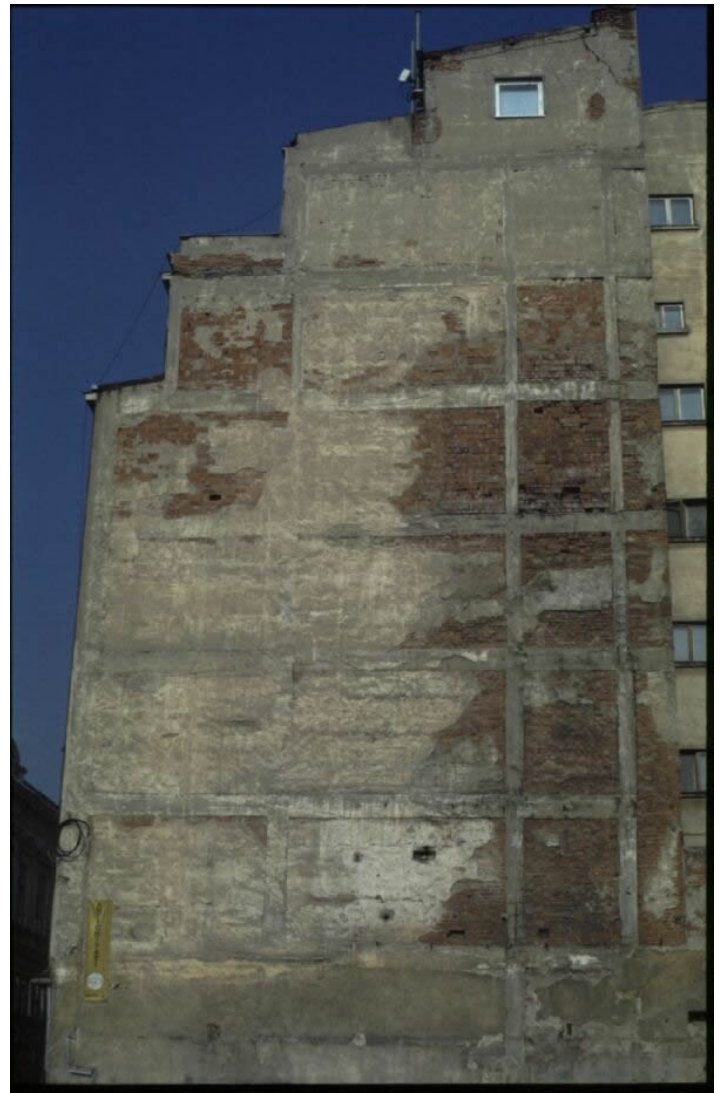
Side wall of a typical building (from Bostenaru(2004))

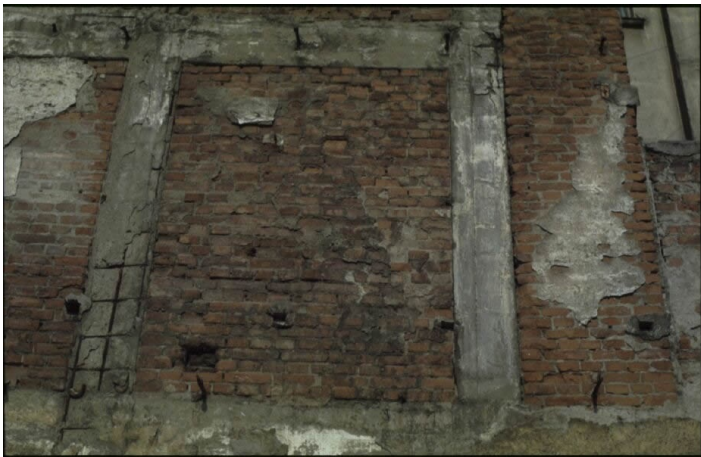
Structural detail

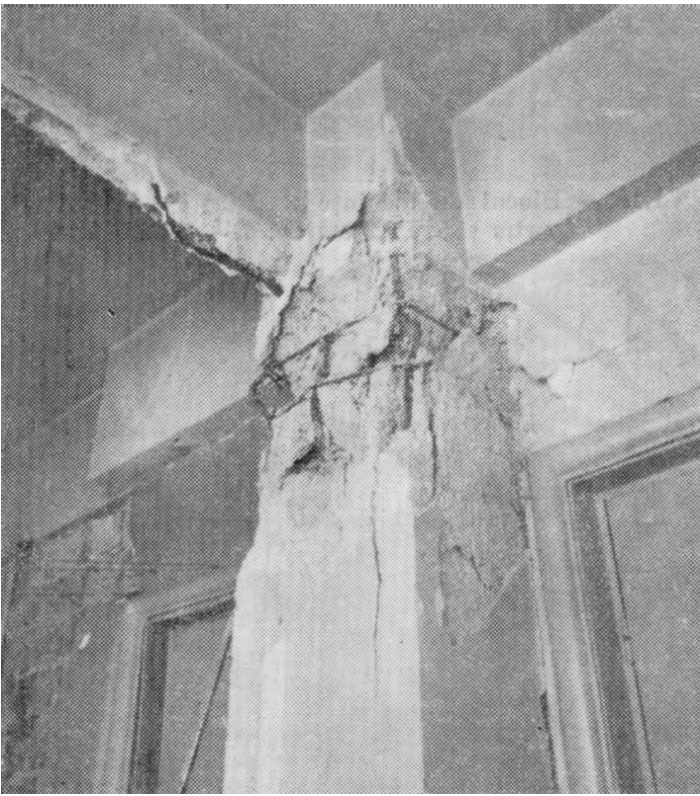
Bending damage at upper end of a column in a block with partial collapse (see Balan, 1980: Figure VI.19:b. on page 246)

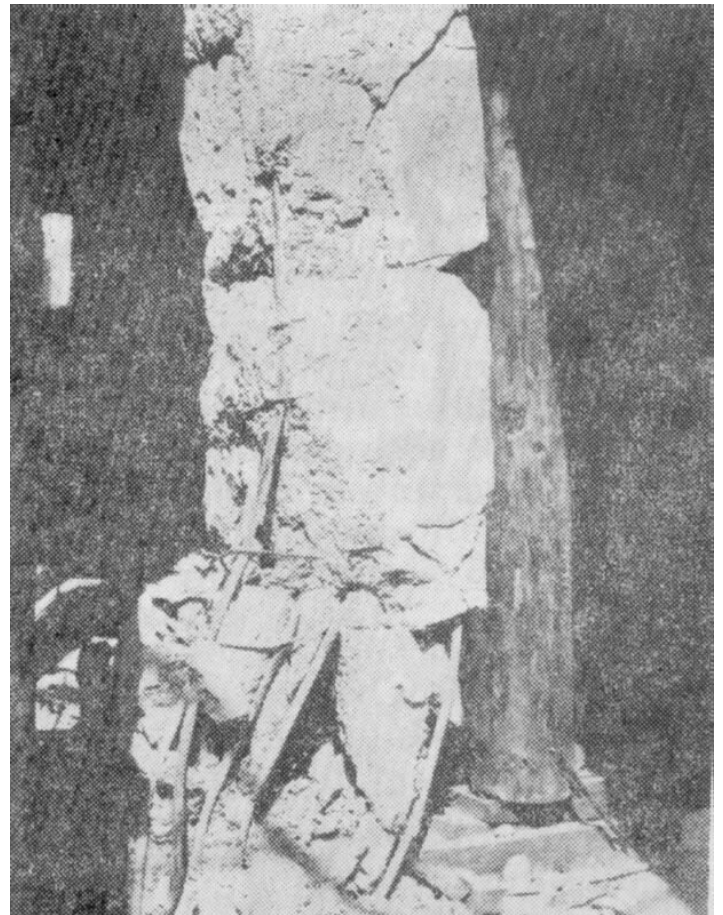
Ground floor column, destroyed due topounding with neighbouring building (see Balan,1980: figure VI.20.d. on page 247)

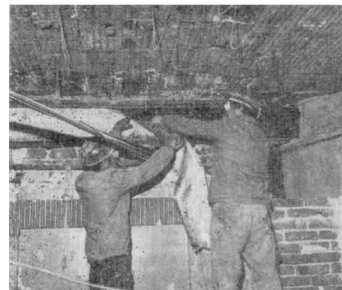
Application of the weaving over the resin layer

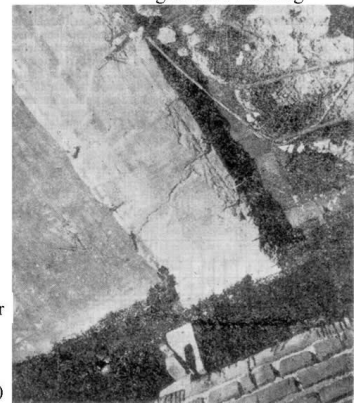
Beams plated with glas fibre weaving embeded in epoxy resin (black colour)

Surface reparation of RC beams throughplating with woven glass embeded in epoxy resins:(see Balan, 1980: figure VIII.18. on page 423 and figure VIII.19.a. and b. on page 424)

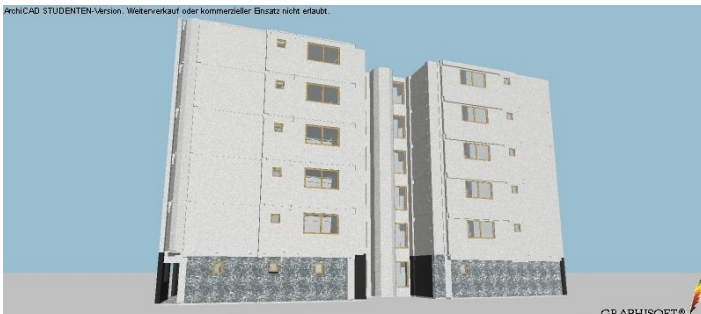
Perspective view after retrofit

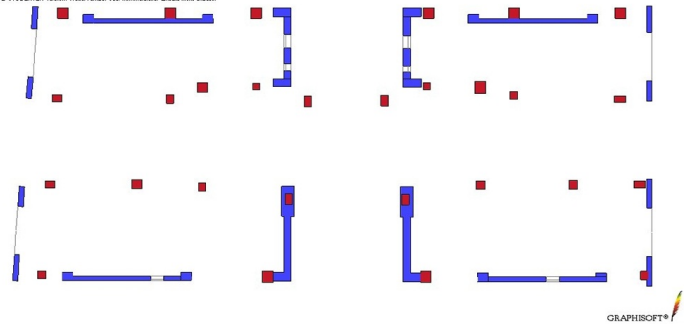
Layout of vertical load bearing elements after retrofit

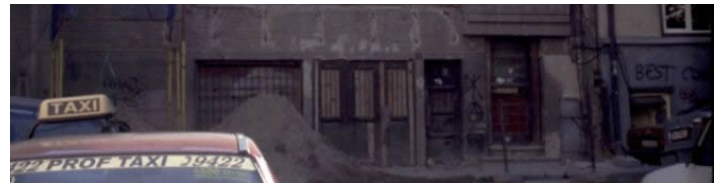
**Current retrofit of a block of flats
from that time**
