# World Housing Encyclopedia

## HOUSING REPORT

### Popular, non-engineered urban housing on flat terrain

<b>Report #</b>	67
<b>Report Date</b>	05-06-2002
<b>Country</b>	VENEZUELA
<b>Housing Type</b>	RC Moment Frame Building
<b>Housing Sub-Type</b>	RC Moment Frame Building : Designed for gravity loads only, with URM infills
<b>Author(s)</b>	Argimiro C. Gandica, Francisco L. Almansa
<b>Reviewer(s)</b>	Sergio Alcocer

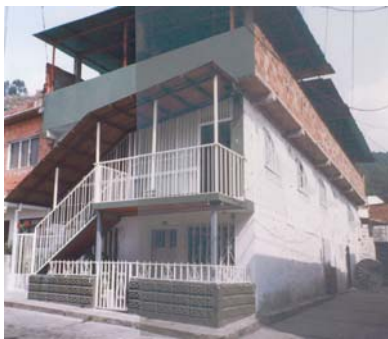
Figure 1: Typical Building

This is an urban housing construction type found in the Andean states of Venezuela. In some cities, e.g., Mérida, this construction accounts for 40% of the total building stock. Typical buildings of this type are two to three stories high. Typically, there are two or three bays in the longitudinal direction (spaced at 3 to 4 m) and four or five bays in the transverse direction (4 to 5 m apart). The main load-bearing system consists of reinforced concrete frame (columns and beams) with hollow clay

See Figure 1.

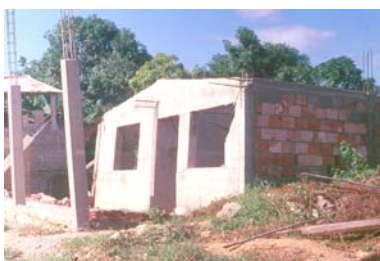
Figure 6: A Photograph Illustrating Typical Damage (1997 Cariaco earthquake)

Date	Epicenter, region	Magnitude	Max. Intensity
1997	10.5N 5.3°W Depth 9.4 km (Caríaco, Venezuela)	6.8	VIII (MMI)

See Figure 6.
