World Housing Encyclopedia

HOUSING REPORT Traditional Naga Type House

Report#	147
Last Updated	
Country	India
Author(s)	Amir Ali Khan,
Reviewers	Gayatri Kharel, Andrew W. Charleson,

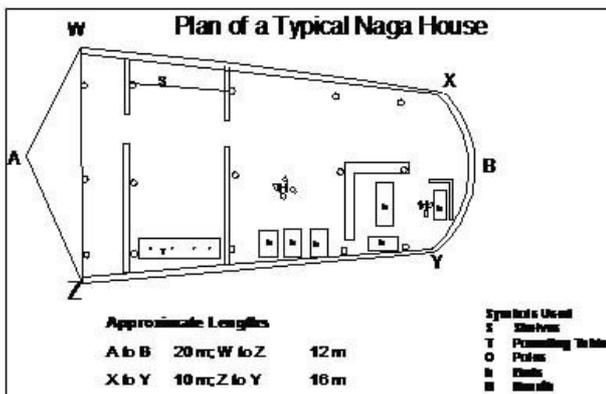
Plan of typical Naga House

Plan Shape	Rectangular, solid Curved, solid (e.g. circular, elliptical, ovoid)
Additional comments on plan shape	Most of these buildings are rectangular in shape. A few tribes build in circular shapes as well.
Typical plan length (meters)	10-15
Typical plan width (meters)	4-5
Typical story height (meters)	4.1702
Type of Structural System	Wooden structure: Load-bearing Timber Frame: Walls with bamboo/reed mesh and post (Wattle and Daub)
Additional comments on structural system	The vertical load-resisting system is timber frame. Structure provides a continuous load path. Load is transferred through wooden/bamboo beams and columns/ posts embedded into the ground. The lateral load-resisting system is timber frame. Roof truss/bracing; long wooden pieces / bamboo are used as beams and compression members. They are tied well with the help of bamboo rope/cane. Lateral forces are resisted by cantilever action of the embedded posts and the bracing effect of diagonal bracing members where they are provided.

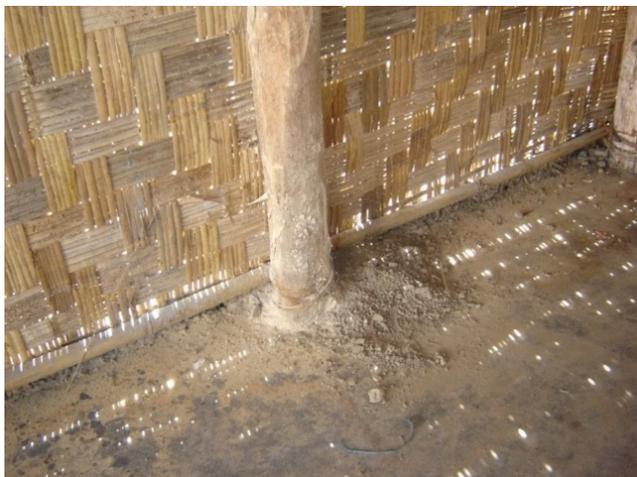
Timber posts are embedded directly into the ground

Bamboo posts are inserted into the ground. Generally, the depth is 1 meter.

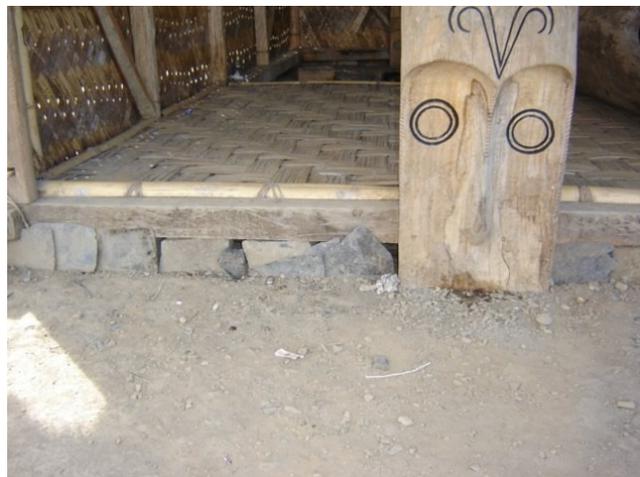
Flooring system used in the housing type

There is no suspended flooring. Ground floor is simple earthen floor with mud plaster in some cases. At times the floor of the house is raised slightly. This safeguards against flooding and dampness during the rainy season. Bamboo matting is used to cover the mud floors.

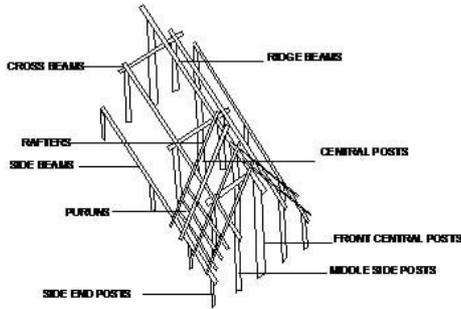
Understructure used in this type of houses

This type of house, generally, utilizes a simple post and beam system. The structure has a beam and the number of posts varies between 3, 5 or 7, which determine the length of the house. The main structural frame consists of roughly-hewn unseasoned timber posts and beams, whereas the roofing framework comprised of bamboo and timber in symbiotic combination. The front wall which is generally curved or circular is covered with secondary open-like roof projecting beneath the front gable.

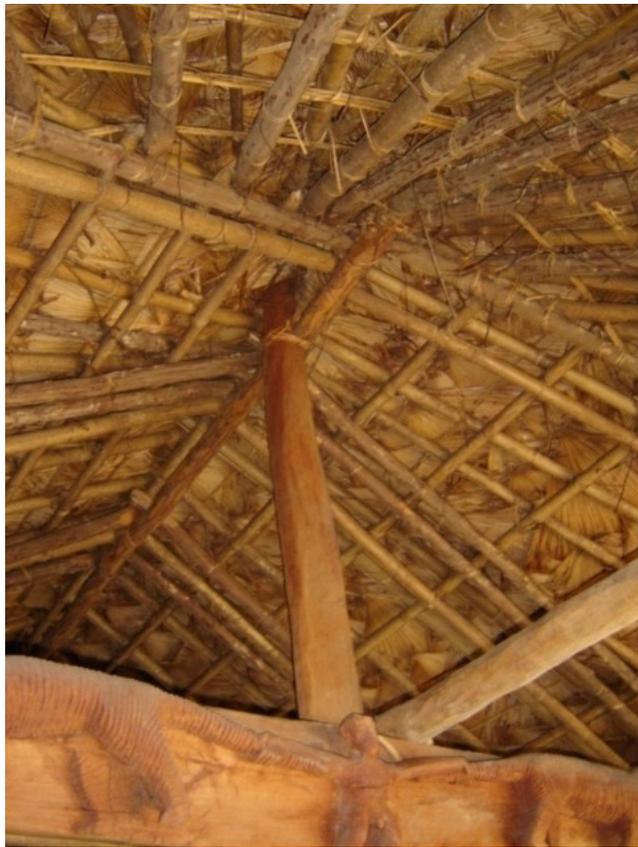
Connection details in the roof understructure

Understructure used in this type of house

Additional comments on structural and architectural features for seismic resistance	?Roofing framing is tied together w ith bamboo ropes (cane). ?There is not much maintenance done to these houses. Average life of a house is 10-15 years, after w hich the old house is abandoned due to deterioration of the material used. How ever, during the life span of houses, w alling and roofing material (thatch) is replaced 3-4 times.	
Vertical irregularities typically found in this construction type	Other	
Horizontal irregularities typically found in this construction type	Other	
Seismic deficiency in walls		
Earthquake-resilient features in walls	Very light material - bamboo mat covered with mud plaster	
Seismic deficiency in frames	No foundation for columns Rope used for the connections betw een timber members may fail	
Earthquake-resilient features in frame	Proper load transfer path available w here there are diagonal bracing members w ithin the w all framing. Joints made of rope (cane)

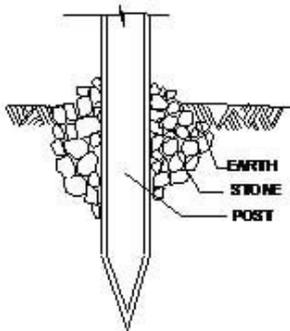
Foundation Details

Flooring System Used
