World Housing Encyclopedia

HOUSING REPORT **Adobe houses**

Report#	166
Last Updated	
Country	PAKISTAN
Author(s)	Sarosh Hashmat Lodi, Abdul Jabbar Sangi, Adam Abdullah,
Reviewers	Marcial Blondet,

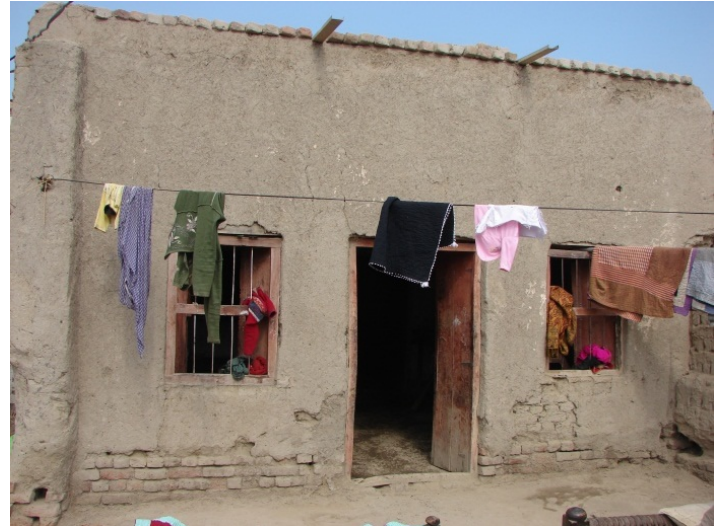
Typical adobe house in rural areas of Sind and Punjab.

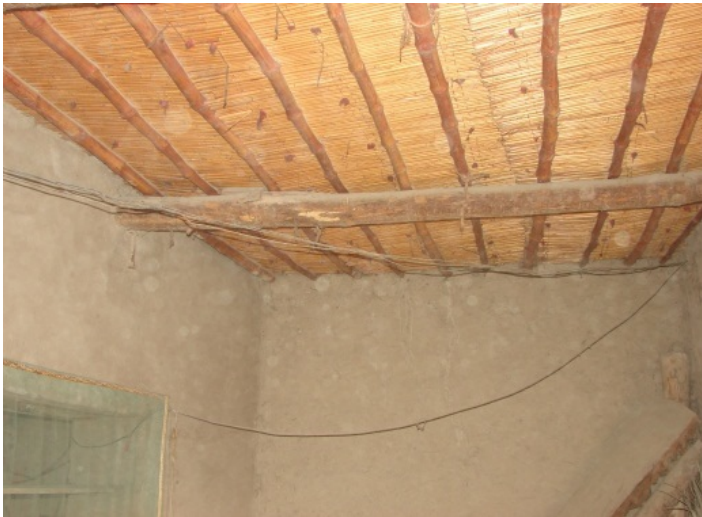
Adobe house roof - interior. Timber planks with bamboo stalks supporting wooden chick.

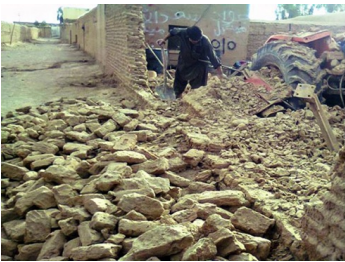
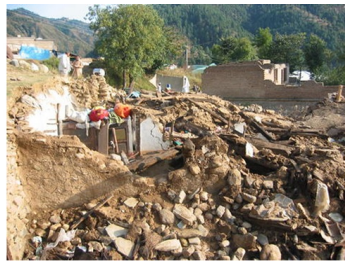
Typical damage caused by the Dalbandin earthquake in 2011.

Indian plate upon which Pakistan, India and Nepal lie, is continuously moving northward and subducting under the Eurasian plate, thus triggering earthquakes in the process and forming Himalayan mountains. Within the Suleiman, Hindu Kush and Karakoram mountain ranges, the Northern Areas and Chitral district in NWFP, Kashmir including Muzaffarabad, and Quetta, Chaman, Sibi, Zhob, Khuzdar, Dalbandin, the Makran coast including Gwadar and Pasni in Balochistan are located in high or very high risk areas. Cities of Islamabad, Karachi and Peshawar are located on the edges of high risk areas. Figure 8 shows the seismic zoning map of Pakistan, which was developed after 2005 Kashmir earthquake [2]. A large number of major earthquakes have hit Pakistan in 20th Century including: 1935 Quetta earthquake, 1945 Makran coast earthquake, 2001 Bhuj earthquake and 2005 Kashmir earthquake [3]. Figure 9 and 10 show the total collapse of adobe houses in Ziarat 2008 Earthquake and Dalbandin 2011 earthquake in Balochistan. .
