World Housing Encyclopedia

HOUSING REPORT

Reinforced Masonry Building: Clay brick masonry in cement mortar

Report#	175
Last Updated	
Country	Colombia
Author(s)	Luis Carlos Hackmayer, Lars Abrahamczyk, Jochen Schwarz,
Reviewers	Dina D Ayala,

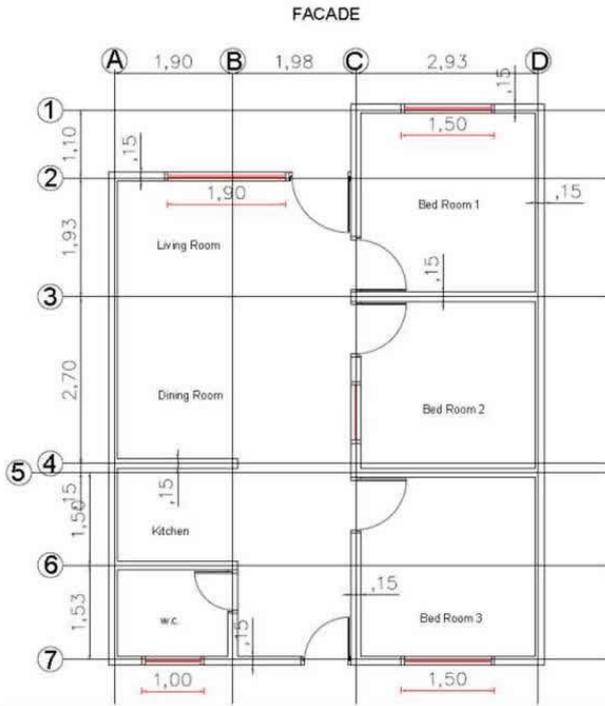
Plan view of typical housing.

Wall Openings	The openings are often located in the facade and there may be one or two openings of 1.2 to 1.5 meters width equally spaced (see Figure 3 and Figure 4).
Is it typical for buildings of this type to have common walls with adjacent buildings?	No
Modifications of buildings	Typical patterns of modifications observed are vertical expansions (adding new stories) and in some cases adding division walls for new rooms.
Type of Foundation	Shallow Foundation: Mat foundation
Additional comments on foundation	The foundation is often a concrete slab, with longitudinal reinforcement for bending. The vertical reinforcement for the walls is placed before casting the slab, so the correct location is important since this will define the final wall location.
Type of Floor System	Other floor system
Additional comments on floor system	Structural concrete: Solid slabs (cast-in-place), Waffle slabs (cast-in-place)

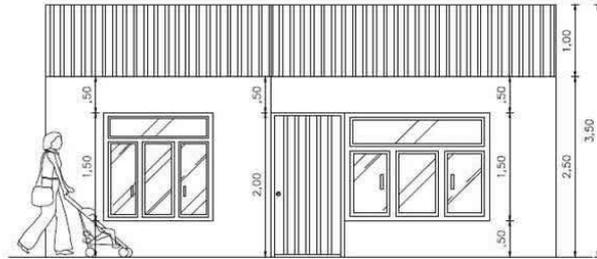
Facade of Typical housing

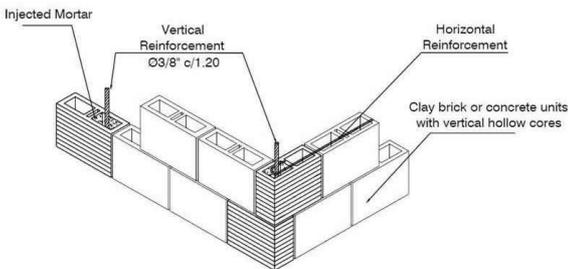
Details of the assembled reinforced masonry wall.

Plan Shape	Rectangular, solid
Additional comments on plan shape	
Typical plan length (meters)	10-15
Typical plan width (meters)	6-9
Typical story height (meters)	2.5
Type of Structural System	Masonry: Reinforced Masonry: Clay brick masonry in cement mortar
Additional comments on structural system	<p>Lateral load-resisting system: The lateral load-resisting system is reinforced masonry walls. The horizontal actions are supported by masonry walls reinforced with vertical and horizontal steel rebar. The amount of vertical and horizontal reinforcement and the quantity of mortar-filled cores of the masonry walls depend on the selected energy dissipation capacity (R-factor). The criteria to select the energy dissipation capacity of the building is the responsibility of the structural engineer and should be based on experience, available materials at the construction site, location of the structure (closely related to the earthquake prone areas) since low energy dissipation structures are not allowed on high seismic areas, etc. The R-factor represents the structural response modification factor (behavior factor in the Eurocodes) and the basic values are tabulated in the Colombian seismic code for different structure types and energy dissipation capacities [3]. The building type under study corresponds to masonry walls with intermediate energy dissipation capacity ($R_o=2.5$ acc. to [3]). For this type of building, only the cores that contain vertical reinforcement are filled with mortar. The maximum distance between vertical reinforcement is 1.20 meters and there should be at least one bar of 12mm diameter located at the end of the walls and next to the openings. The horizontal reinforcement is placed each 0.6 meters in between the horizontal bed joints and is a bar of 4 mm diameter, in the openings two bars of 10 mm diameter are placed at the top and bottom with an extension of 0.6 meters into the wall (see Figure 5). At wall ends, where the</p>

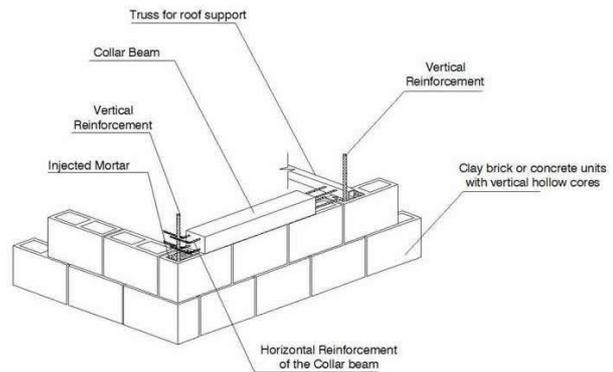
Details of the connections for the roof system.

Type of Roof System	Roof system, other
Additional comments on roof system	The roof system consists of corrugate sheets supported on steel trusses (normally tube sections of 2#x1#x1/4# (Figure 6).

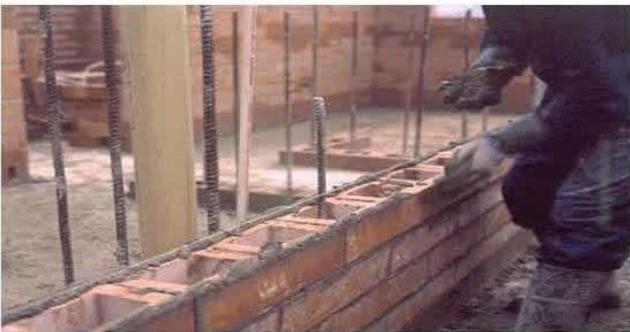
Location of the reinforcement and application of the mortar [2].

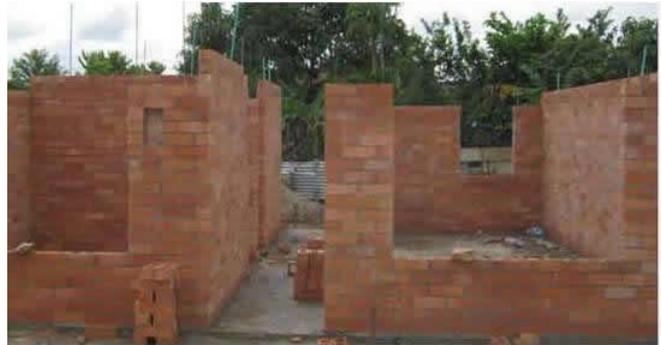
Reinforced masonry walls' assembly after the mat foundation. (August 2011) [1].

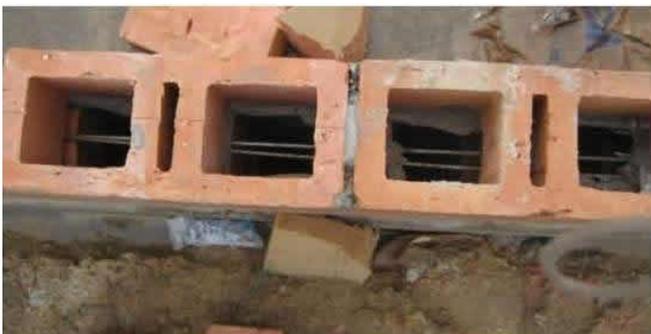
Horizontal reinforcement placed in between the horizontal bed joints. (2 bars of 4mm diameter) (August 2011) [1].

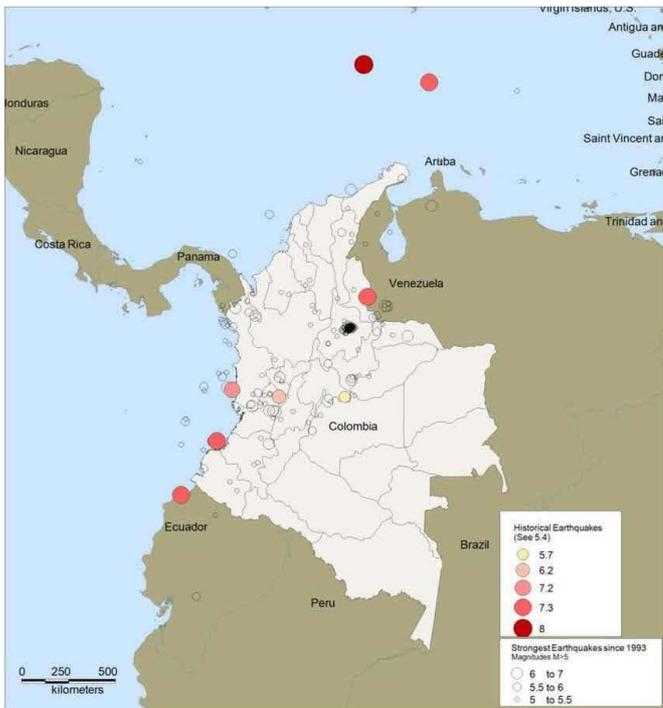
Strongest earthquakes in Colombia (see Table in Chapter 5.4).

After the Popayan earthquake in 1984, most of the structures were considerably damaged and many of them collapsed. Many of the buildings were unreinforced/reinforced masonry and moment resistant reinforced concrete frames, but the first seismic code was still not developed. Figure 10 shows the historical earthquakes with a Magnitude > 5 since 1875 in Colombia according to [5] and [6].
