World Housing Encyclopedia

HOUSING REPORT

Low-ductile RC frame buildings (C1L, C1M)

Report#	183
Last Updated	01/26/2016
Country	Cuba
Author(s)	Grisel Morejon Blanco, Kenia Leyva Chang, Dario Candebat Sanchez, Zulima Rivera Alvarez, Yelena Berenguer Heredia, Madelin Villalon Semanat, Dominik H. Lang, Abdelghani Meslem,
Reviewers	Jaiswal, Kishor,

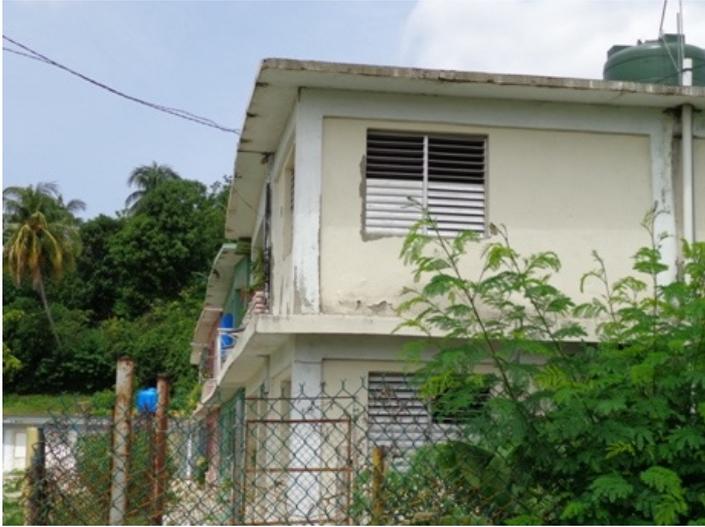
Figure 2. Low-Rise Concrete Moment Frame House

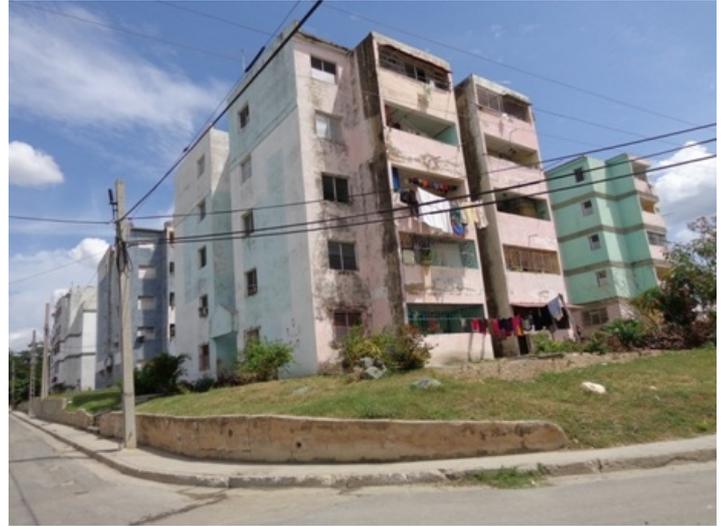
Figure 3. Mid-Rise Concrete Moment Frame Building

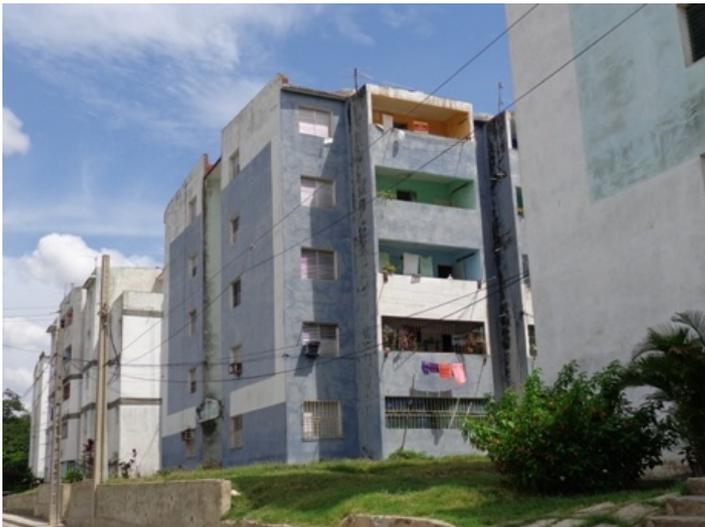
Figure 4. Mid-Rise Concrete Moment Frame Building

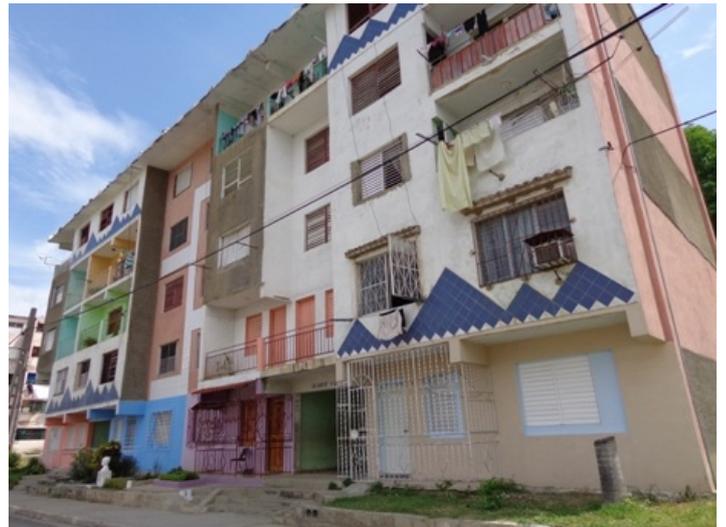
Figure 5. Mid-Rise Concrete Moment Frame Building
