# World Housing Encyclopedia

## HOUSING REPORT

### Dual precast RC system (IMS5, IMS8, IMS12, IMS18)

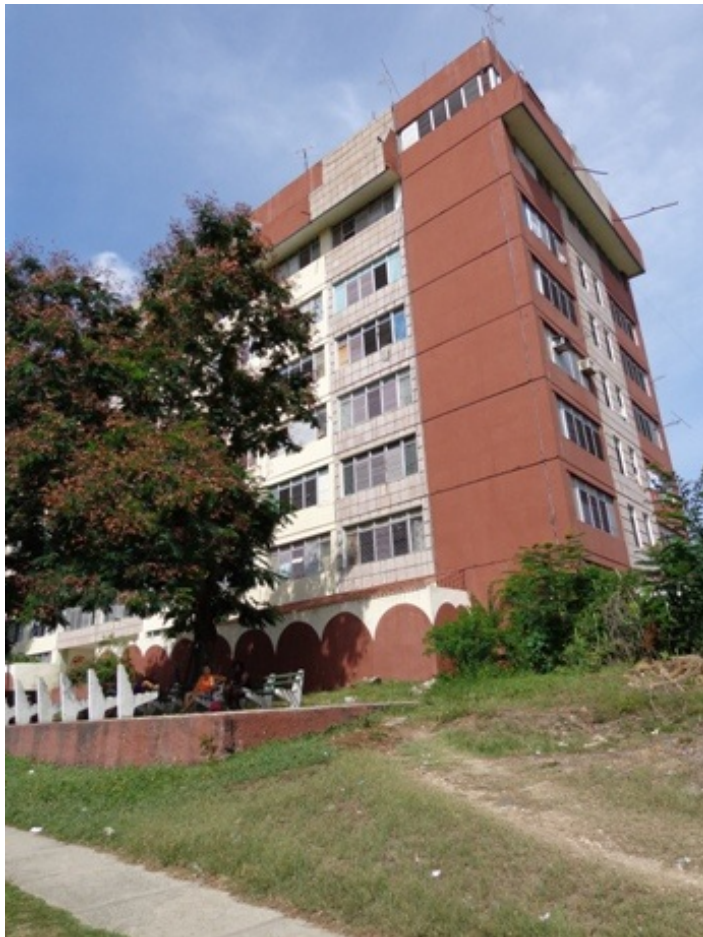
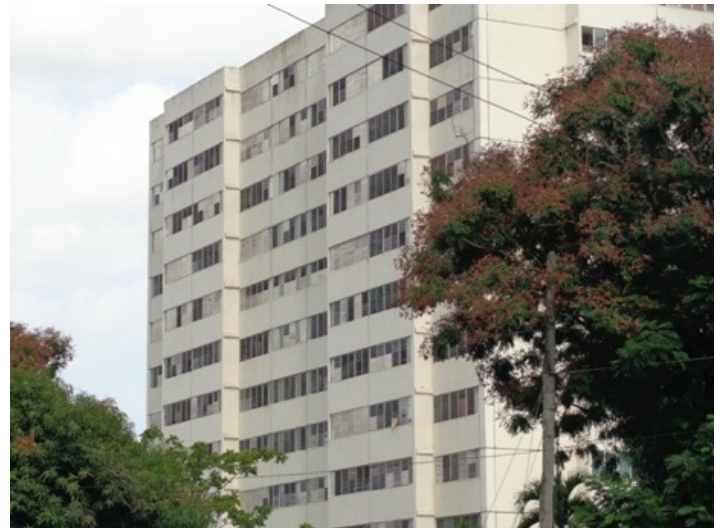
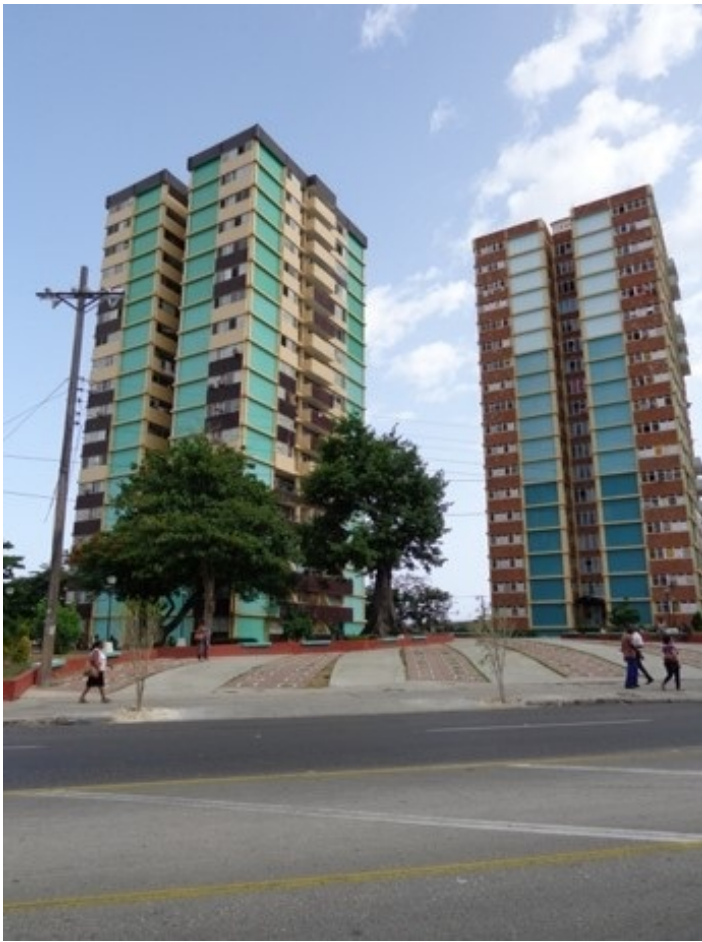
Consisting of precast post-tensioned slabs; the beams are formed when the joints between the horizontal elements (slab-slab) are constructed forming the rigid diaphragm.
