World Housing Encyclopedia

HOUSING REPORT

Ductile RC frame buildings with infill walls of polystyrene (POLIMAT)

Report#	192
Last Updated	01/26/2016
Country	Cuba
Author(s)	Grisel Morejon Blanco, Kenia Leyva Chang, Dario Candebat Sanchez, Zulima Rivera Alvarez, Yelena Berenguer Heredia, Madelin Villalon Semanat, Dominik H. Lang, Abdelghani Meslem,
Reviewers	Jaiswal, Kishor,

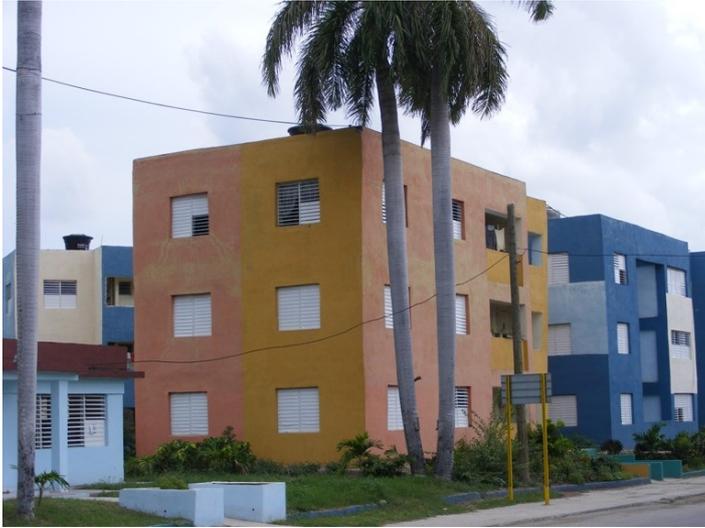
Additional comments on floor system	Cast-in-situ flat slabs
Type of Roof System	Cast-in-place beamless reinforced concrete roof
Additional comments on roof system	Cast-in-situ flat slabs
Additional comments
