World Housing Encyclopedia

HOUSING REPORT

Unreinforced brick masonry with flat roof

Report#	20
Last Updated	
Country	India
Author(s)	Amir Ali Khan, Dr. Khalid Moin,
Reviewers	Ravi Sinha,

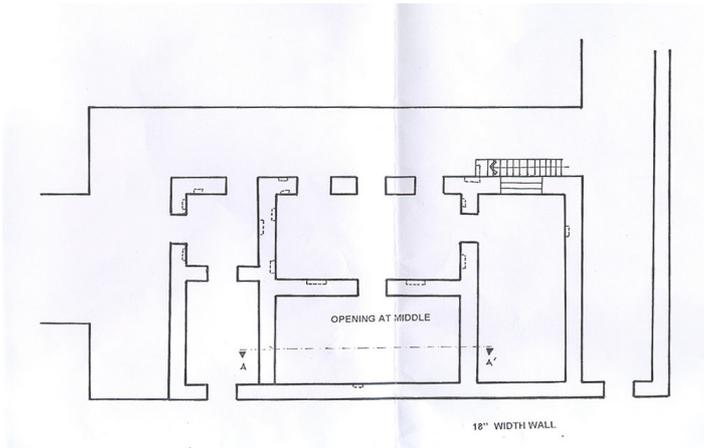
Plan of a Typical Building

Plan Shape	Rectangular, solidL-shape
Additional comments on plan shape	
Typical plan length (meters)	12-18
Typical plan width (meters)	7-10
Typical story height (meters)	3
Type of Structural System	Masonry: Unreinforced Masonry Walls: Brick masonry in mud/lime mortar
Additional comments on structural system	The gravity loads are transferred from the roof through the timber beams to the walls and then to the ground (there are typically no foundations in buildings of this type). There is no special provision for the lateral load transfer; in general, these buildings are very weak against the earthquake loads. Mud mortar is often used as mortar; cement mortar is used much less often. Lime mortar was used in some older construction (more than 50 years old). The roof is laid over the wooden beams fixed in the slots in the walls (Fig. 4); bricks or tiles or redstones are laid over the beams. To seal the leakage and improve bonding, a 1 ft. thick mud overlay is placed atop the tiles; thickness of this overlay increases with time (as the owner add more and more mud each year before the rainy season).

typical wall densities in direction 2	15-20%
Additional comments on typical wall densities	The typical structural wall density is 12 - 20%.
Wall Openings	This type of buildings have very less openings, generally there are no openings except doors. The buildings are usually comprised of two rooms. The inner rooms do have only one door in the middle while outer rooms have 3 doors. There are usually no other openings. In some cases small opening are made in the outer room over the doors. These houses usually constructed in form of the cluster with wall to wall attachment and as such there are no opening spaces except front portion of the buildings. In general, the opening are found above the middle door in the shape of small ventilators with some traditional shapes such as.
Is it typical for buildings of this type to have common walls with adjacent buildings?	No
Modifications of buildings	As such there are no modifications in this type of buildings. The only modifications take place in terms if providing extensions by constructing one room in the over the terrace of the housing unit.

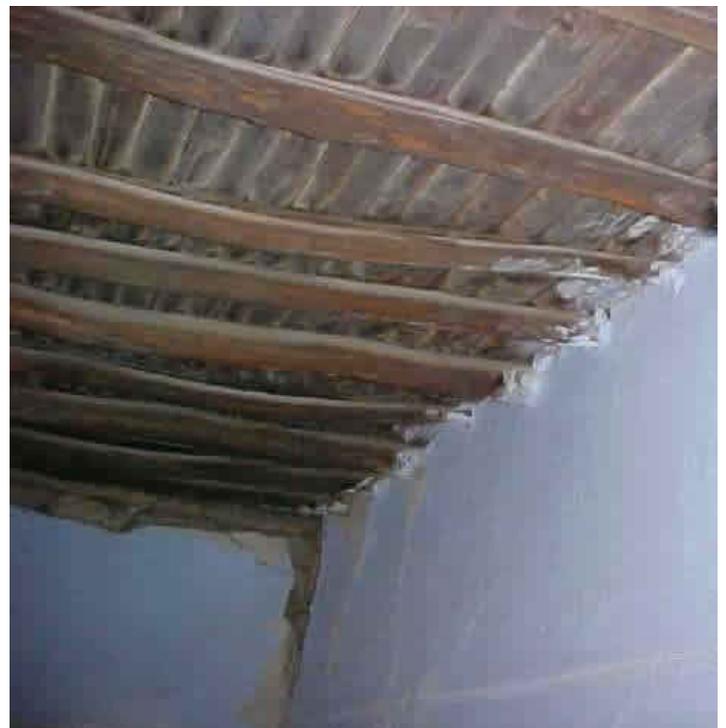
Critical Structural Details - Roof Structure (Source: Sudhir K. Jain, IIT Kanpur)

Type of Foundation	Shallow Foundation: Wall or column embedded in soil, without footing
Additional comments on foundation	
Type of Floor System	Other floor system
Additional comments on floor system	
Type of Roof System	Wooden beams or trusses with heavy roof covering
Additional comments on roof system	In this type of buildings timber beams are put over the walls. Clay tiles cover these beams and overlaid by mud. The mud layer may be of about 1 feet thick, which is laid over the clay tiles/bricks. This type of buildings are single - storey units in general. In few of the buildings one room is built over the roof. As such no flooring is done. The roofs are flexible in nature. To avoid leakage of rain water, mud is overlaid upon the roof year after year and thus the thickness of mud keep on increasing over the roof.
Additional comments	Houses may be located closely without chink or with

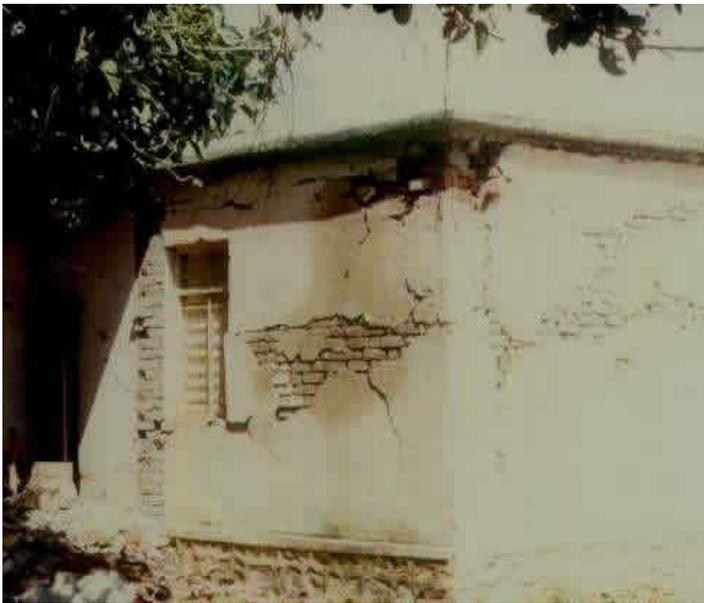
Critical Structural Details - Unreinforced Brick Masonry Wall in Mud Mortar (1993 Killari Earthquake), Source: Sudhir K. Jain, IIT Kanpur

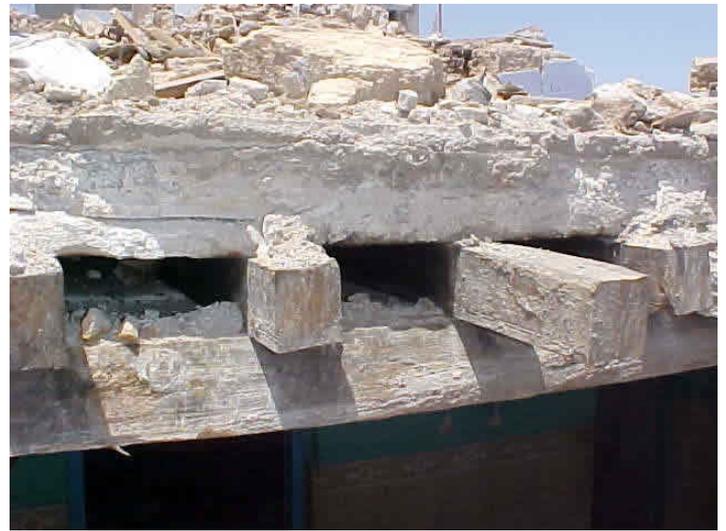
Key Seismic Deficiencies - Heavy Roof

Earthquake-resilient features in frame	
Seismic deficiency in roof and floors	##No proper connection between the wall and roof##Heavy load of mud over the roof.
Earthquake resilient features in roof and floors	
Seismic deficiency in foundation	
Earthquake-resilient features in foundation

Structural Deficiency	Seismic Strengthening
Heavy roof due to extensive mud overlay	Removal of mud from the roof top will help in overall weight reduction of the building
Inadequate wall resistance due to the absence of seismic provisions	i) Covering the wall with seismic belt (iron wire mesh and cement mortar) at lintel level on both (inner as well outer) sides of the wall (-1 ft to +1 ft at lintel level) (Seismic belt at +1 ft. above slab level covering parapets is proposed to enhance the box action / integrity of the roof and wall)
Roof (New Construction)	#NAME?
Foundation (New Construction)	Provision of strip foundation (currently, many buildings of this type do not have foundations at all)
Wall (New Construction)	- Provision of RC ring beams are plinth, lintel and roof levels - Provision of vertical steel reinforcement bars at the wall corners and intersections
Additional comments on seismic strengthening provisions

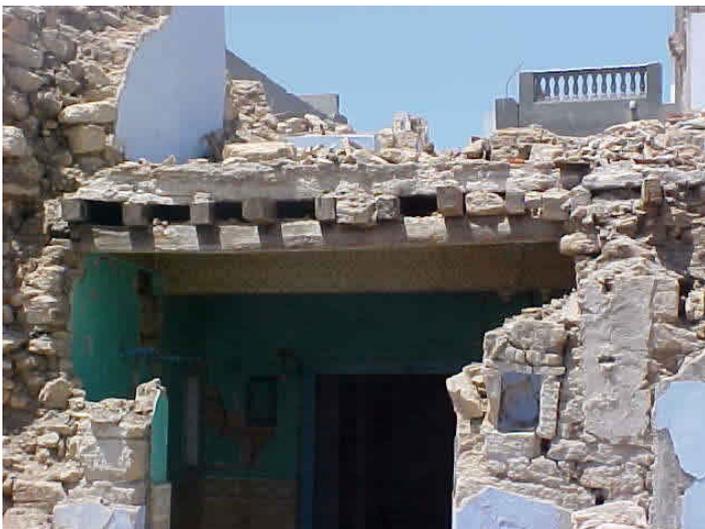
Typical Earthquake Damage in the 2001 Bhuj Earthquake Damage in the 2001 earthquake (Source: Sudhir K. Jain, IIT Kanpur)

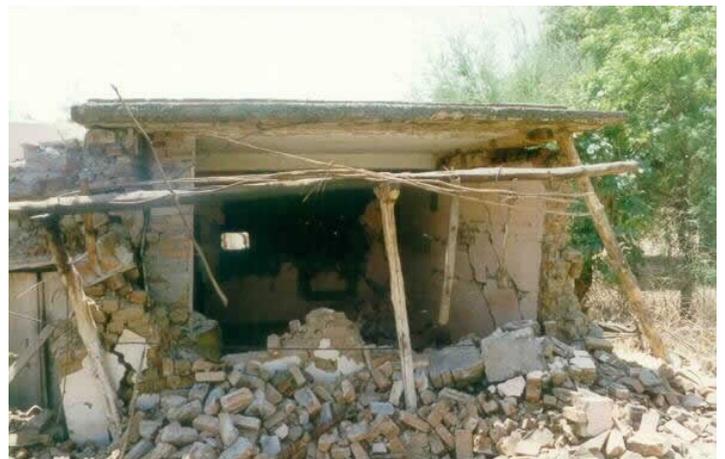
Typical Earthquake Damage - Failure of Masonry Walls in the 1997 Jabalpur Earthquake (Source: Sudhir K. Jain, IIT Kanpur)
