World Housing Encyclopedia

HOUSING REPORT PC Frame Buildings (Series 1-451)

Report#	202
Last Updated	
Country	Armenia
Author(s)	
Reviewers

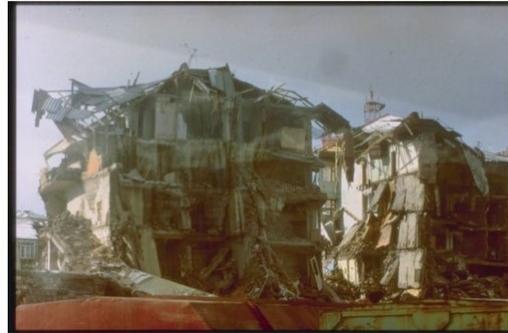
Partial Collapse of Masonry Building, Spitak, Armenia

Partially collapsed five-story stone masonry building in Spitak. Such unreinforced buildings were all heavily damaged in Spitak, but in Leninakan many survived with little or no damage.

(a) Out-of-plane collapse of stone walls (ref. 1) (b) Partial collapse of building at Gyumri (by NSSP EEC)
 Figure 5.3-7 Damages of stone buildings, series 1-451, at the Spitak earthquake

Damage patterns observed in past earthquakes for this construction type	The 1988 Earthquake with epicenter in Spitak, Armenia (Mw 6.9) affected buildings of this construction typology. The lack of unification between the seismic bands and the floor void slabs, as well as the floor void slabs supported by longitudinal walls, caused larger damages such as out-of-plane failures of stone-bearing walls located at the side of the buildings.
--	--
