# World Housing Encyclopedia

## HOUSING REPORT Confined masonry building

<b>Report#</b>	50
<b>Last Updated</b>	
<b>Country</b>	Peru
<b>Author(s)</b>	Cesar Loaiza, Marcial Blondet,
<b>Reviewers</b>	Sergio Alcocer,

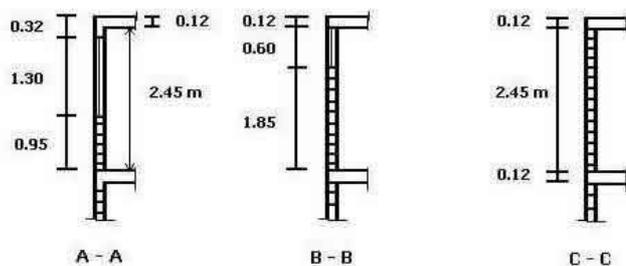
**Critical Structural Details - Wall Sections**

Masonry walls are built with serrated endings, then tie columns are cast against them. After that tie beams, lintels and floors are built simultaneously. The equipment commonly used is: concrete mixer, traveling crane, winch, trucks. Typically not built incrementally, buildings originally designed for final constructed size.

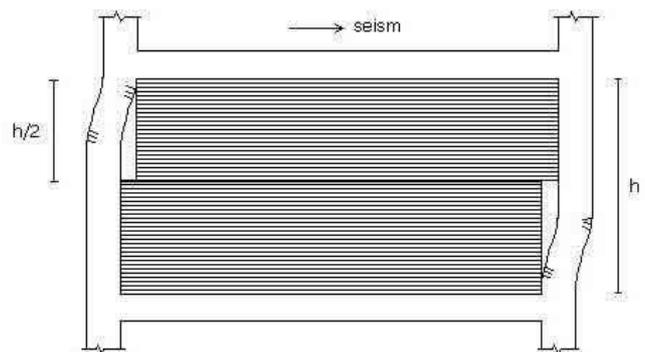
**An Illustration of Key Seismic Deficiencies**

-Walls or opening end zones without confinement; - Poor quality of mortar; -Deficient construction joints; -Inadequate reinforcement detailing at the tie-column-to-tie beam joints.

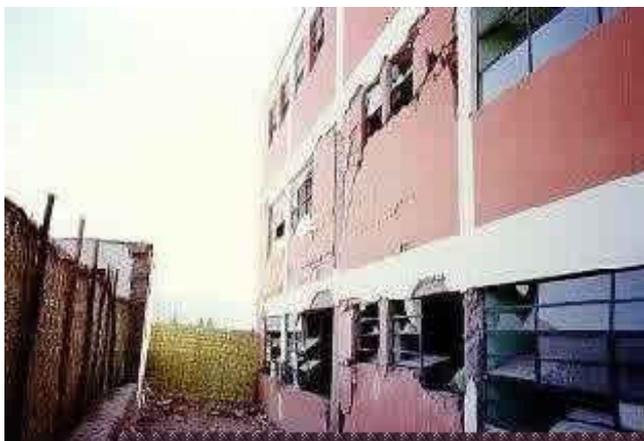
***A Photograph Illustrating Typical Earthquake Damage***

<b>Damage patterns observed in past earthquakes for this construction type</b>	Wall shear cracking that propagates through tie columns.
<b>Additional comments on earthquake damage patterns</b>

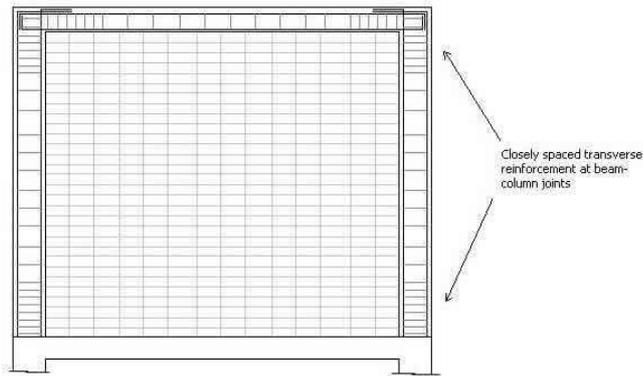
## ***Illustration of Seismic Strengthening Techniques***

<b>Structural Deficiency</b>	<b>Seismic Strengthening</b>
Columns	Installation of additional shear reinforcement in tie columns (Figure 7)
Parapets and nonstructural walls (new construction)	Parapets are confined with tie-columns and bond-beams. When parapets are located between tie-columns, walls are isolated through construction joints.
<b>Additional comments on seismic strengthening provisions</b>	
<b>Has seismic strengthening described in the above table been performed?</b>	Yes, parapets are confined and non structural walls are isolated from the structure.
<b>Was the work done as a mitigation effort on an undamaged building or as a repair following earthquake damages?</b>	The seismic strengthening was done in a new construction.
<b>Was the construction inspected in the same manner as new construction?</b>	N/A
<b>Who performed the construction: a contractor or owner/user? Was an architect or engineer involved?</b>	Usually engineers are involved.
