World Housing Encyclopedia

HOUSING REPORT **Confined masonry house**

Report#	51
Last Updated	
Country	Peru
Author(s)	Cesar Loaiza, Marcial Blondet, Papa Simona,
Reviewers	Sergio Alcocer,

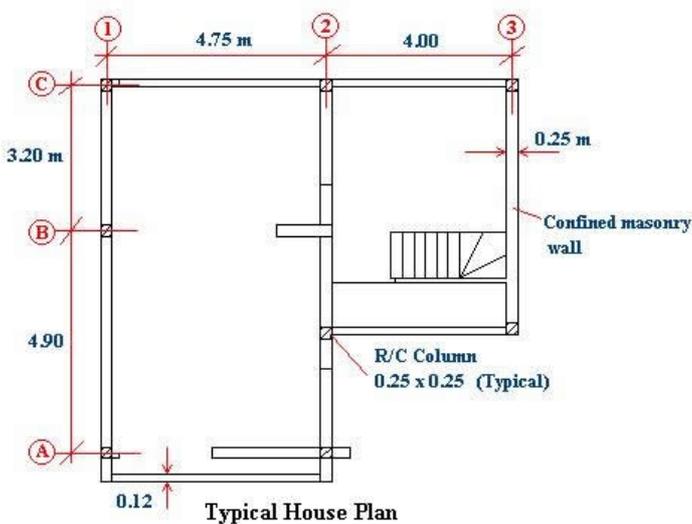
Plan of a Typical Building

Plan Shape	Rectangular, solid L-shape
Additional comments on plan shape	Rectangular shape or L-shape.
Typical plan length (meters)	10-15
Typical plan width (meters)	5-10
Typical story height (meters)	2.6 - 2.8
Type of Structural System	Masonry: Confined Masonry: Clay brick masonry with concrete posts/tie columns and beams
Additional comments on structural system	<p>The lateral load-resisting system is confined masonry wall system. Masonry shear walls give stiffness to the structure and control lateral drifts. Tie columns and bond beams provide adequate confinement and ductility to the masonry walls. Typical houses have a good wall density in one horizontal direction, but a lower wall density in the other. This makes the house particularly vulnerable in the horizontal direction where the density is lowest. Tie columns have enough longitudinal reinforcement to resist overturning moments. Closely spaced transverse reinforcement at beam-column joints provides adequate ductility to resist seismic forces. Floors/roofs can consider to be rigid diaphragms in the analysis. Typical wall thickness is 150 mm or 250 mm. In general, the same system as describe above. Floors/roofs transmits gravity loads to the structural walls.</p>

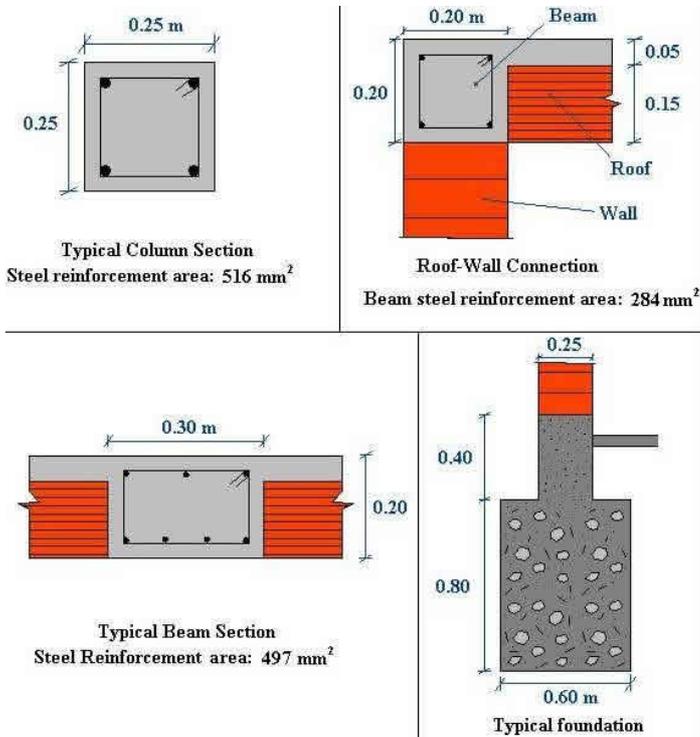
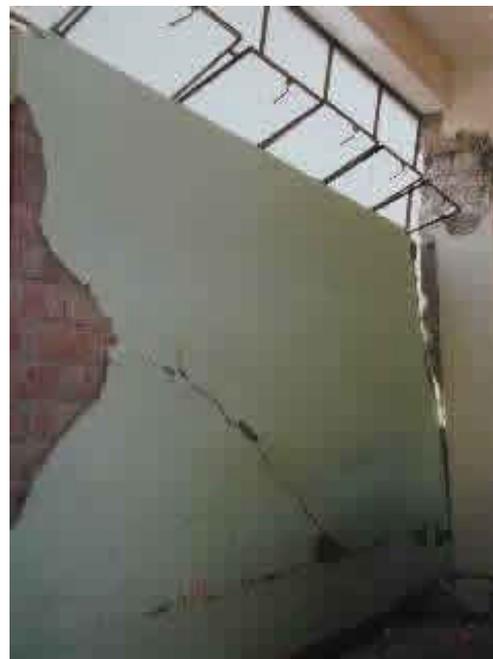
Key Seismic Features-Slender Walls

Additional comments on structural and architectural features for seismic resistance	
Vertical irregularities typically found in this construction type	Other
Horizontal irregularities typically found in this construction type	Other
Seismic deficiency in walls	-Inadequate thickness to resist gravity and seismic loads (slender walls). -Inadequate wall density in one direction.

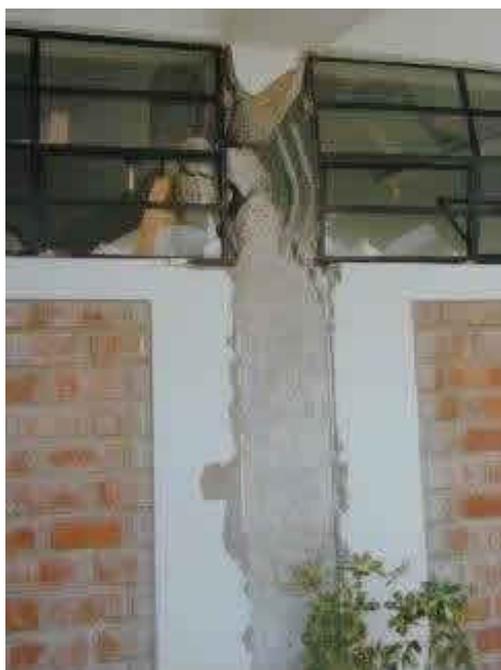
Seismic Deficiencies - Short Column

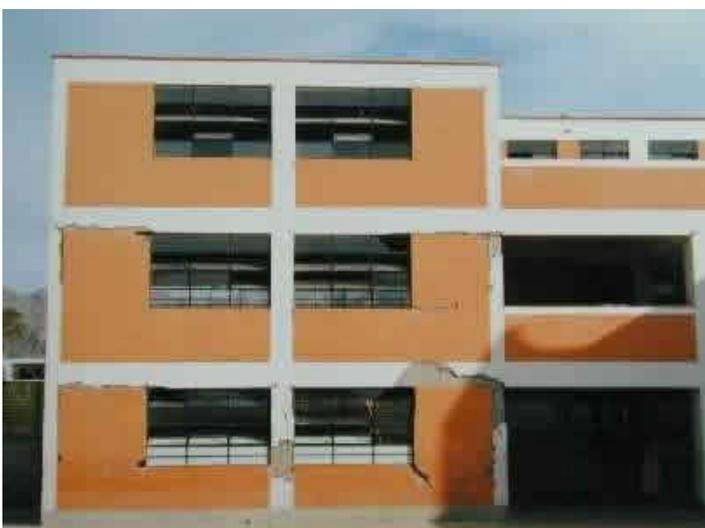
A Photograph Illustrating Typical Earthquake Damage (1996 Nazca earthquake)

Damage patterns observed in past earthquakes for this construction type	
Additional comments on earthquake damage patterns	Shear cracking in the walls (cracks propagate through tie columns).

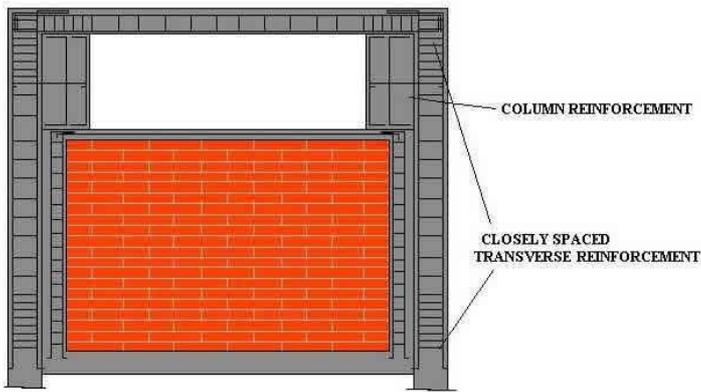
Illustration of Seismic Strengthening Techniques

Structural Deficiency	Seismic Strengthening
Parapets and nonstructural walls	Parapets and nonstructural walls are confined with tie columns and bond beams. When parapets are located between tie columns, they are isolated with a construction joint.
Additional comments on seismic strengthening provisions	
Has seismic strengthening described in the above table been performed?	Yes, parapets are confined and nonstructural walls are isolated from the structure.
Was the work done as a mitigation effort on an undamaged building or as a repair following earthquake damages?	The seismic strengthening was done in a new construction.
Was the construction inspected in the same manner as new construction?	Yes
Who performed the construction: a contractor or owner/user? Was an architect or engineer involved?	Usually engineers are involved in the strengthening efforts.
What has been the performance of retrofitted buildings of this type in subsequent earthquakes?	Good seismic performance: parapets resist overturning forces and cracking effects were reduced in non structural walls.
