# World Housing Encyclopedia

## HOUSING REPORT

### Wood panel wall buildings (typical seria 181-115-77cm of #Giprolesprom#)

<b>Report#</b>	57
<b>Last Updated</b>	
<b>Country</b>	Russia
<b>Author(s)</b>	Mark Klyachko, Andrey Benin, Janna Bagdanova,
<b>Reviewers</b>	Svetlana Uranova,

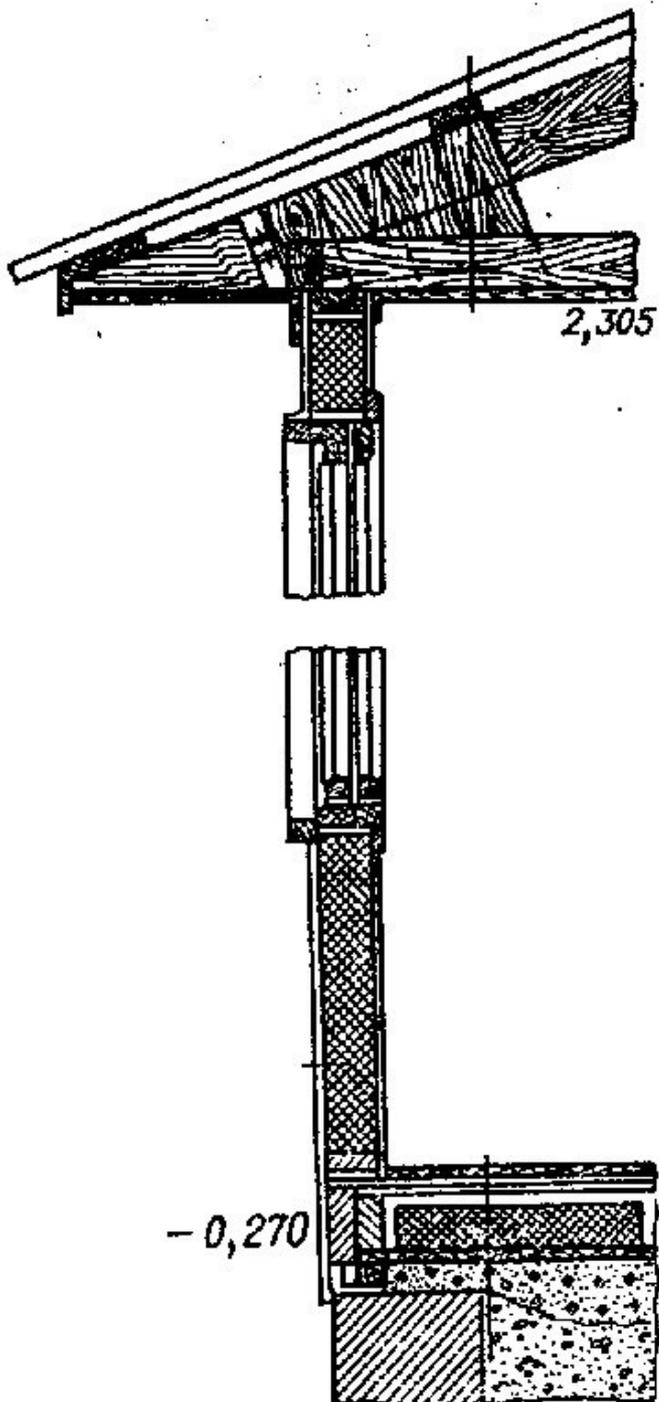
***Critical Structural Details - Vertical Sections Through the Wall***
